# 66000A-05 <u>S E R V I C E N O T E</u>

## 66000A DC Power Supply System Mainframe

#### Non-functioning trigger In/Out capability when using multiple 6610XA modules

March 22, 2007

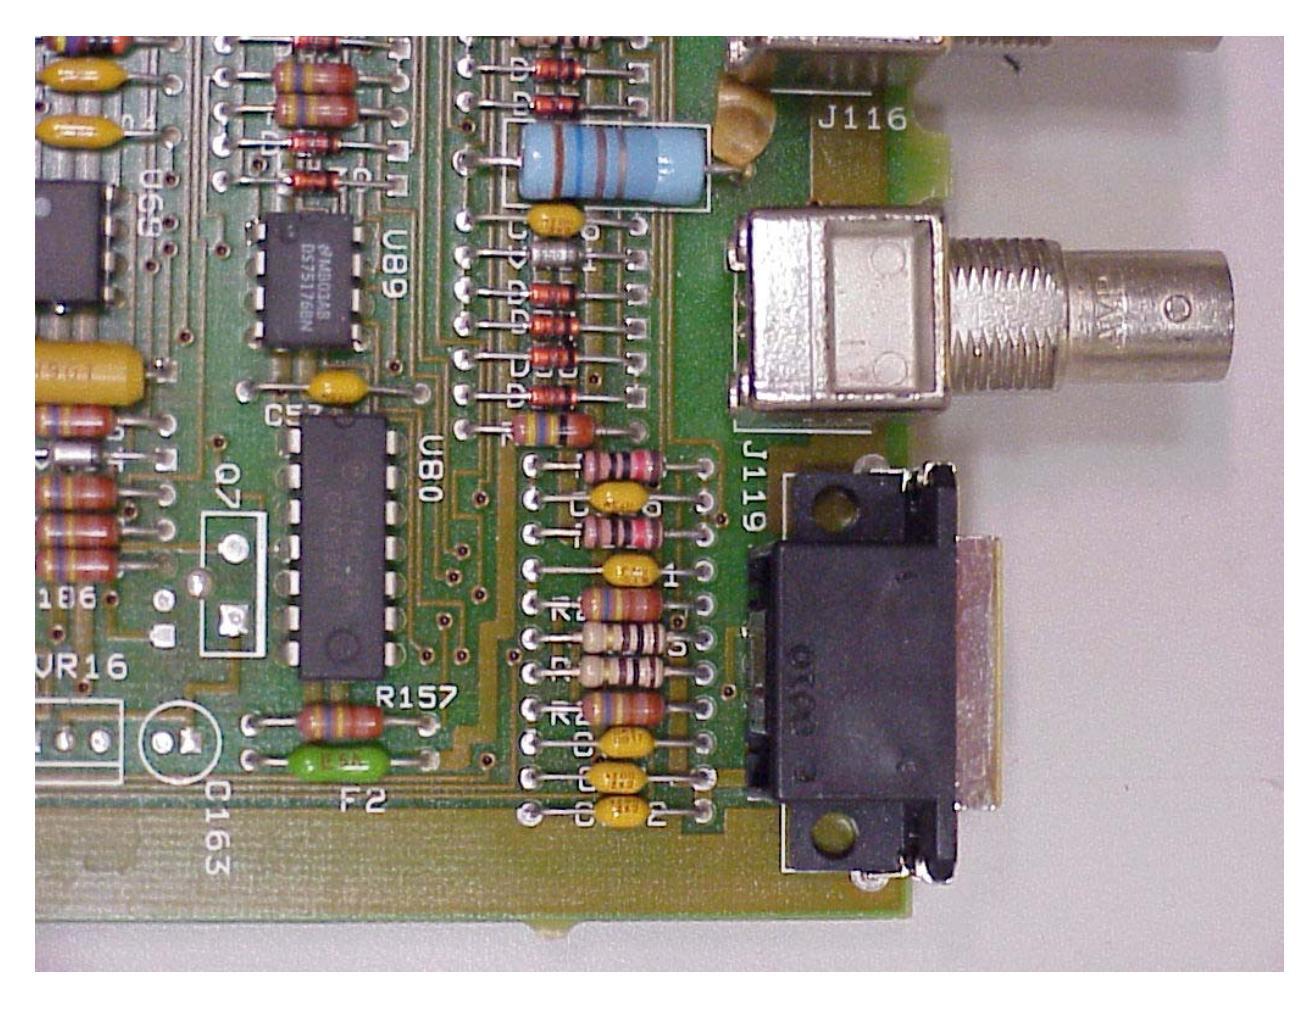
Figure 2 below has been provided to help locate the IC (circuit reference "U80") which is on the PCA P/N 66000-60020 and the tested PCA assembly p/n 66000-61020.

It has been recommended that any 66000A mainframe that has (Circuit Reference "U80") with the defective date code shown in figure 1, the defective part should be replaced. The replacement part can be any approved manufacture of p/n 1820-3097. It has been determined that any approved manufacture and dated code can be used except for Fairchild date code P0530AB.
