# 66321D-09 <u>SERVICE NOTE</u>

# 66321D – Mobile Communication DC Source, 15V/3A with Battery Emulation. GPIB

Serial Numbers: MY43003480 – MY43005710 SG43003480 – SG43005710

Power-On Self test Errors, Auto reboot, Blank display. No output Communication errors. No communication when using the GPIB Interface.

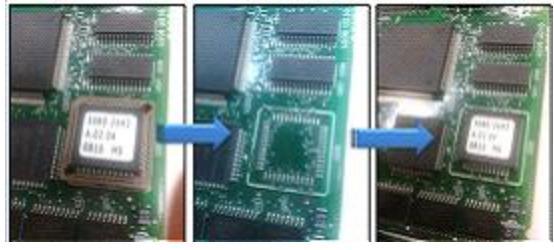
When the EEPROM is installed in the PLCC SOCKET (Circuit Reference U205) on the Interface board if there is not a gas tight connection between the EEPROM pins and the socket pins an intermittent connection will occur.

It has been determined when removing the socket and soldering the EEPROM (circuit reference U205) directly on the interface assembly "A2" would be very difficult (See Picture below), even having the correct tools, removal of the socket and replacement of the EEPROM is very difficult and may cause additional quality and reliability issues.

The EEPROM may have bent and or dirty pins. Bent Pins and dirty pins will cause reliability problems. The EEPROM can be over heated and damaged during this procedure and will cause reliability problems. The EEPROM is a static sensitive device and can be damaged due to ESD.

- 1. The problem can be solved by replacing the GPIB Interface assembly. See above for the tested interface P/N that is required to repair the instrument. The correct tested assembly for the specific model must be used when repairing a defective instrument.
- 2. This problem can also be solved by removing the socket (circuit reference U205) on the "A2" interface assembly and soldering the Original EEPROM directly to the Printed Circuit assembly
