Modification Recommended Service Note

B2962A 6.5 Digit Low Noise Power Source, 32W, 210V, 3A, 2ch

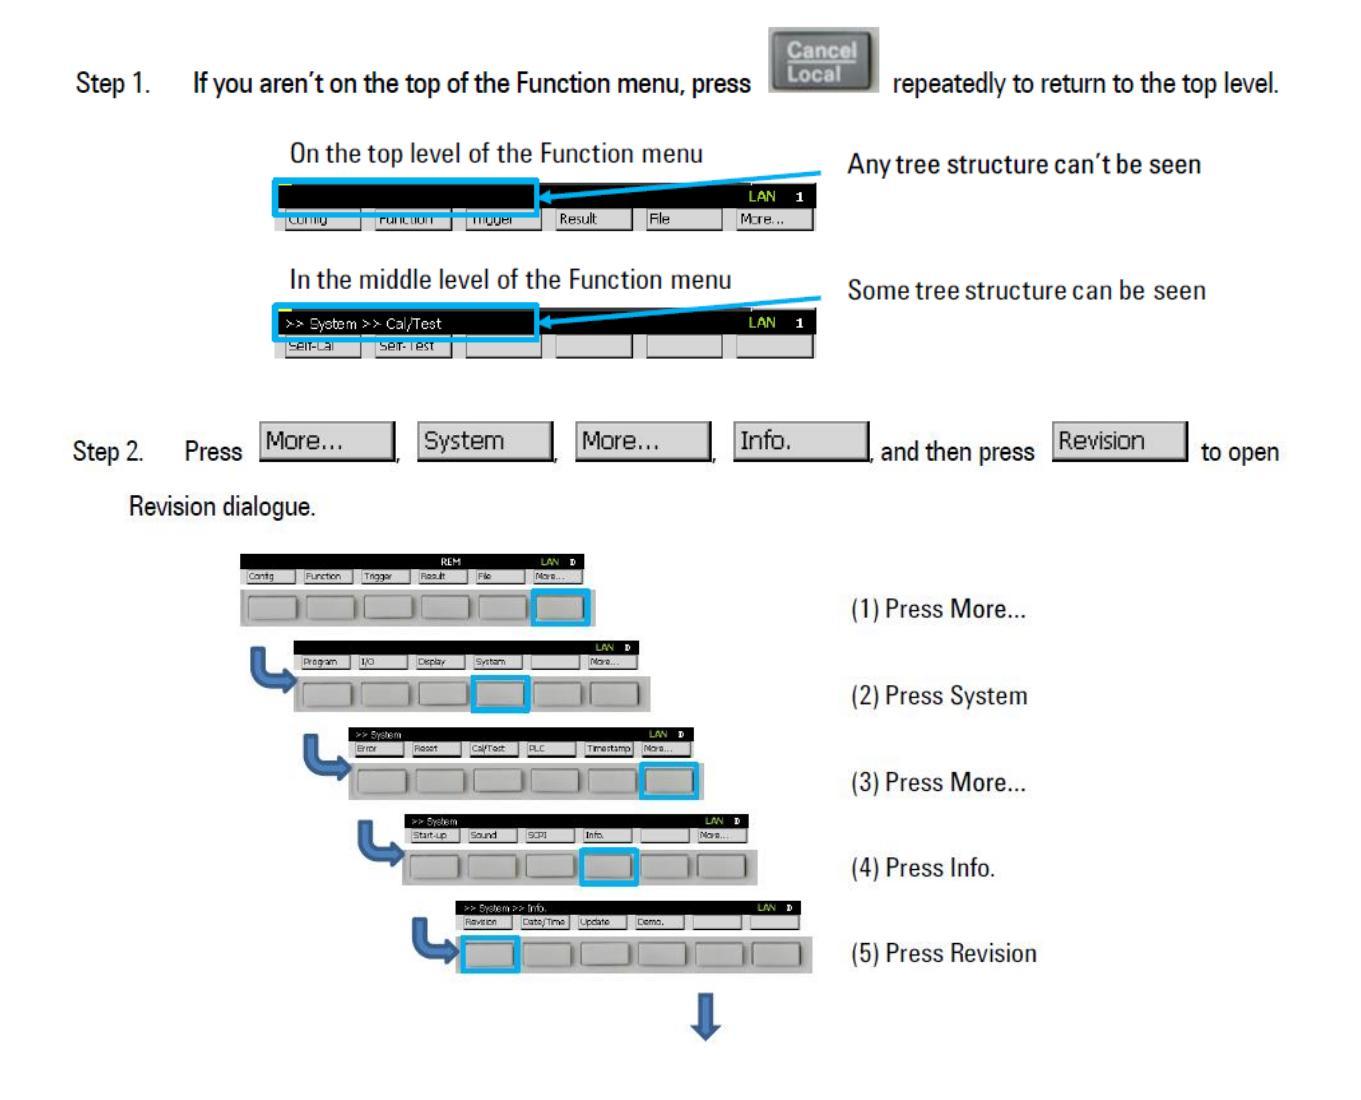
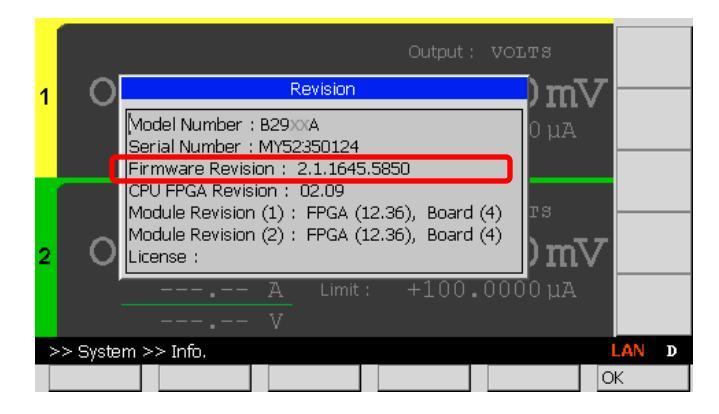
The B2962A with the following firmware revisions may have an internal communication error. This error may occur at the power on or when updating the firmware to the below revisions.

Firmware revision: 2.1.1645.5850 Firmware revision: 2.2.1744.8725

(a) Confirm the firmware revision as follows and check against the table above.

Step 2: If the firmware revision displayed is 2.2.1744.8725 or earlier, install the firmware 2.2.1831.4380 or later, following the procedure below.
