E6601A-01 <u>S E R V I C E N O T E</u>

E6601A Wireless Communications Test Set

Recover On-Failure (ROF) Program for CISPR 11 radiated emissions test failure.

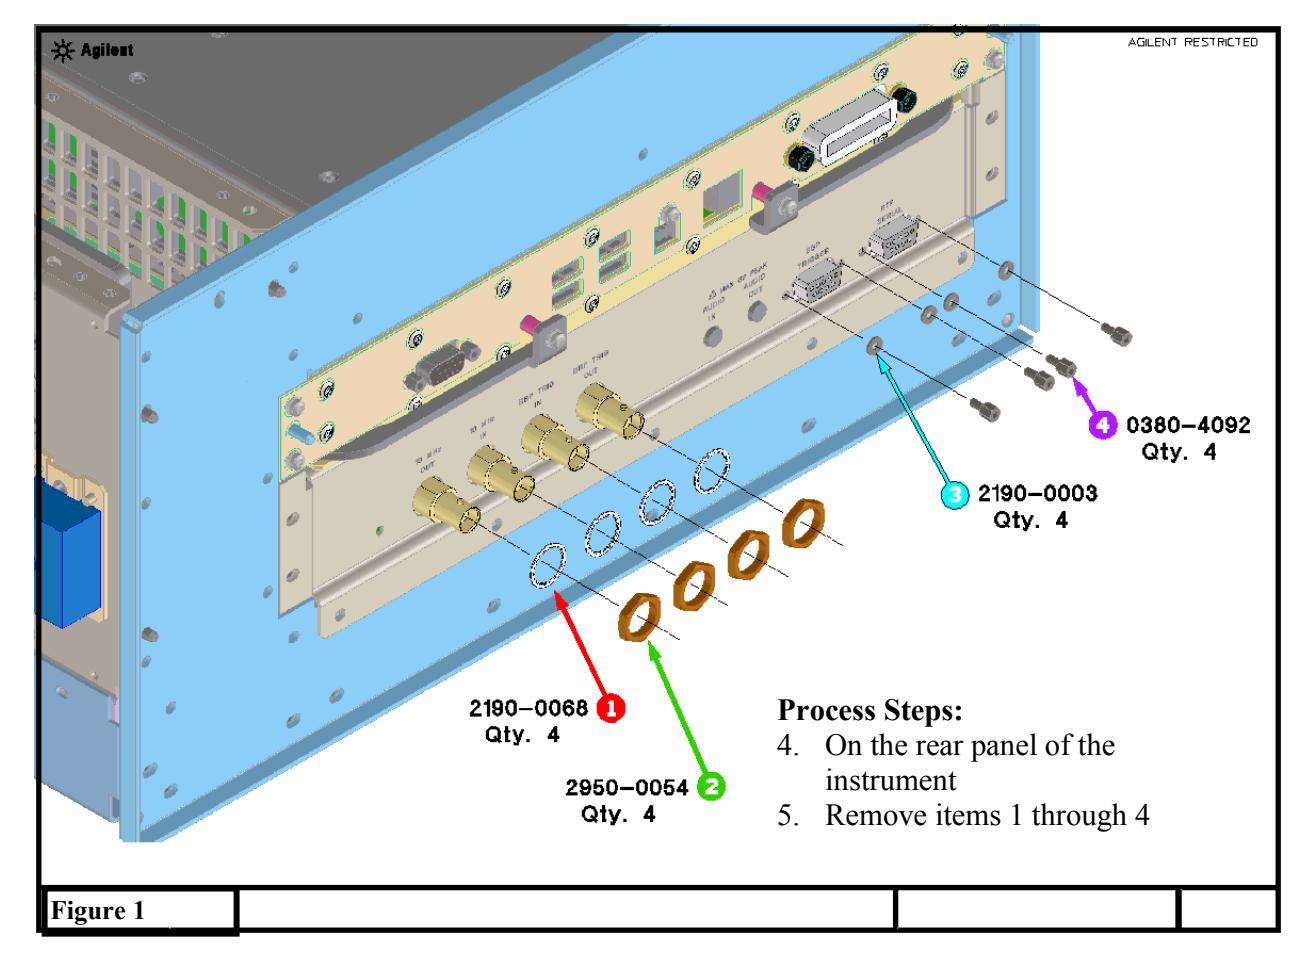
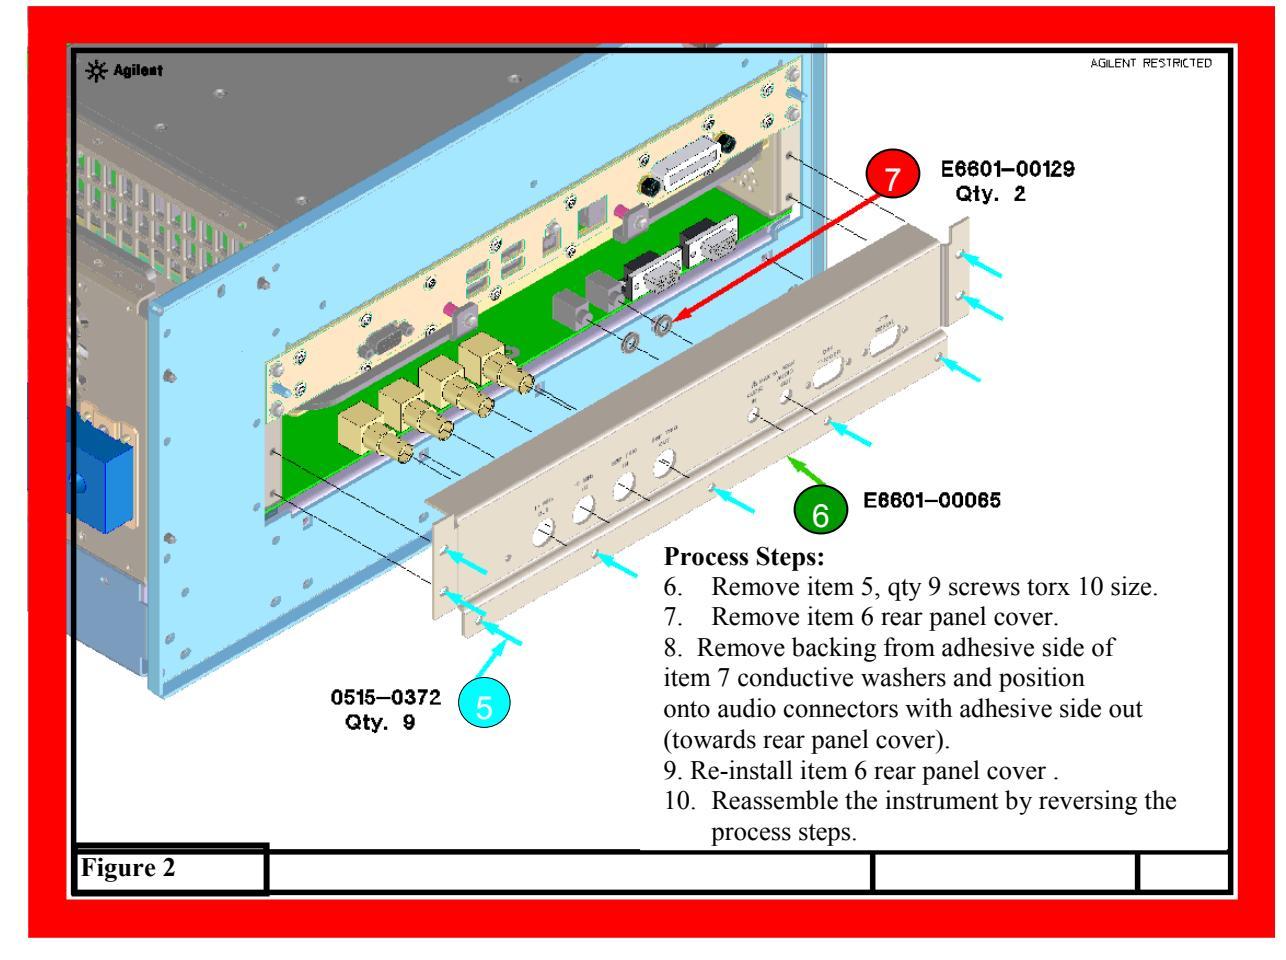
CISPR 11 radiated emissions test failure due to insufficient grounding on the rear panel Audio In and Audio Out connections.

Rear panel connections Audio In and Audio Out require additional grounding. This is accomplished by inserting a conductive washer between the rear panel cover and the audio connectors on the mother board. Figures 1 and 2 show the location of the parts to be installed.

- 1. If the instrument is turned on, shut the instrument down via the front panel on/off button and unplug the line cord from the instrument.
- 2. Attach an electrostatic discharge strap to the instrument and take necessary electrostatic discharge precautions.
- 3. Go to Figure 1 and follow the process steps:

11. After the conductive washers have been installed and the instrument rear panel cover has been reassembled, plug in the instrument and verify the E6601A is operating properly.
