Modification Recommended Service Note

M9018B PXIe Chassis: 18 Slot, 3U, 8 GB/s

M9018B Soft Front Panel displays Unexpected Internal Software Error (BFFA0018)

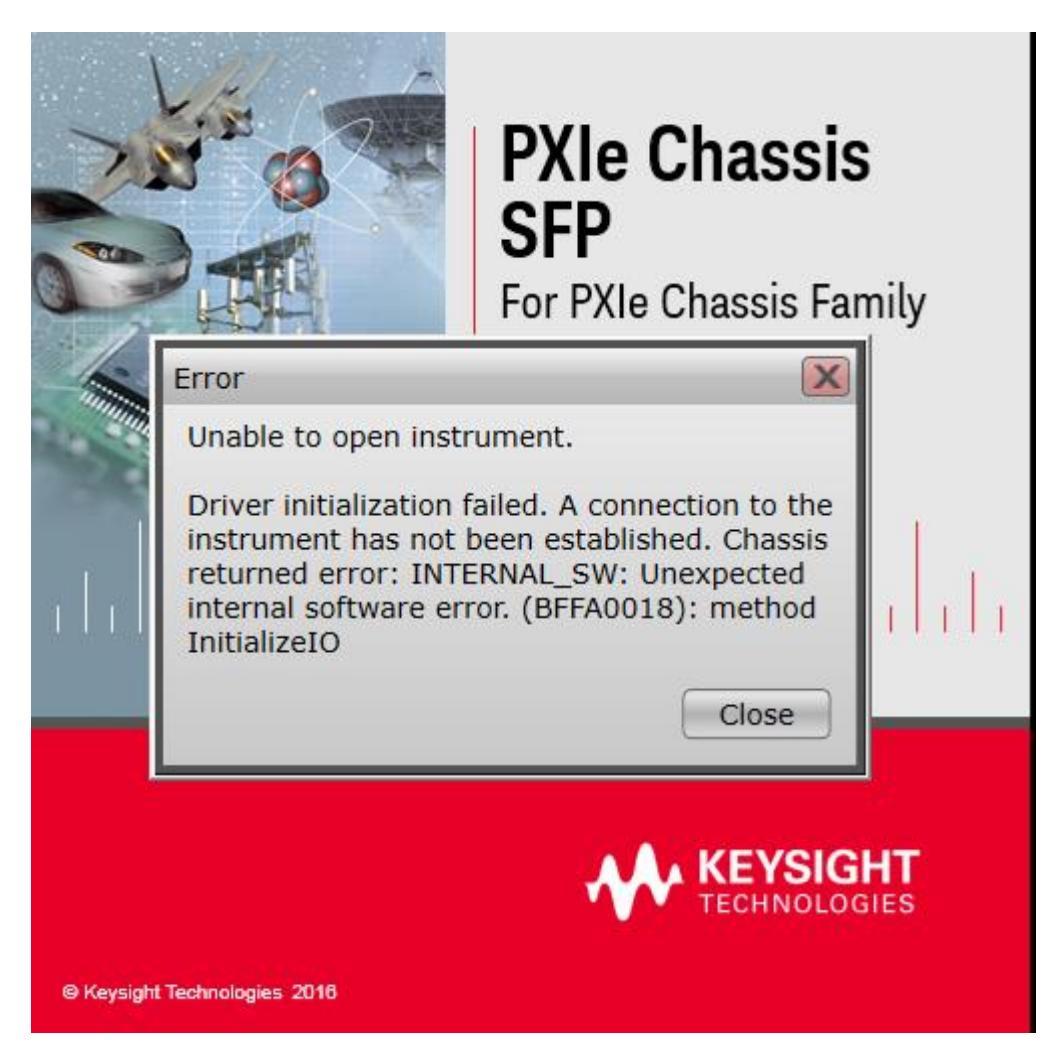
It has been found that when the Soft Front Panel for a PXIe Chassis M9018B was opened, the following Soft Front Panel error was generated:

It was discovered that the trigger bridge of the firmware was displaying the incorrect User Code, which generated the above error and prevented the chassis SFP from being opened.

The user must program the left bridge trigger using the "lattice_xsvf_player" program tool. See the Syntax.txt file located in the zipped Lattice for how to run the tool. **Program the trigger bridge 2 times to ensure it is working properly.**
