# N1996A-03 <u>S E R V I C E N O T E</u>

### N1996A Agilent CSA Spectrum Analyzer

#### DIF FPGA Upgrade Failure While Upgrading to >= A.02.00 Firmware

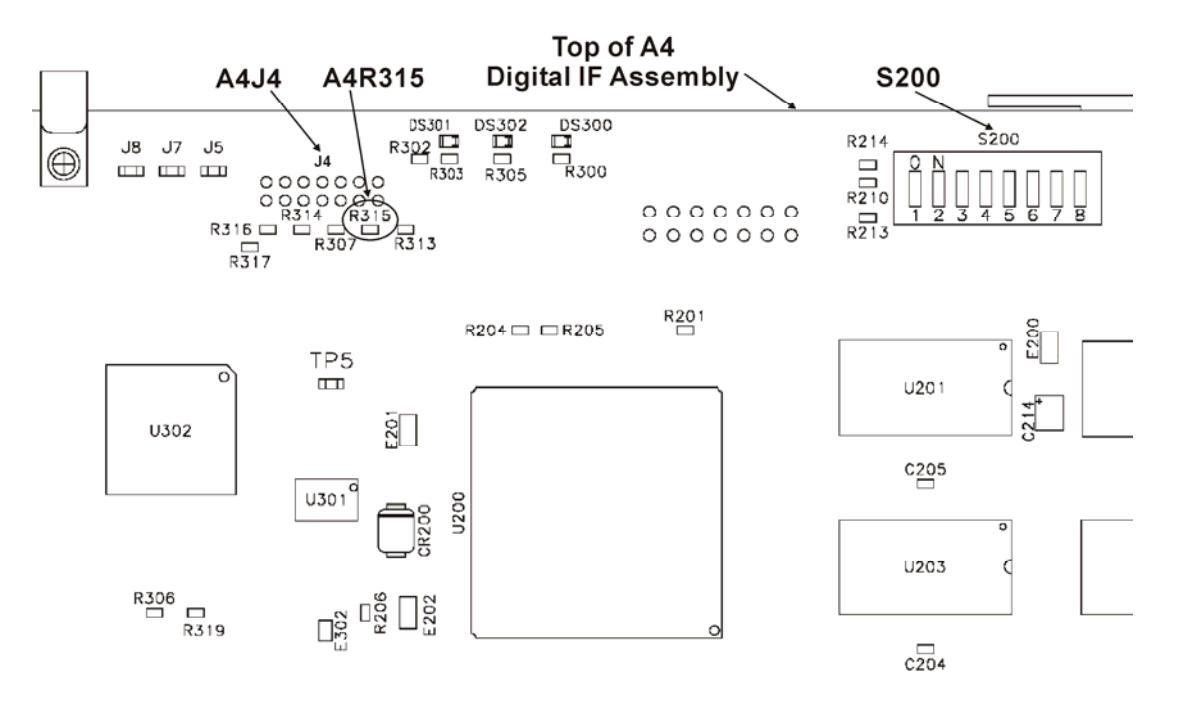
When performing a firmware upgrade on older N1996A spectrum analyzers to  $\geq$  A.02.00, one of the last steps of the upgrade process is to upgrade the FPGA code on the A4 Digital IF ("DIF") board. This upgrade process is very susceptible to glitches on the data and clock lines. If a glitch occurs at the wrong time during the DIF FPGA upgrade process, the upgrade will fail, leaving the N1996A in an inoperable state.

N1996A spectrum analyzers with serial numbers US/MY/SG46490000 and above have a newer A4 DIF board, p/n N1996-60033, which have a lower value for R315 which prevents the glitches from occurring.

Figure 1. A4 Digital IF Assembly – Location of A4J4 JTAG connector and A4R315.

Also, by changing the value of R315 on the A4 DIF board to 75 Ohms, this problem will be avoided in the future. The resistor part number is 0699-3921.

The programming cable requires the A4 DIF board to have diagnostic connector J4 loaded. Early A4 DIF boards have this connector loaded but later boards do not. Therefore, it may be necessary to also load J4 with p/n 1253-6145.

- 2. Remove the analyzer's board cover as described in the Board Cover, Removal procedure in the N1996A Service Guide.
- 3. Remove A4 DIF assembly as described in the A4 IF Board, Removal procedure in the N1996A Service Guide.
- 4. Refer to Figure 1 below to locate A4R315. Remove A4R315 and replace it with a 75 Ohm resistor, p/n 0699-3921.
- 5. Refer to Figure 1 below. If J4 is not loaded, install a 14-position, right-angle connector header, p/n 1253-6145, in the space provided for J4.
