N2830A-01

Modification Recommended Service Note

N2830A 4 GHz InfiniiMax III+ Series Probe Amplifier

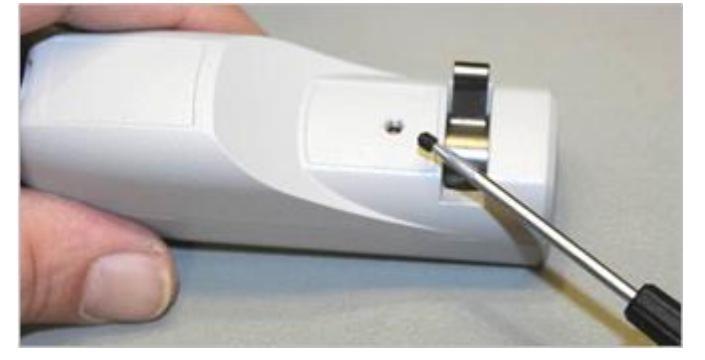
If the set screw is not stainless, it looks like the following after the sticker has been removed:

- a. If the screw is stainless, then remove adhesive and replace the label.
- b. No need to re-calibrate.
- c. If screw is black remove screw using T6 Torx.

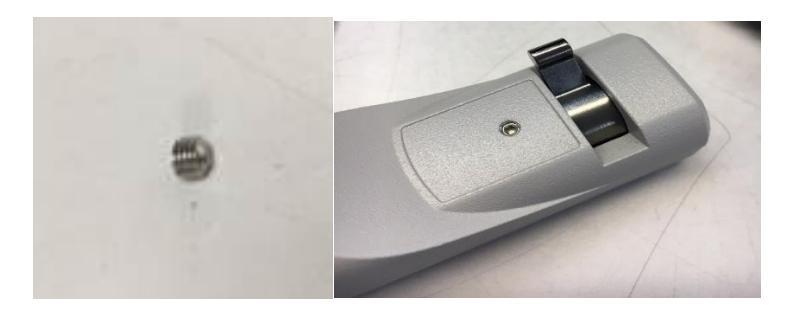
Below is what the new set screw should look like when inside the probe.

Install screw 0515-5534 Tighten T6 to 18 in oz.

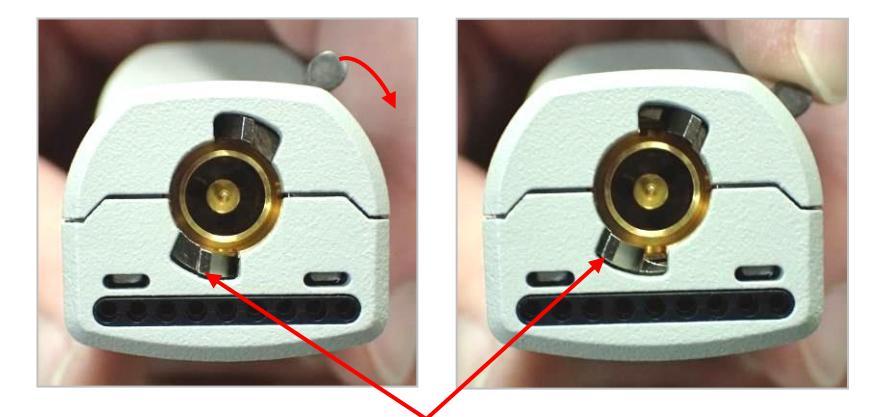
BNC tab rotates with BNC latch rotation

Test the BNC connector by rotating the wing latch clockwise, and verify the BNC tab rotates inside the pod housing.
