N8300A-03 <u>S E R V I C E N O T E</u>

N8300A Wireless Networking Test Set

Batch Related Component Issue May Result In A Non-Functioning Instrument

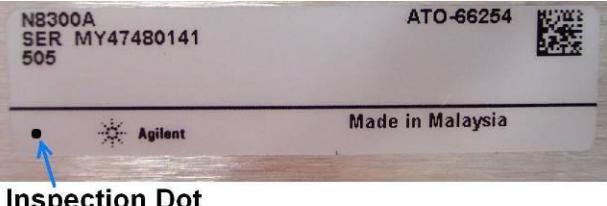
Inspection Dot

Check the rear panel serial tag for a small black inspection dot (see image below). If a black dot is present, similar to what is depicted, then the instrument has been repaired already, and no further action is required.

If the dot is not present then the instrument must be returned to Agilent; contact information is available at: http://www.agilent.com/find/assist

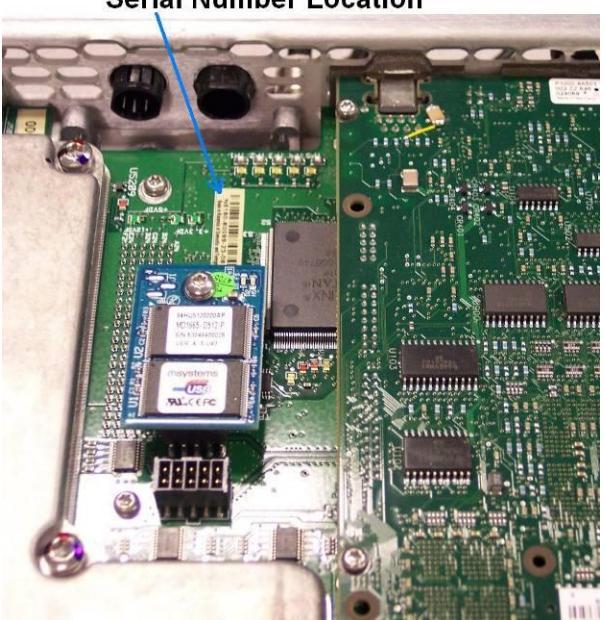
Serial Number Location

- (a) If the instrument cannot be powered-on, then it has a fault that is unrelated to this Service Note. This fault must be located and repaired before proceeding any further.
- (b) Remove the external covers from the instrument, and check the serial number of the Source Assembly (see image below for location and example).

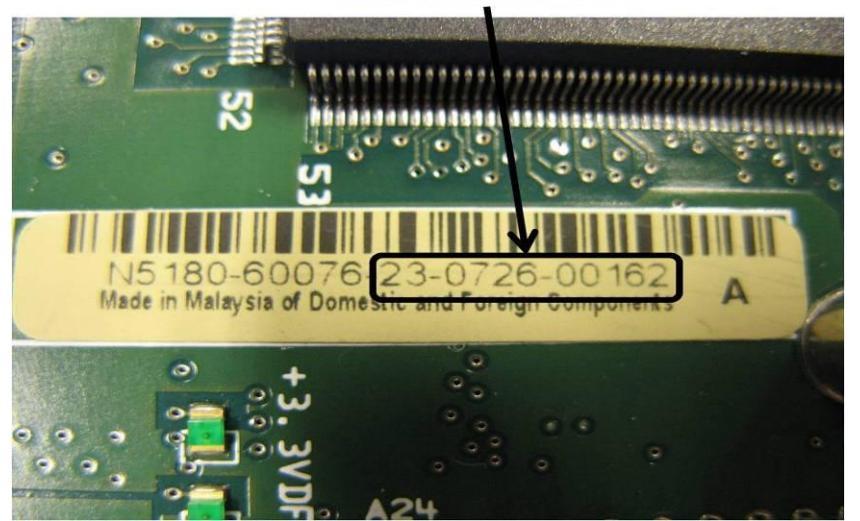
Serial number format

The serial number is the last 11 digits of the identification tag. In the following example the serial number is 23072600162.

- (c) If the Source Assembly serial number falls within the range of 23080500002 to 23081200228 then proceed to (f).
- (d) If the Source Assembly serial number does not match the serial numbers listed, then use a permanent marker to place a black dot on the serial tag as depicted in Step 1. Doing so will assist in future quick recognition that a specific unit has been inspected or repaired.
- (e) Re-fit the external cover to the instrument, and power it on to ensure it is functioning without displaying any errors.
 - If any errors are present, then the instrument has a fault that is unrelated to this Service Note.
 - If the instrument has no errors, then it can be returned to the customer; adjustment is not required.
- (f) Carefully remove the Source Assembly from the instrument.

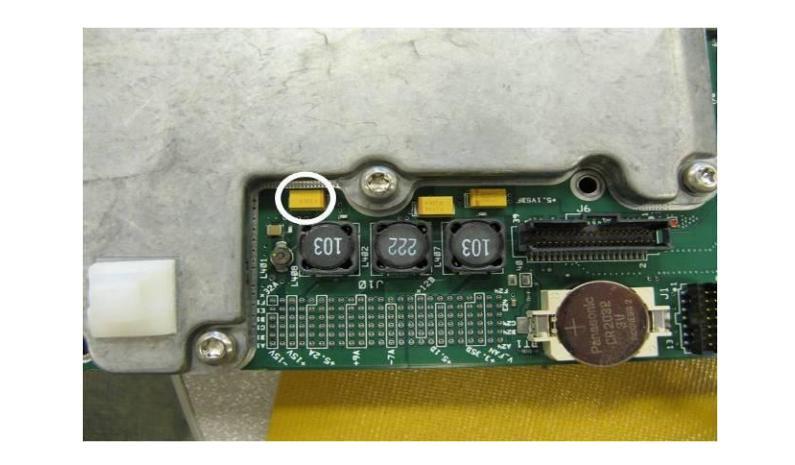
(g) Inspect C408 (10uF, 0180-4536) on the Top Side of the Source Assembly for lot code 712H2:

- (i) If parts are found with lot code **712H2**, replace the part with part number 0180-4536. Refer to the **Removing and Replacing Parts** section for soldering instructions.
- (j) If neither of the capacitors have lot code 712H2, or after the suspect capacitor(s) are replaced, reassemble the N8300A.

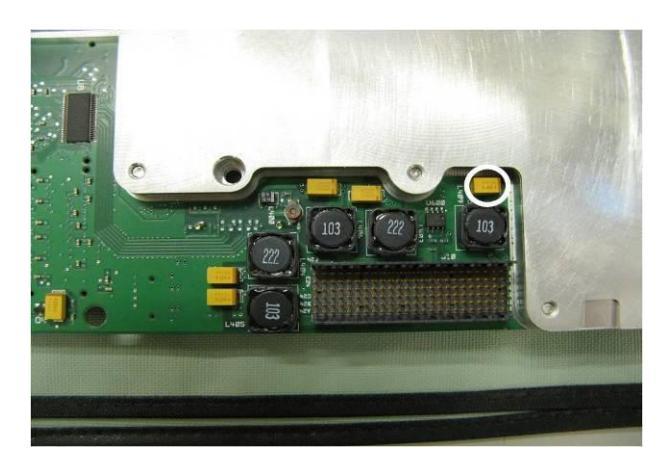
(h) Inspect C409 (10uF, 0180-4536) on the Bottom Side of the Source Assembly for lot code 712H2:
