U9405A-01 <u>S E R V I C E N O T E</u>

U9405A i1000 Small Foot Print Inline

Change in Fixture position sensor and brackets to prevent cable damages.

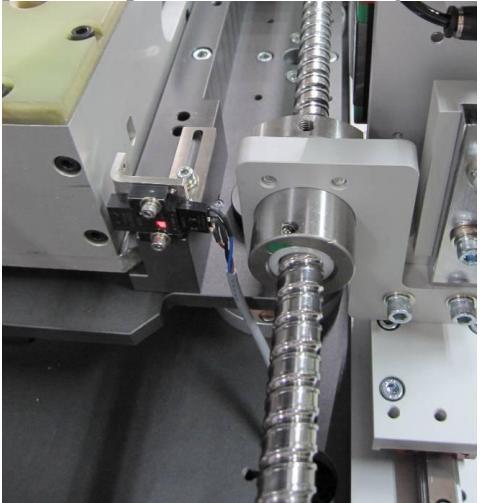
The Fixture position sensor is mounted at the back of the SFP to detect the fixture when it is inserted. The wires from the sensor are currently very close to the Conveyor width adjustment shaft. As such, it presents a potential risk for damage to occur.

The change is to replace the existing sensor and the metal bracket with a new sensor and new bracket.
