# **x6000-03** <u>S E R V I C E N O T E</u>

## Medalist x6000 Systems

Serial Numbers: N7280A = ALL

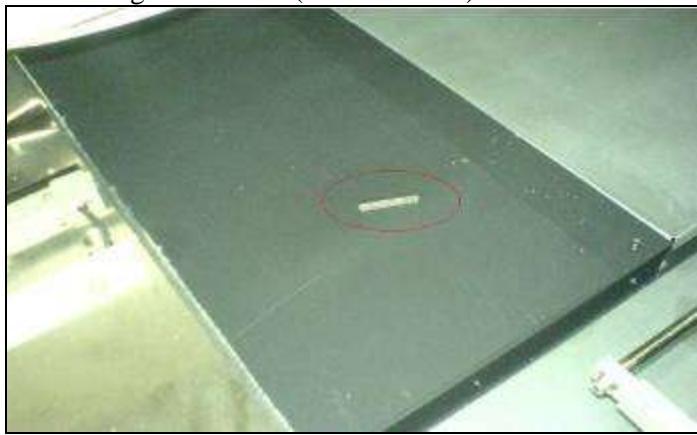
Parts sitting on the FSA (N7280-20205) or FSA side skirts:

Customers need to take precautions in the design of fixtures/carriers or other media to ensure that foreign objects (examples are screws, fixtures/carriers and PCBAs) do not fall into the machine. If anything should fall into the machine it should be cleared from the machine before continuing to use or operate the machine, i.e. no board should be in the machine before homing rails or initializing the system/software. These objects can jam between the FSA and the moving parts of the stage causing damage to the FSA, which can take approximately 4 hours to replace depending on the damage. The following pictures will help to illustrate what the damage to the FSA might look like.

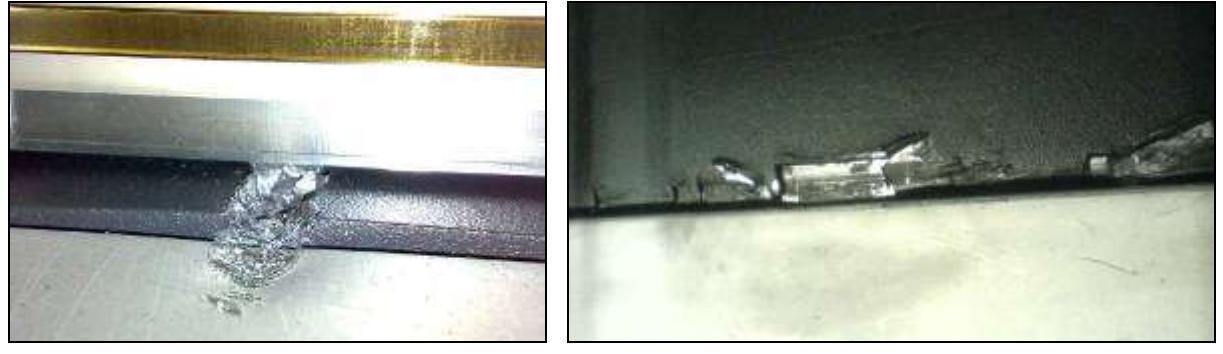
Damaged FSA mounting screws (2 items of 0515-5007 found in N7280-88787 "Field Stop Assembly screws kit" – contains 6 screws), damaged tooling pins not shown:

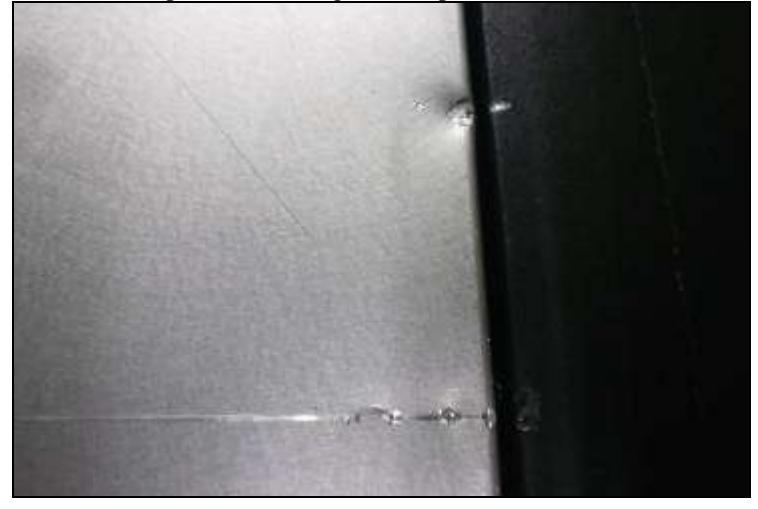
FSA has been pushed to the right in the picture (rear of machine), notice the gap between the skirt and the FSA:
