33519B-03

# Modification Recommended Service Note

## 33500 Series Waveform Generator

The Problem – The dot key

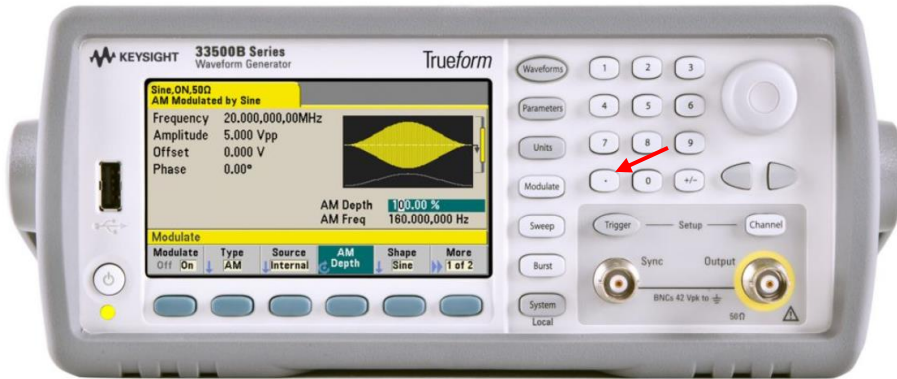
User may experience the dot key on the front panel intermittently inactive when pressed.

For units with inactive dot key, please return units back to Service Center for repair.

1. Replace the front panel board (part number: 33500-66308).
2. Turn on the instrument and check if the dot key is active when pressed.
