**6060B-04A-S**

**S E R V I C E N O T E**

**6060B - DC ELECTRONIC LOAD SINGLE-INPUT  
3-60 V. 0-60 A, 300 W DC**

**POSSIBLE “SHOCK PINCH” HAZARD**

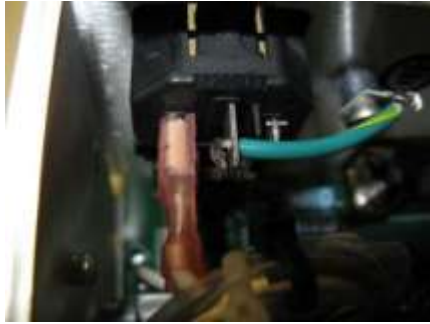
Figure A

Refer to Figures “A” & “B” below. These figures are representative of insufficient solder connections at the ground pin of the AC INPUT MODULE and the instrument chassis ground.

If the Safety ground wire connections shown in Figures “A” & “B” do not meet or exceed acceptable solder connections as shown in Figure “C”, then the Safety ground connections must be repaired any person doing the repair must have the required knowledge to identify defective solder joints. It is also a requirement that the person doing the repair has the required skills to use hand tools and a soldering iron.

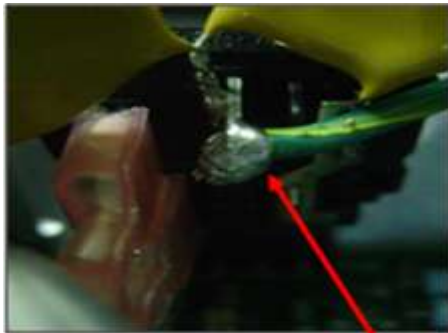
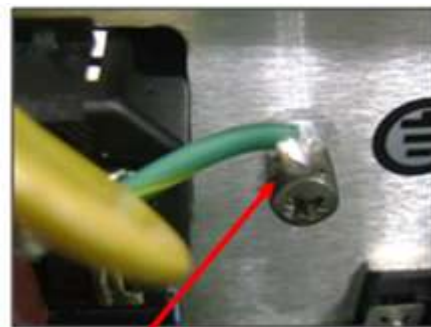
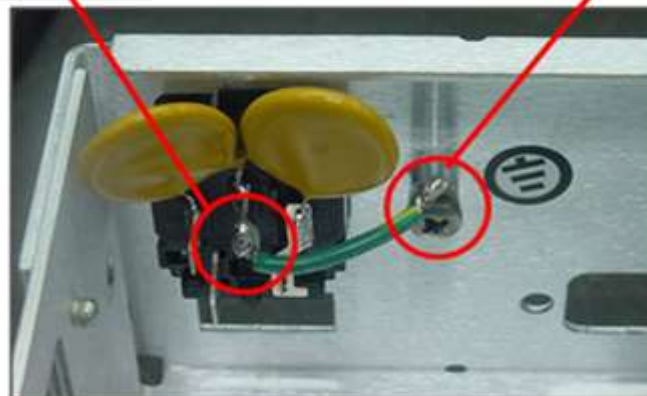
Figure “C”

**“ACCEPTABLE GROUND CONNECTIONS”**
