6624A-13

S E R V I C E N O T E

6624A DC Power Supply

Intermittent Power Transformer "Magmate" Connections

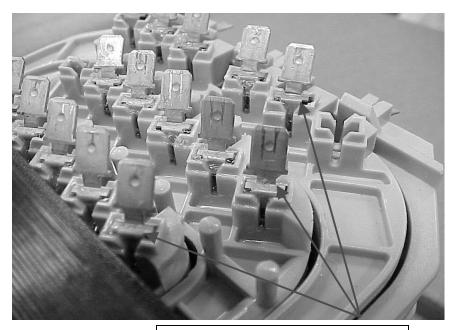
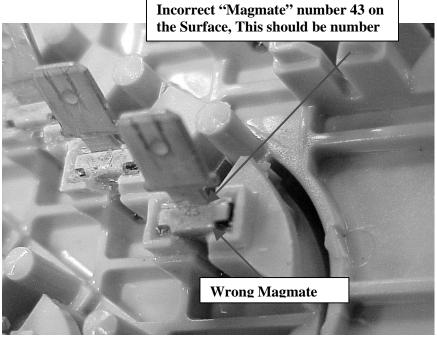
The power transformer vendor mistakenly installed the wrong "Magmates" in a run of power transformers. The incorrect "Magmates" have a # 43 stamped on them, which corresponds to a 15 gauge wire size. The correct size "Magmate" should be # 24 designed for a 19 gauge wire size.

This could result in a variety of intermittent as well as steady hardware problems and errors. Examples: HDW ERR CH 1, Blank front panel display, not meeting specifications.

Replace the Power Transformer with a new replacement Transformer, see the table above for the correct power transformer part number.

NOTE: Please inspect the new transformer for the correct "Magmate" number stamping.
