<u>SERVICE NOTE</u>

6625A-11

6625A DC Power Supply

Intermittent Power Transformer "Magmate" Connections

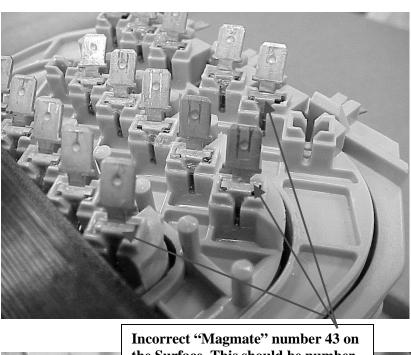
The power transformer vendor mistakenly installed the wrong "Magmates" in a run of power transformers. The incorrect "Magmates" have a # 43 stamped on them, which corresponds to a 15 gauge wire size. The correct size "Magmate" should be # 24 designed for a 19 gauge wire size.

Replace the Power Transformer with a new replacement Transformer, see the table above for the correct power transformer part number.

NOTE: Please inspect the new transformer for the correct "Magmate" number stamping.

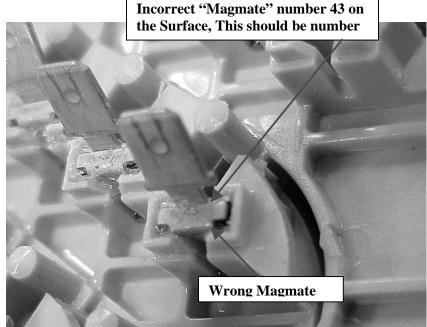
Top View of Power Transformer:

This could result in a variety of intermittent as well as steady hardware problems and errors. Examples: HDW ERR CH 1, Blank front panel display, not meeting specifications.
