6627A-07

SERVICE NOTE

6627A DC Power Supply

Intermittent Power Transformer "Magmate" Connections

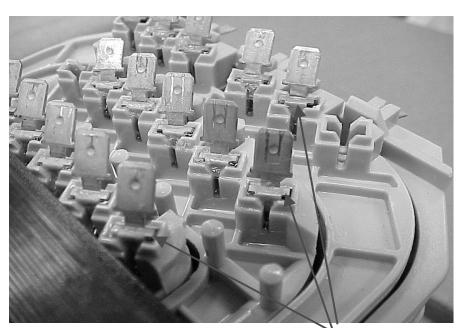
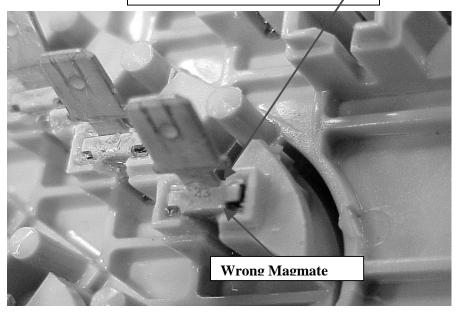
The power transformer vendor mistakenly installed the wrong "Magmates" in a run of power transformers. The incorrect "Magmates" have a # 43 stamped on them, which corresponds to a 15 gauge wire size. The correct size "Magmate" should be # 24 designed for a 19 gauge wire size.

Incorrect "Magmate" number 43 on the Surface, This should be number

Replace the Power Transformer with a new replacement Transformer, see the table above for the correct power transformer part number.

NOTE: Please inspect the new transformer for the correct "Magmate" number stamping.
