6642A-07

Modification Recommended Service Note

6642A DC power supply, 0-20 V, 0-10 A, 200 W. GPIB

The Problem – 6642A exhibited out of specification values for 9.0V to 10.5V at front panel read back readings.

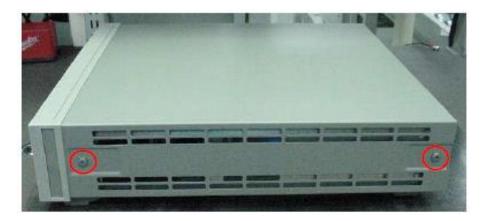
1. Remove 2 screws from each side as shown.

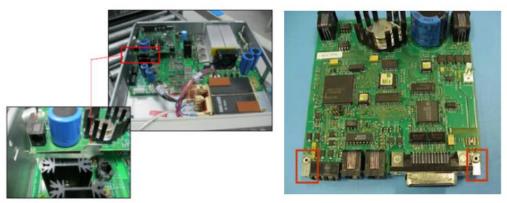
5. Remove bracket and GPIB PCA as shown.

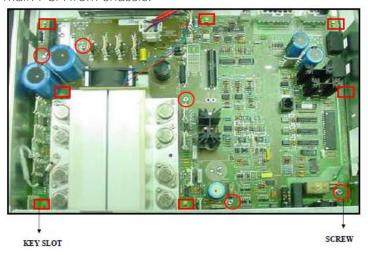
6. Remove 5 screws from the main board and slide out the PCA from the 7 slots, then remove the main PCA from chassis.

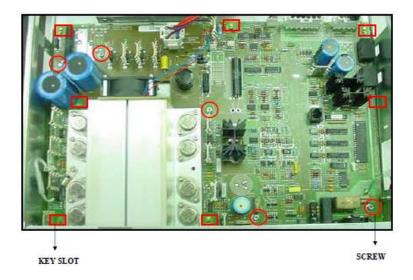
8. Place PCA into chassis on key slot 7 positions and push to lock in position at 7 locations. Use 5 screws to secure the board to chassis.

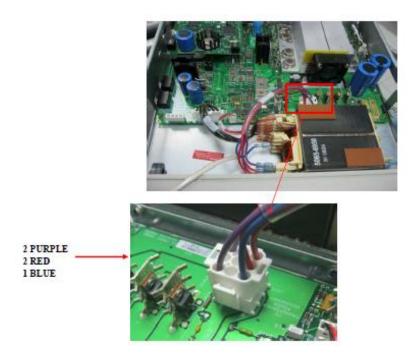
10. Connect cable assembly (5080-2206) from transformer to J401 PCA as shown.

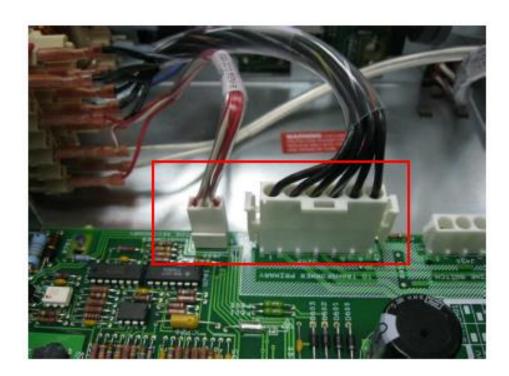
11. Connect cables.

- a. Connect transformer cable to PCB as shown.
- b. Connect 5080-2213(red and red/white) to J600.
- c. Connect 5080-2205(1 black/green,1 black/yellow, 1 black/red, 1 black/orange, 1 black white, 1black to J452)

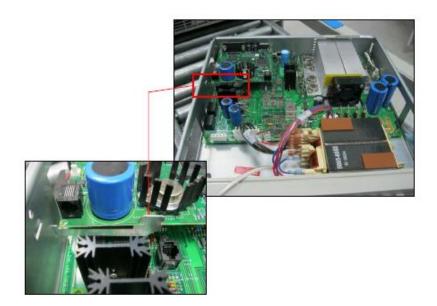
12. Slide bracket into side of chassis as shown. Place GPIB board in unit, swing TAB into notch in PCB as shown.

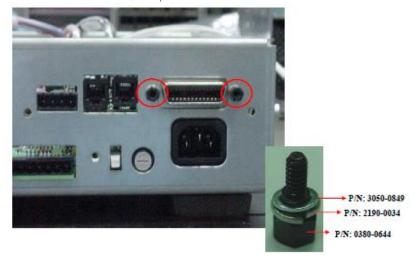
13. Use 2 flat washers, 2 split washers and 2 nuts and mount the GPIB board to rear panel.

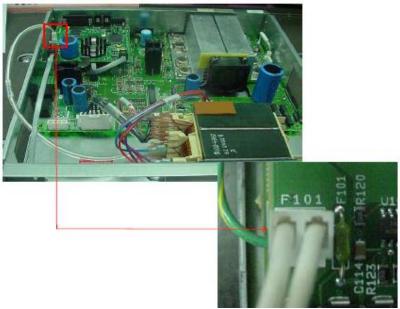
17. Connect cable (5080-2209) to F101 GPIB from the transformer.

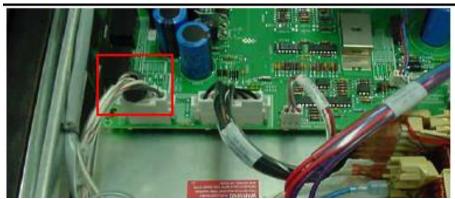
18. Insert the cable to J450 main PCA.

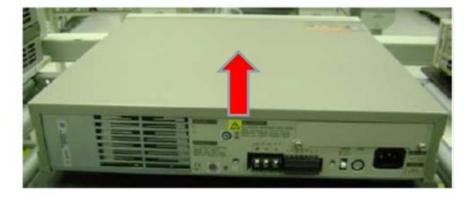
19. Slide in the cover to chassis.

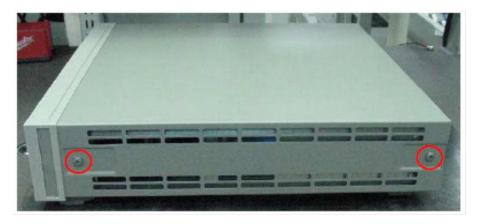
20. Tighten 2 screws of each side of the unit as shown.
