E3631A-13D

S E R V I C E N O T E

E3631A DC Power Supply

Metal Strap Kit for tightening loose bumper and for fitting rear lock link in side-by-side rack mounting

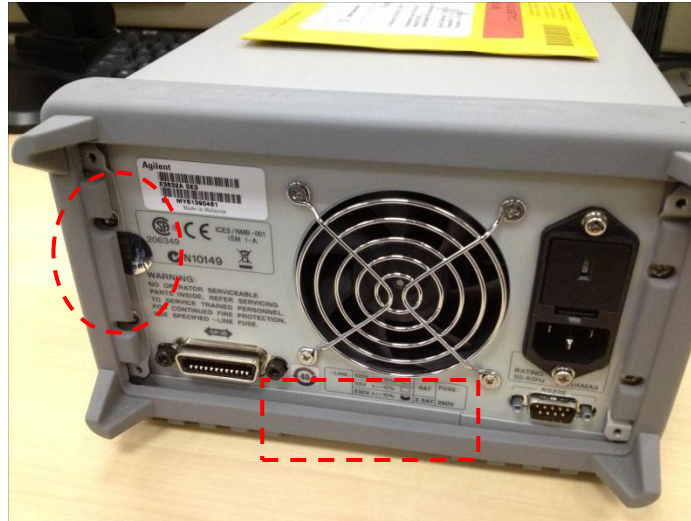
There is a new rear bumper design starting from serial number MY51240260. The rear bumper may become loose or it may slip out of the instrument chassis when force is applied to the rear bumper, as shown in Figure 1 below.

Figure 1: Loose rear bumper – gap observed between bumper and chassis

Use two metal straps (part number E3631-07901) to secure each side of the bumper as shown in Figure 4 below.

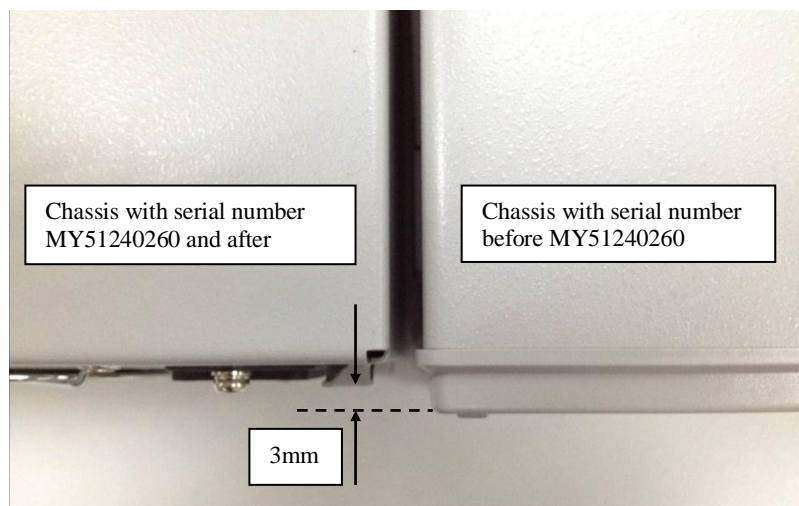
The chassis depth difference between the two designs is 3mm as shown in Table 1 and Figure 2 below.

Figure 2: Top view 3mm gap observed between two different chassis designs

Use metal strap (part number E3631-07901), and stack the provided two metal straps together to form 3mm thickness and secure it with the provided screws on the rear lock link as shown in Figure 5 below.

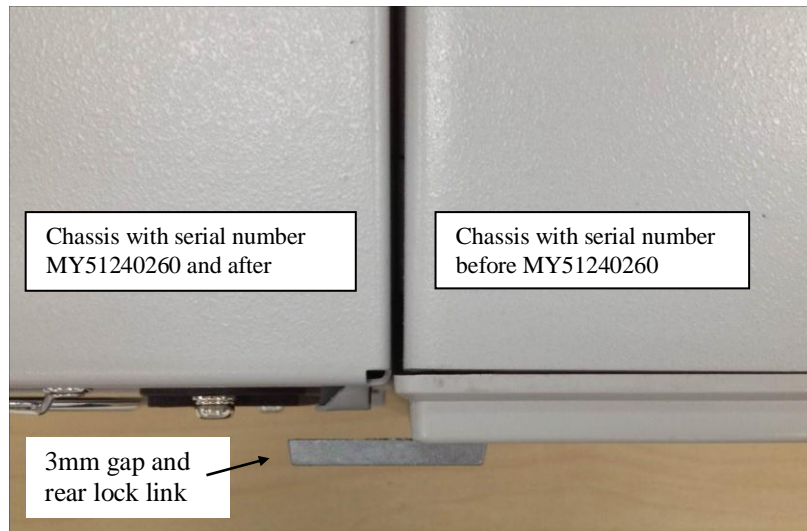
The 3 mm gap between the two different chassis may cause difficulties in securing them together using a rear lock link kit (part number 0050-2167) for side-by-side rack mounting as shown in Figure 3 below.

Figure 3: Top view 3mm gap observed on rear lock link for side-by-side rack mounting

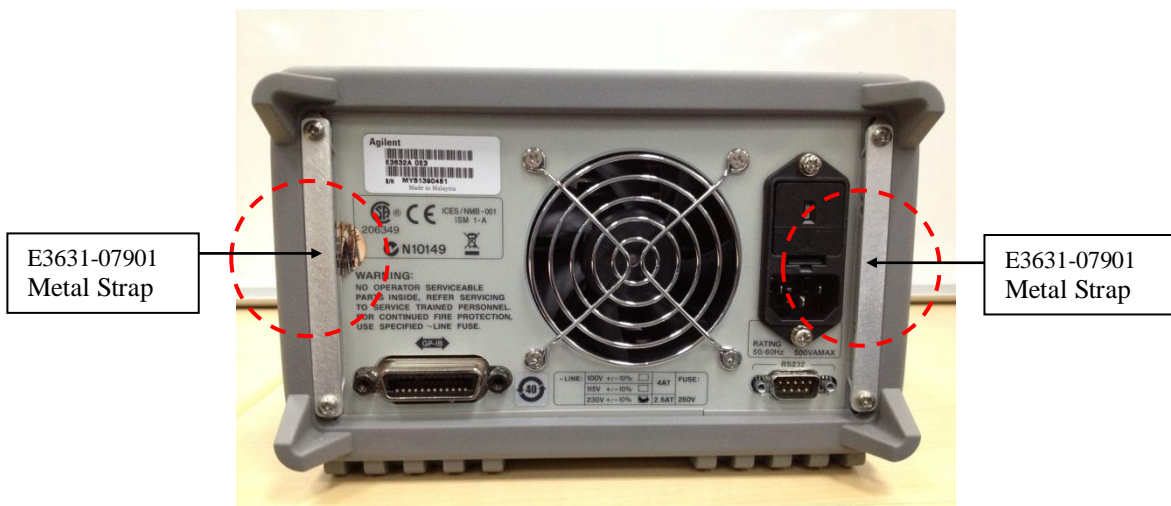
Figure 4: Secure with metal straps – no gap observed between the bumper and chassis

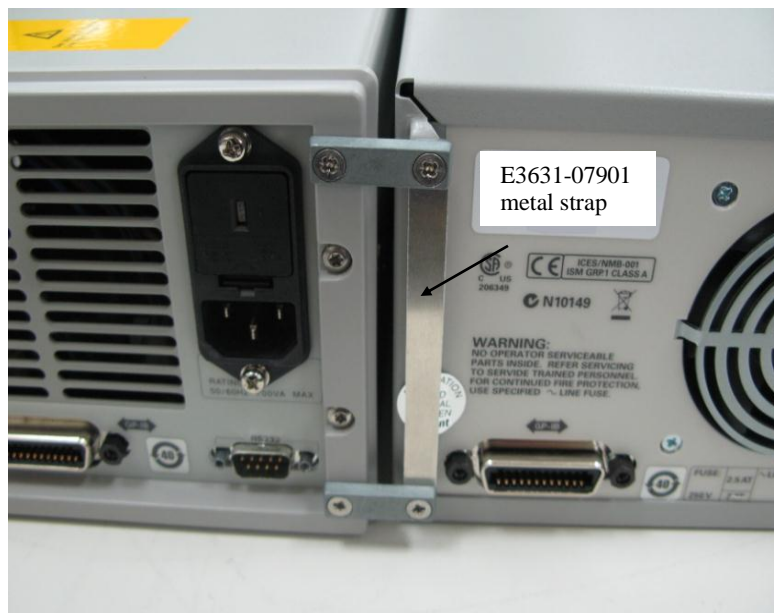
Figure 5: Rear view rear lock link secured with metal straps kit for side-by-side rack mounting
