E3648A-04A

S E R V I C E N O T E

E3648A DC Power Supply

Procedure to ensure tight fitting of the rear bumper

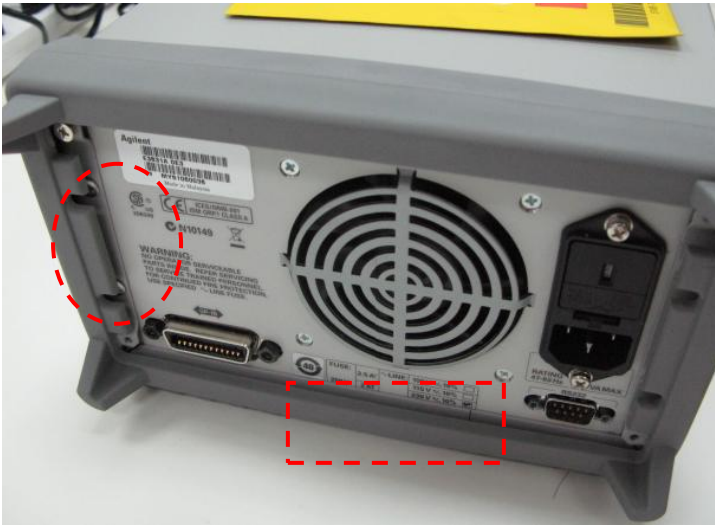
There is a new design rear bumper starting from serial number MY51240078. This bumper fits too tightly into the packaging foam material. During transportation, movements may cause the rear bumper to rub against the packaging foam and the rear bumper may become loose or slip out of the instrument chassis, as shown in the Figure 1 below. The foam design has already been modified to ensure good enough fitting.

Figure 1: Loose rear bumper – gap observed between bumper and chassis

If customers observe that their instrument's rear bumper has become loose or has slipped out, then the customer is advised to follow the following steps to properly fit the rear bumper back into the instrument chassis.

1. Make sure all four corners of the rear bumper are completely pushed inwards. A 'click' sound must be heard (Figure 2, see arrows marked '1').
2. Then, push the four sides of the bumper to make sure the whole bumper fits tightly into the instrument chassis. (Figure 2, see arrows marked '2').
3. These 2 steps will ensure a tight fitting of the rear bumper as shown in Figure 3 below.

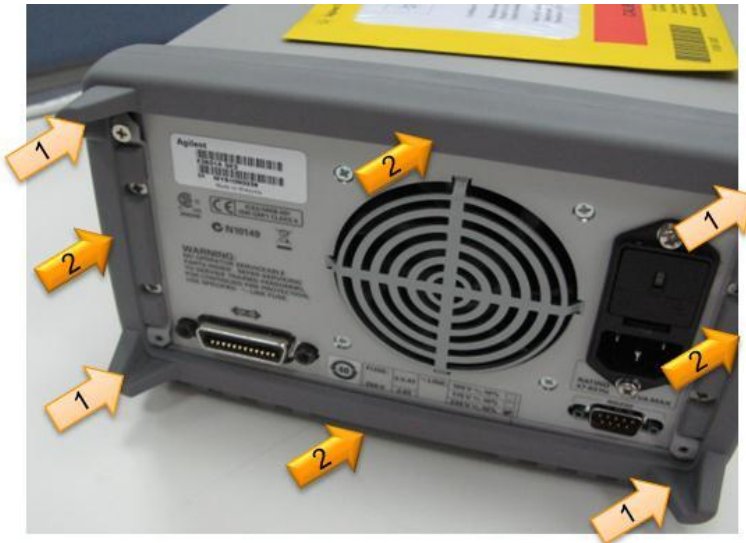
Figure 2: Proper fitting method for instrument rear bumper

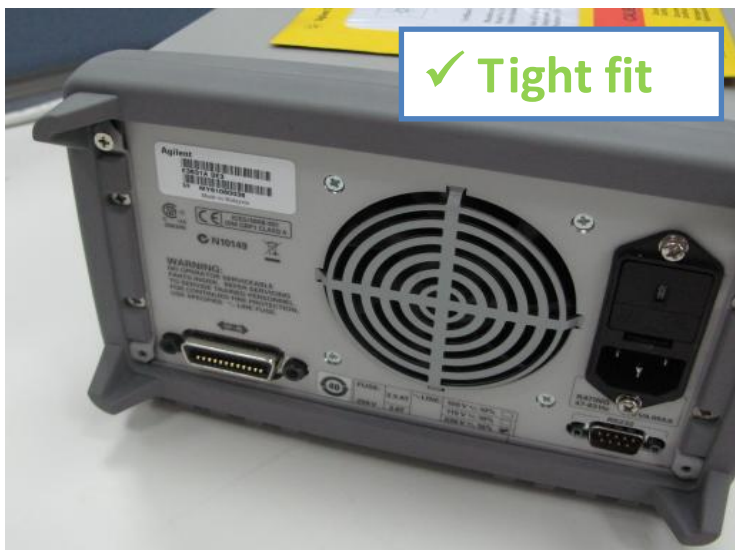
Figure 3: Tightly fitted rear bumper – no gap observed between the bumper and chassis
