E4419B-08A-S

S E R V I C E N O T E

Agilent E4419B EPM Power Meter

Correct Orientation of the Power Supply's Force-fit Connector

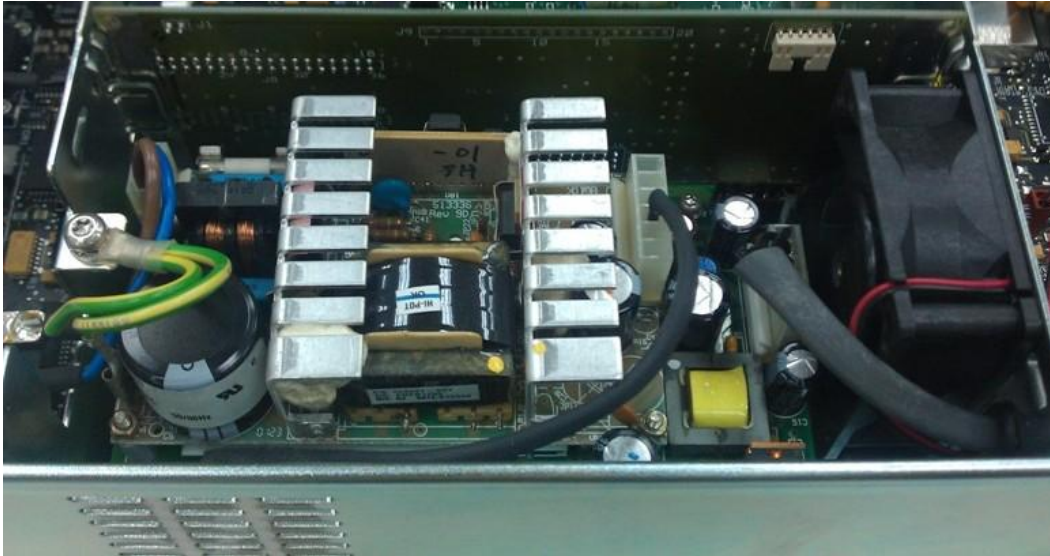
Figure 1: Interior Layout of Power Supply Unit, P/N: 0950-3681

The interior layout of the respective power supply unit is shown in figure 1 and figure 2.

The Power Supply Unit, P/N: 0950-3681 has been replaced by another Power Supply Unit, P/N: 0950-2649 for the standard E4419B since June 2007 for E4419B with serial number MY45102599 onwards. The design layout of 0950-2649 is different from 0950-3681 and does not cause any possible shock hazard.

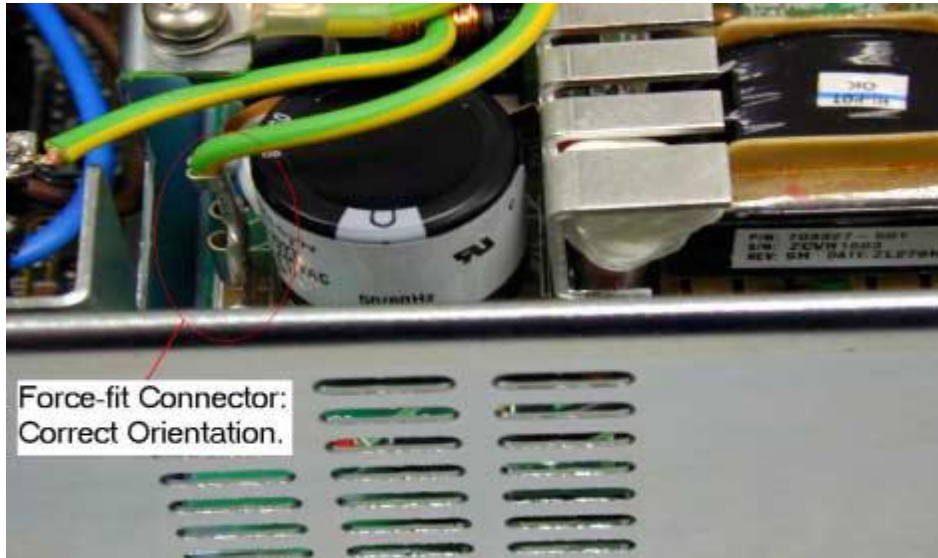
Figure 3: Correct orientation of force-fit connector.

It has been highlighted that the force-fit connector connecting the earth wire to the Power Supply Unit, (P/N: 0950-3681) can be fitted in two different ways on the E4419B.

By fitting the connector with the bottom (flat) side facing the large capacitor on the Power Supply Unit, the gap between them is maximized (approximately 2mm).

By fitting the connector with the top (rounded) side facing the large capacitor on the Power Supply Unit, the gap between them is minimized (approximately 1.2mm).

The gap should be maximized at all times to ensure the unit meets the design and regulatory requirements relating to electrical insulation. This requirement is such that the gap should be at least 1.71mm.

Ensure that this connector is re-fitted such that the bottom (flat) side of it is facing the large capacitor on the Power Supply Unit, P/N: 0950-3681.
