E4438C-23A

SERVICE NOTE

E4438C Vector Signal Generator

Intermittent CPU boot-up and/or No display

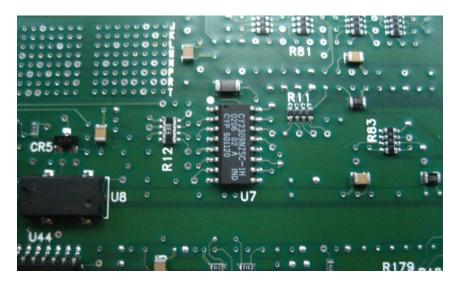
The clock buffer, U7 on the A12 CPU board, part number E4400-60500 may cause intermittent boot up and/or no display when the instrument is powered up. It is recommended that this modification is performed on any instrument within the serial numbers above that exhibits an intermittent boot-up and/or a blank display.

Figure 1 U7 location – bottom side of the board.

Using the appropriate soldering technique and ESD station, perform a modification on the U7 circuit on the A12 CPU board. Connect U7 pin 8 to 3.4V (wire pin 8 to pin 4) and connect U7 pin 9 to DCOM (wire pin 9 to pin 12).

- 1. Refer to E4428C/38C Service Guide for the A12 CPU removal procedure.
- 2. Refer to Figure 1 for U7.
- 3. Use 30 AWG wire for wiring pin 8 to pin 4, and pin 9 to pin 12 per Figure 2.
- 4. Re-install CPU and cover.
- 5. Run self test.
- 6. No calibration is required.
