E4990A-09A

### Service Note

## E4990A – Impedance Analyzer, 20 Hz to 10/20/30/50/120 MHz

E4990A A5 TRD module failure – EOS (Electrical Overstress) identification and recommended handling by Service Center

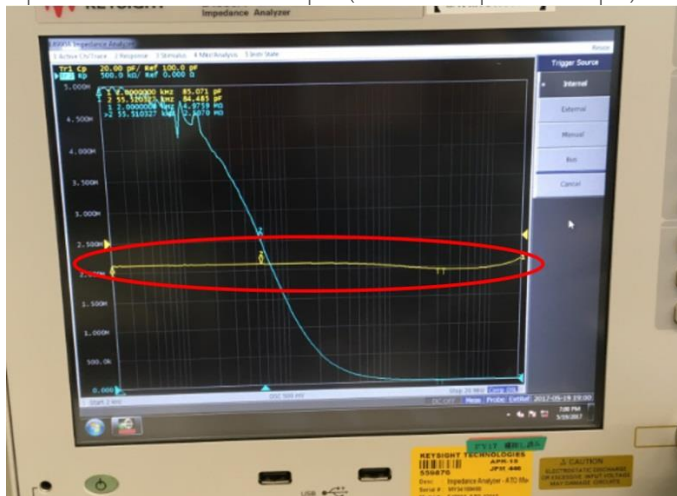
Good (no abuse)

Cp values are about 80 pF (within 50 pF – 120 pF) at all frequencies

1. Cp value of Hpot connector is over 700 pF at frequencies lower than 2 kHz. (If you have an impedance analyzer (E4990A-120/4294A) with 42941A, you can check it easily.)

Note: Normally, the Cp value of Hpot is about 80 pF. However, the Cp value of Hpot is changed to 700 pF or more when the U45 on the A5 TRD module is burnt due to the charged device (customer's abuse).

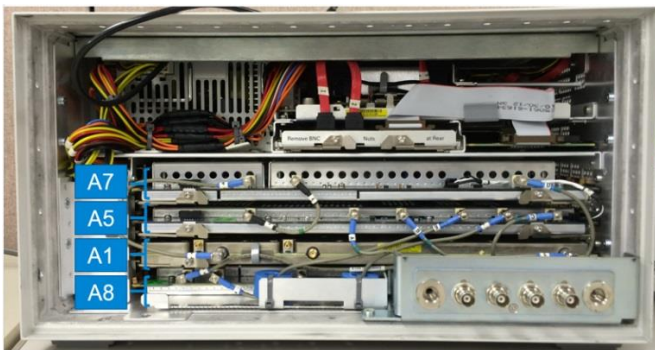
2-1. Remove the A5 TRD module from the defective E4990A. The location of A5 is shown in the figure below.
