S E R V I C E N O T E

Agilent E5000A PRML Bit Error Analyzer

Serial Numbers: JP1KC00101 / JP1KC00178

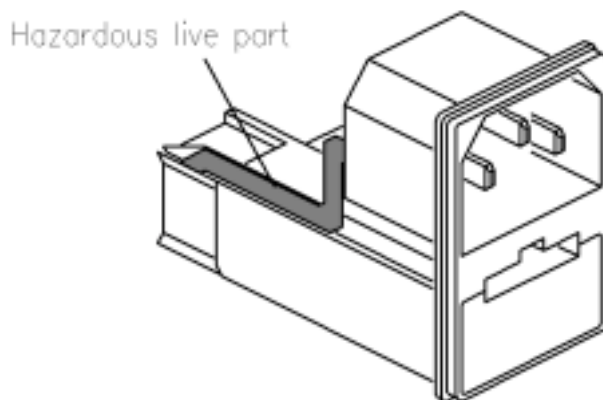
The AC inlet (P/N 1252-6951) has the potential to slip out of the instrument's rear panel slot if the AC power cord is forcefully pulled in a diagonal direction. When this happens, an exposed connection on the AC inlet module may touch the rear panel of the instrument and cause an electrical short if the AC power cord is still connected to the AC power outlet. See Figure 1.

Figure 1. AC Line Connector

In the worst case, there is also a possibility of an electric shock hazard to the user if the user completes a circuit between the instrument panel and another grounded connection while the AC power cord is still connected to the AC power outlet.

- Remove the AC power cable from the AC power outlet and the product.
- Remove the top, bottom, and side covers.
- Seal the hot line terminal on the AC inlet with silicon paste (P/N 5183-4112).
- Reinforce the connection between the AC inlet and the rear panel with silicon paste.
- Perform Self Test to verify instrument operation.

- Remove the AC power cable from the AC power outlet and the product.
- Remove the top, bottom, and side covers.
- Seal the hot line terminal on the new AC inlet with silicon paste (P/N 5183-4112).
- Replace the AC Inlet (P/N 1252-6951)
- Reinforce the connection between the AC inlet and the rear panel with silicon paste.
- Perform Self Test to verify instrument operation.

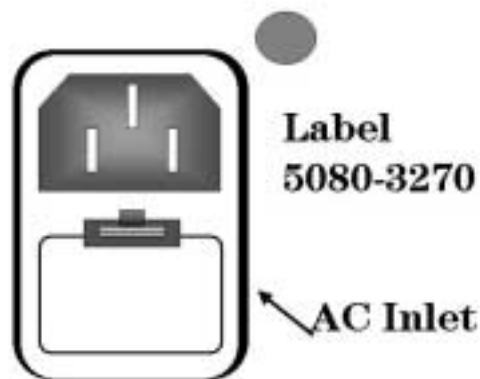
Fig. 2

Figure 2. Repair Completed Label

After completing the above instructions, stick the label (P/N 5080-3270) next to the AC Inlet on the rear panel as a mark that this repair has been completed. See Figure 2.
