E8244A-09

S E R V I C E N O T E

E8244A CW Signal Generator

When replacing an analog power supply (0955-3700), replace the screws on the bottom of the power supply with shorter screws.

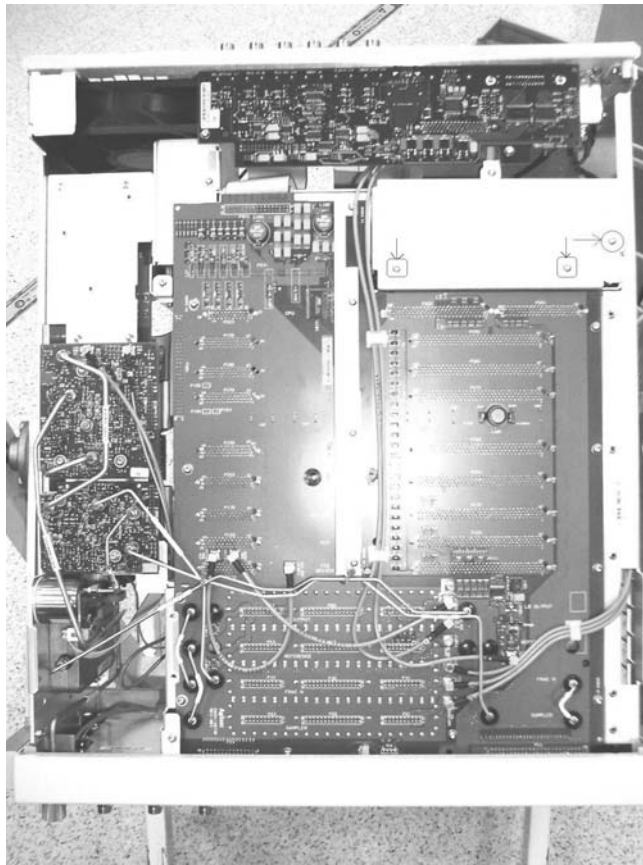
Due to variations in component locations within the power supply (a purchased part) , if components are tilted the wrong way the current screw (0515-0372) is long enough to cause a high pot failure. Since all instruments are high pot tested before being shipped, there is no problem with instruments already in the field. When a power supply is replaced, the 3 mounting screws on the bottom of the instrument should be changed to a shorter screw (0515-0430) to eliminate any potential problem. With the old screws, even if the part spacing becomes too close to cause a high pot failure, there is NO safety issue.

In analog instrument, when a power supply is replaced, replace the 3 mounting screws that hold the power supply with part number 0515-0430. (See picture for parts location).
