E8251A-10

# SERVICE NOTE

# E8251A Analog Signal Generator

When replacing an analog power supply (0955-3700), replace the screws on the bottom of the power supply with shorter screws.

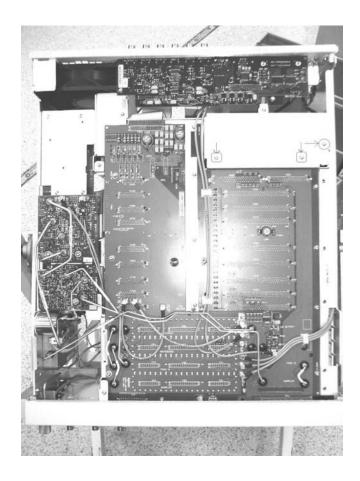
In analog instrument, when a power supply is replaced, replace the 3 mounting screws that hold the power supply with part number 0515-0430. (See picture for parts location).

Due to variations in component locations within the power supply (a purchased part), if components are tilted the wrong way the current screw (0515-0372) is long enough to cause a high pot failure. Since all instruments are high pot tested before being shipped, there is no problem with instruments already in the field. When a power supply is replaced, the 3 mounting screws on the bottom of the instrument should be changed to a shorter screw (0515-0430) to eliminate any potential problem. With the old screws, even if the part spacing becomes to close to cause a high pot failure, there is NO safety issue.
