# SN J6802B-02A

# S E R V I C E N O T E

## J6802B DNA MX

Line filter improperly wired in relation to fuses.

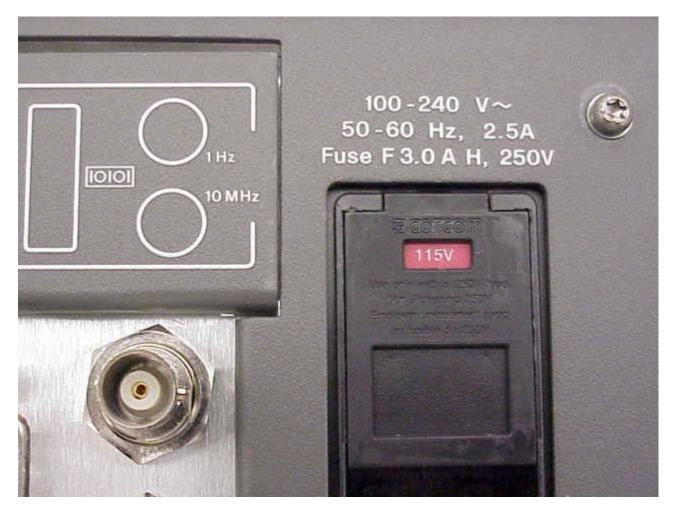
Photo #1 Note: If your unit is EC 11:00 AND has the 115V visible in the window, stop here as this unit already has two fuses.

Using a small thin blade screwdriver, open the fuse-block door to access the fuse block. (See photo #1)

Do to an error in the assembly documentation the line filter was incorrectly wired on most of the first 150 units shipped. The fuse provides no protection for surges in AC line voltages to the power supply. This causes the power supply internal fuse to open and then the power supply ceases to function.

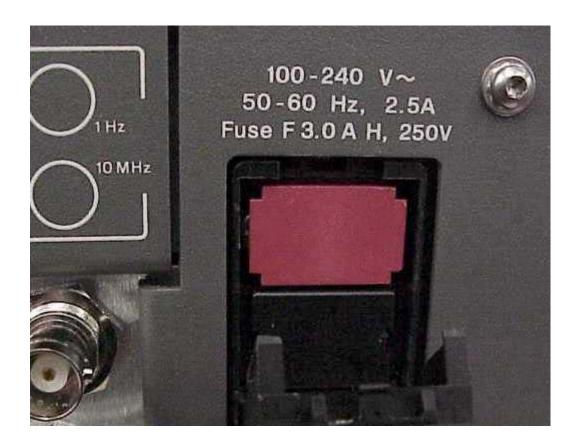
Photo #2

Remove fuse-block from line filter. (see photo #2)

Slide fuse-block (red plastic) back towards you. You may need to use the screw driver again.

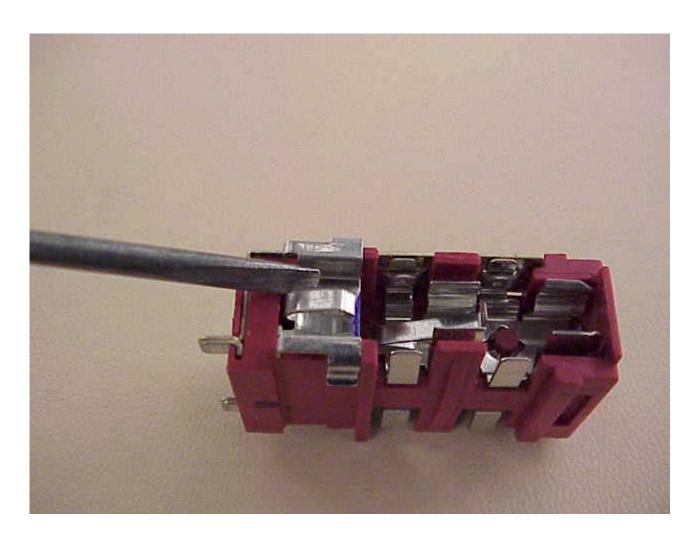
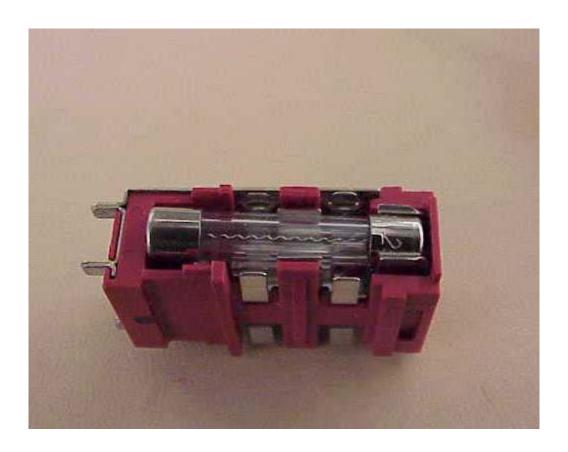
Remove shunt from fuse-block and replace with fuse. (See photos #3 & #4)
