# MSOX2002A-03 <u>S E R V I C E N O T E</u>

# MSOX2002A – Oscilloscope, Mixed Signal, 2+8 Channel, 70MHz

With the oscilloscope's power on and while under normal operation the unit emits a hissing noise.

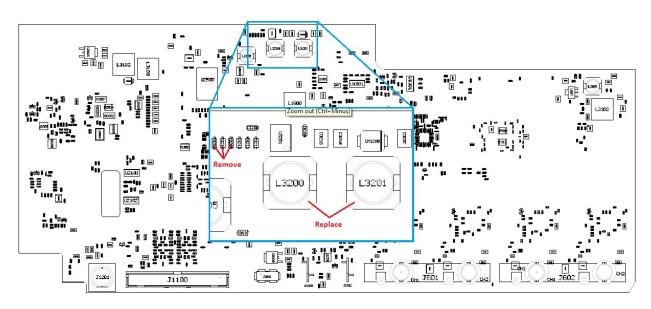
With the oscilloscope power turned on and while under normal operation, the unit emits a hissing noise.

Follow the procedure to remove the acquisition board for the X2000 as in the Agilent 2000/3000 X-Series Oscilloscopes Service Guide (<u>http://cp.literature.agilent.com/litweb/pdf/75019-</u> <u>97039.pdf</u>), pp. 117-121, until you make a visual to the following components:

- 2. As the picture indicates, remove the three resistors (0699-7209, 1 Ohm) located at R3208, R3209, and R3210. They are not to be replaced.
- 3. Remove as well the two inductors (9140-6474, 100uH) located at L3200 and L3201 and replace them with inductors with part number 9140-6151 (68 uH).
- 4. Re-assemble to the point where the unit could be powered up to verify that the hissing is indeed gone. If the hissing is not gone, please, check modifications.
- 5. When the hissing is gone, put oscilloscope back together.
