N1921A-01

S E R V I C E N O T E

Agilent P-Series Power Sensor Wide Band Power Sensors

**Crack on sensor casing after MIL-PRF-28800F Class 3 Temperature Cycle test
and Temperature/Humidity test**

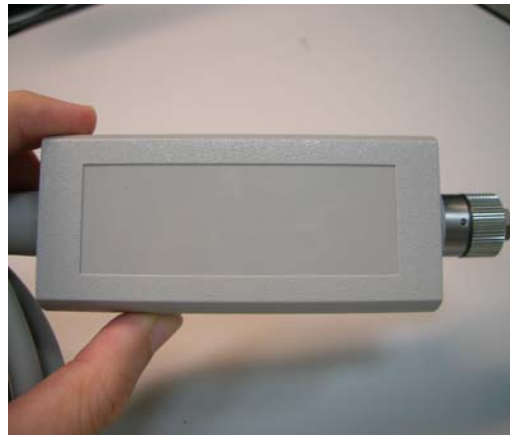
Results

- No abnormalities
- Please refer to pictures

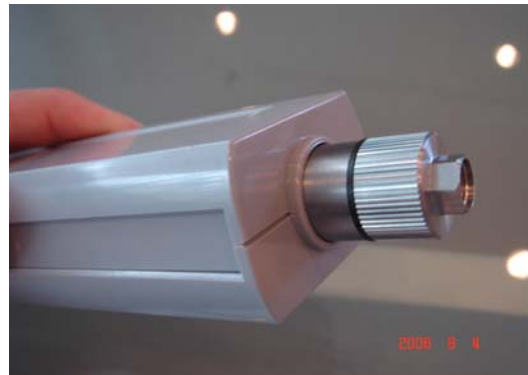
D) Shock

- 1) Take the 4 built units to perform shock test using US Navy (MIL-PRF-28800F, Class 3) testing profile.
- 2) Record visual findings.

Results

- No abnormalities.
- Please refer to pictures.

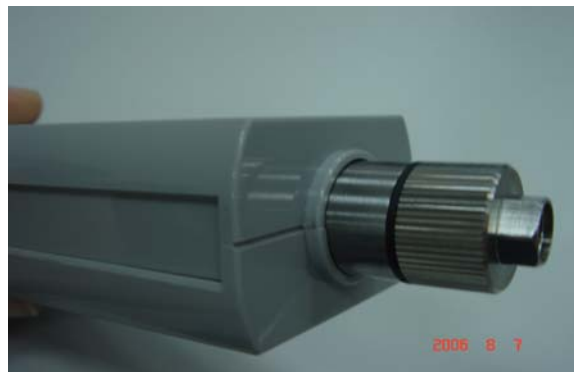
TABLE 3. Random vibration profile by class.

E) Vibration

- 1) Take the 4 built units to perform vibration test using US Navy (MIL-PRF-28800F, Class 3) testing profile
- 2) Record visual findings

Results

- No abnormalities.
- Please refer to pictures

Class	Duration per axis (minutes)	Frequency (Hz)	Slope (dB/Octave)	PSD (g ² /Hz)
1	60	10-1000	0	.04
		1000-2000	-6	-
		2000	-	.01
2	30	10-500	0	.03
3,4	10	5-100	0	.015
		100-137	-6	-
		137-350	0	.0075
		350-500	-6	-
		500	-	.0039
