N5106A-03

S E R V I C E N O T E

N5106A (PXB) Baseband Generator and Channel Emulator

The A11 System Clock board, (N5105-60006) has under rated components increasing the potential for early failure.

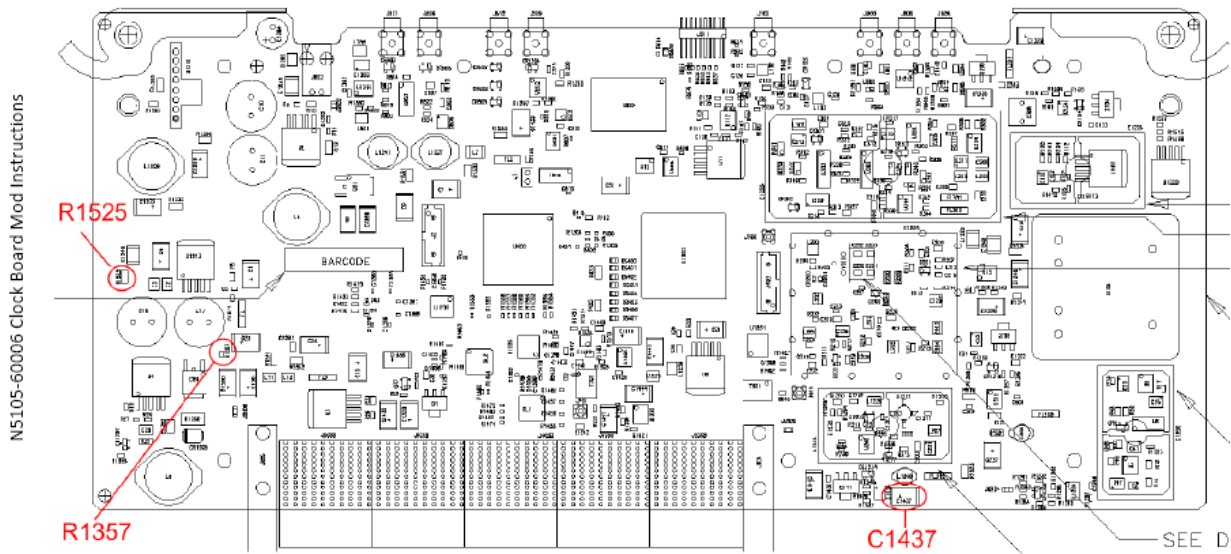
FRONT SIDE MOD LOCATIONS

To determine if you have a modified board look at R1357 and R1525 and verify that the original resistors have been replaced with larger resistors (see photos below). If the modifications have been made do not replace board.

All PXBs of the suspect serial number range need to have their system clock boards checked at next service and replaced if they have the early revision board without modifications. The suspect boards can be identified by the revision code under the left extractor, any board with Rev 003 or before need to be checked to determine if the board has been reworked (see below). If the system clock board has not been reworked replace it with new board from SPO.

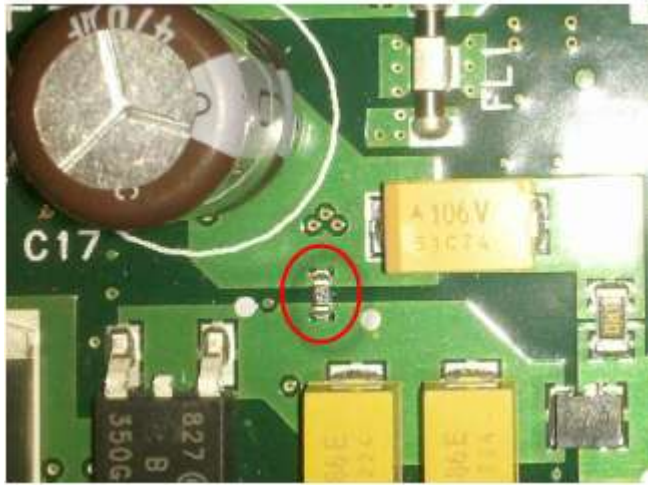
R1357 before modification

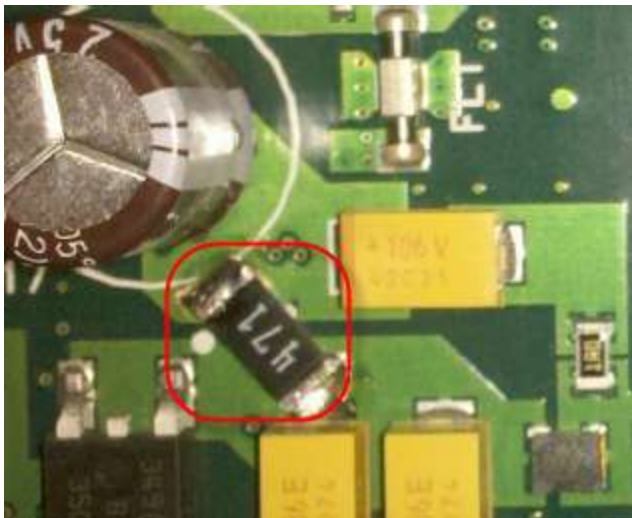
R1357 after modification

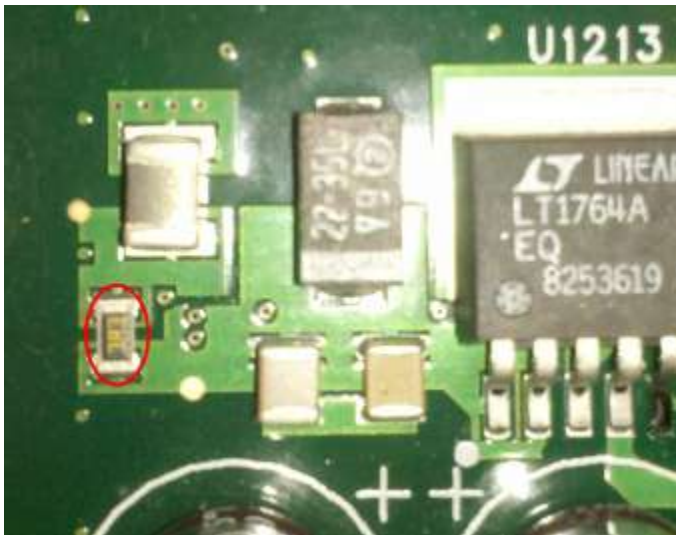
R1525 before modification

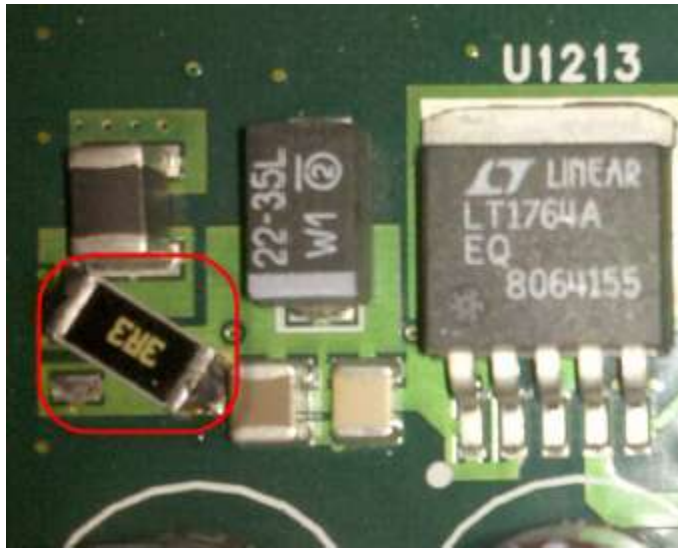
R1525 after modification
