N5183A-12A

Information Only Service Note

N5183A MXG μ Wave Analog Signal Generator

The Problem – Potential for Damage Caused by Safety Testing

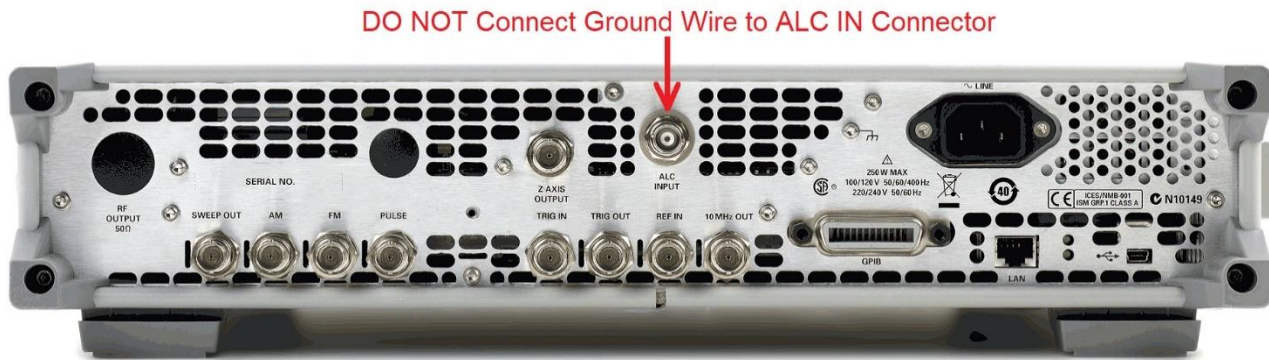
It has come to our attention that instruments have been damaged when performing incoming and outgoing safety testing on these instruments. These safety testers require that a ground wire from the tester be connected to the instrument chassis. This connection is often made to the outer conductor of one of the rear panel BNC connectors. The problem occurs when the ground wire is connected to the ALC IN rear panel BNC connector outer conductor when the test is run. Connecting the ground to this point is a problem because the ALC IN connector outer conductor is not connected to the chassis of the instrument. It is isolated from the chassis ground with a plastic washer. Not only is this an invalid point to connect the ground wire to for this test, it also sends the voltage used for the test directly into the sensitive ALC input circuitry.

Do not connect the safety tester ground wire to the ALC IN connector shield.

It is also recommended that a static safe protective cap be put on the ALC IN connector before it is given to your logistics team so that nobody will be able to easily connect the ground wire to it when they perform a safety test. This will also help to protect it if it goes through an incoming inspection safety test once it has reached its destination.
