N7953A-02

# Modification Recommended Service Note

N7953A – Advanced Power System, Dynamic DC Power Supply, 60V, 16.7A, 1000W

**The Problem** – Charge Present on the AC terminal when unplugging the unit.

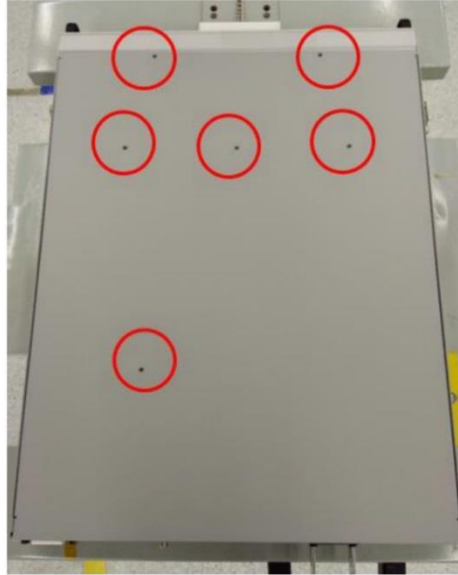
Figure 1

1. Unscrew six screws from top cover as shown in Figure 1.

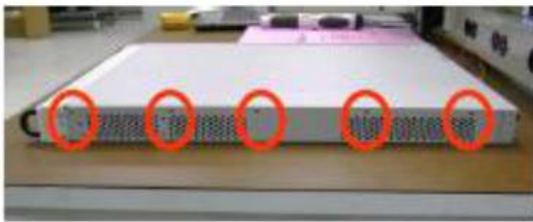
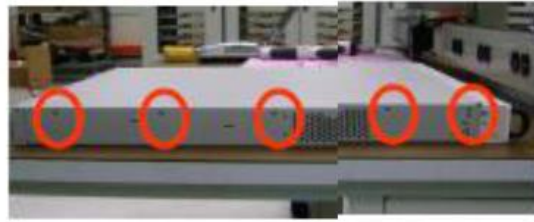
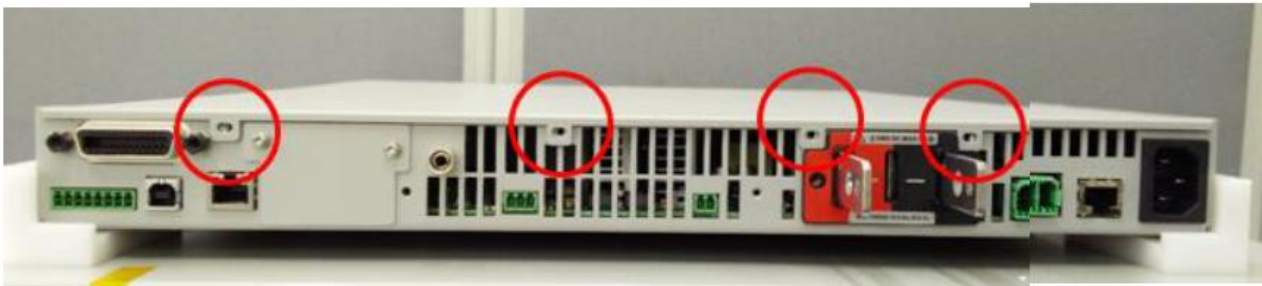
Figure 2

2. Unscrew total of 14 screws from left, right and bottom side as shown in Figure 2.

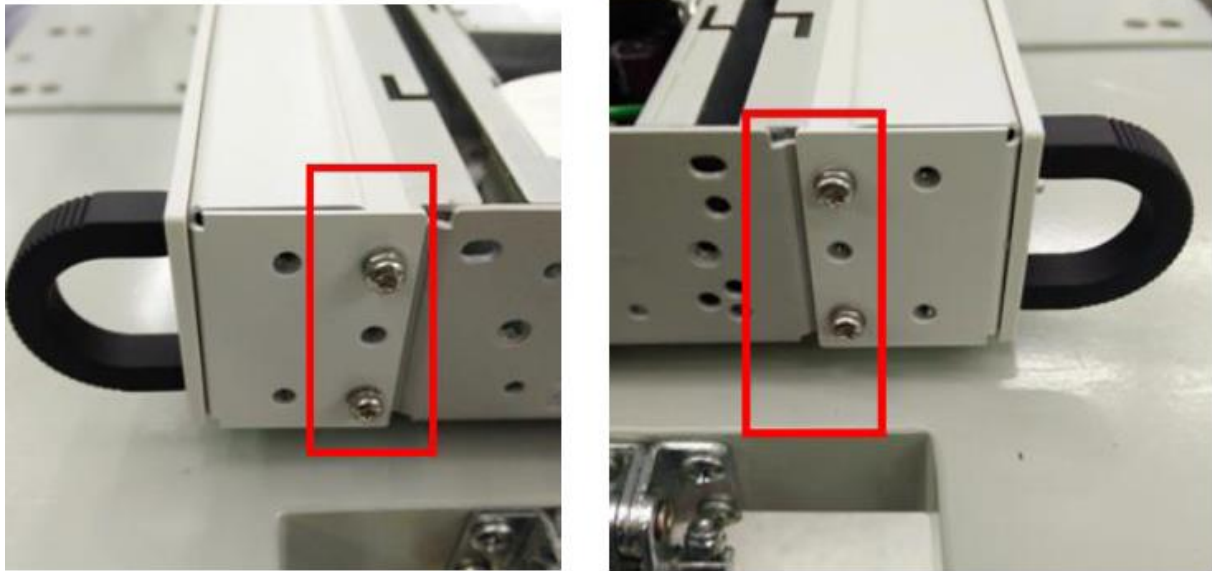
Figure 3

3. Remove 4 screws from both side of front panel as shown in Figure 3.

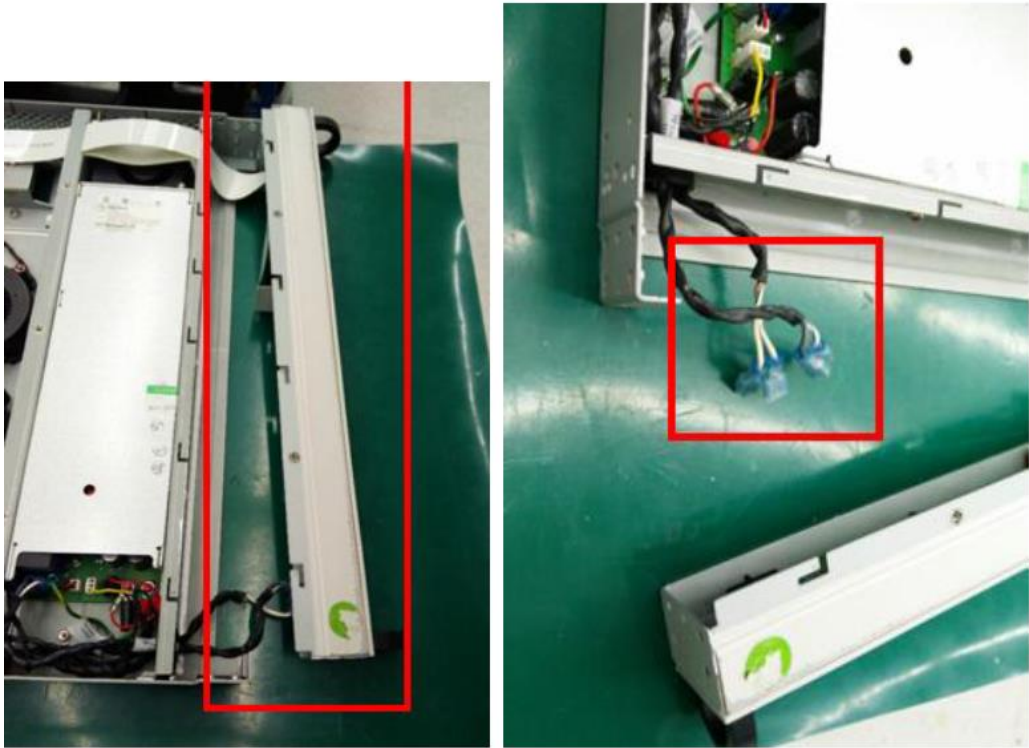
Figure 4

4. Remove the front panel from the chassis and dismantle the AC line cable and cable ASSY from the front panel as shown in **Figure 4**.

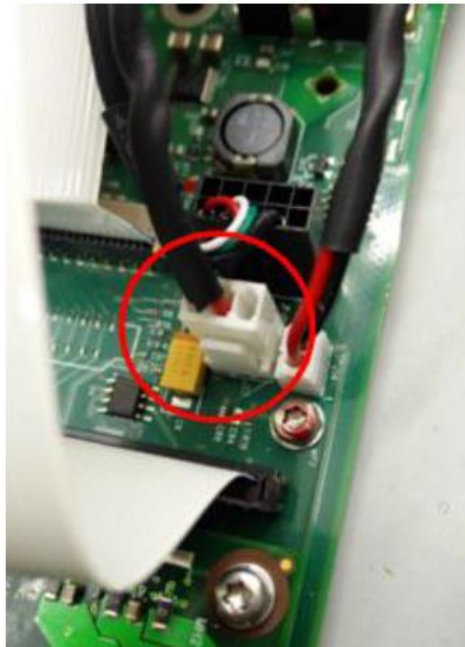
Figure 5

5. Remove AC line cable from constellation PCA Figure 5.

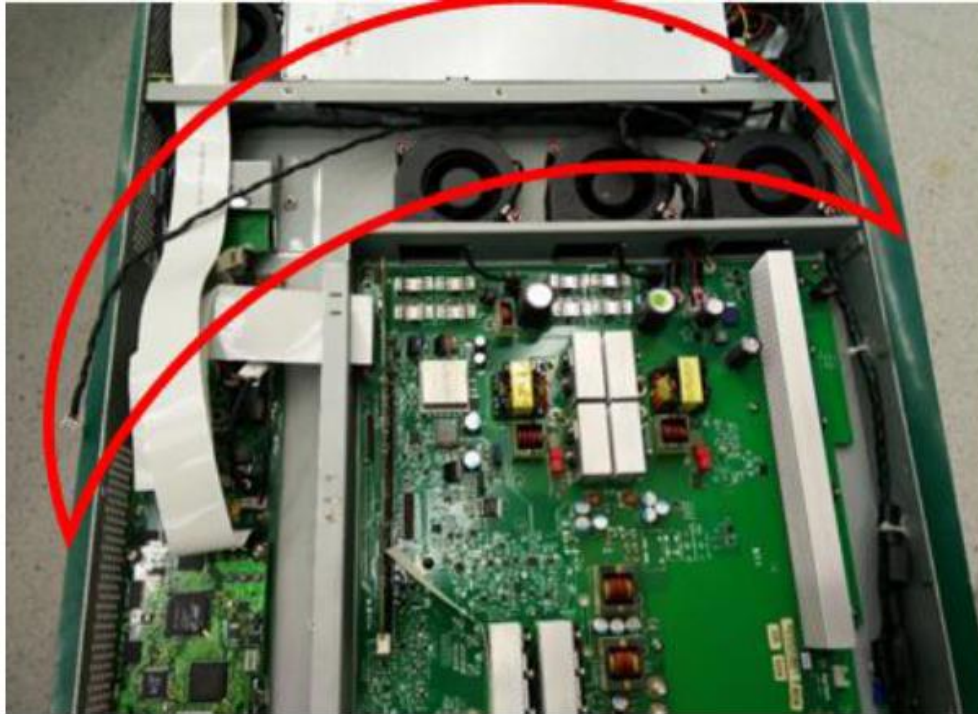
Figure 6

6. Pull out AC line cable from front chassis hole Figure 6.

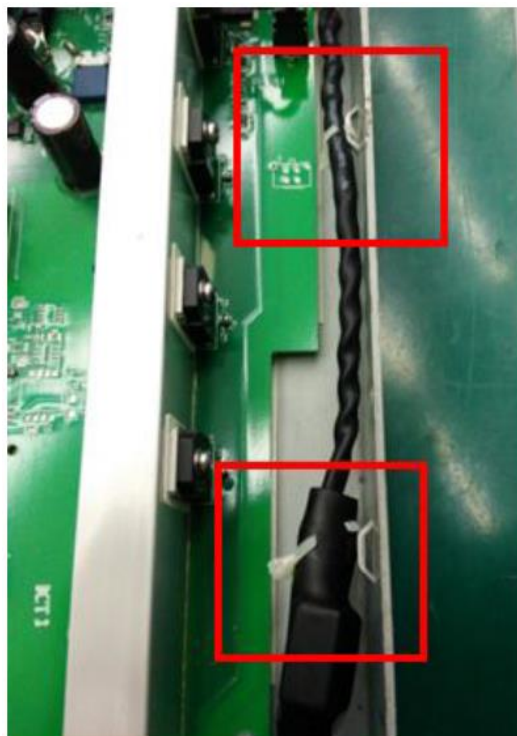
Figure 7

7. Cut 2 of the cable ties which secure the AC line cable as shown in Figure 7.

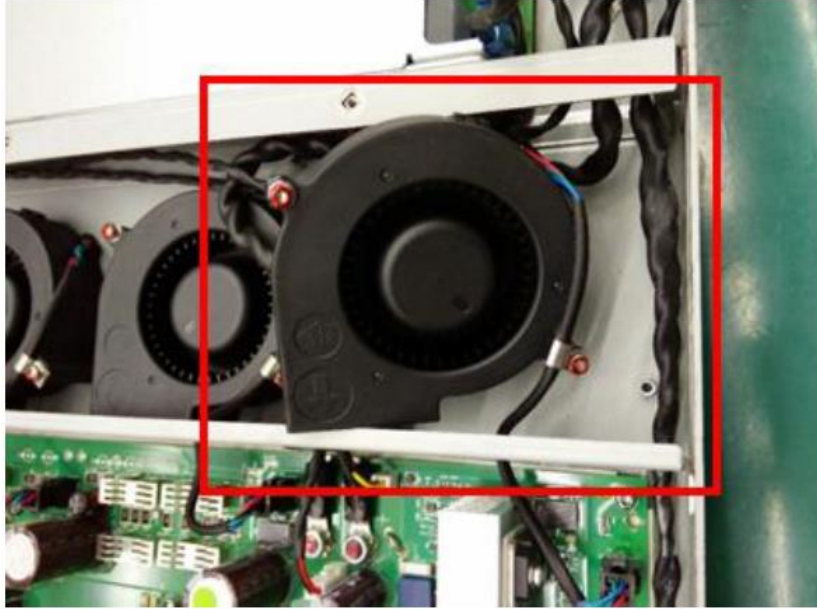
Figure 8

8. Unscrew the most right side fan as shown in Figure 8.

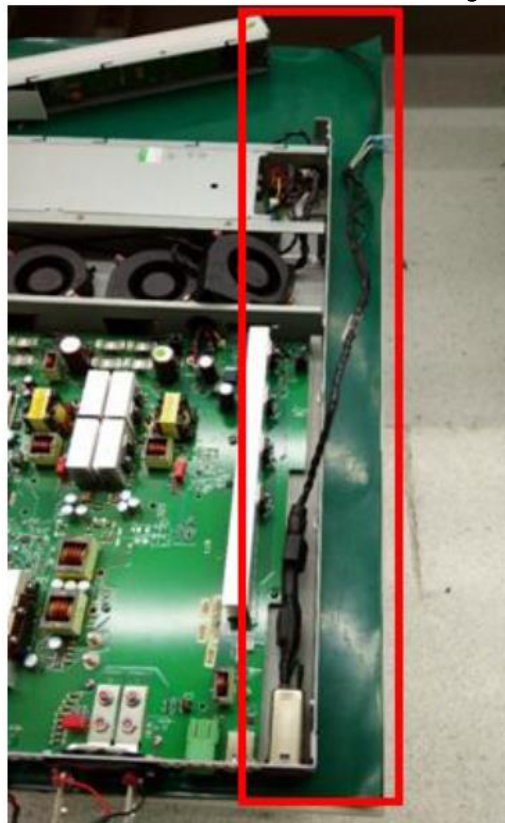
Figure 9

9. Remove AC line cable from middle chassis hole as shown in Figure 9.

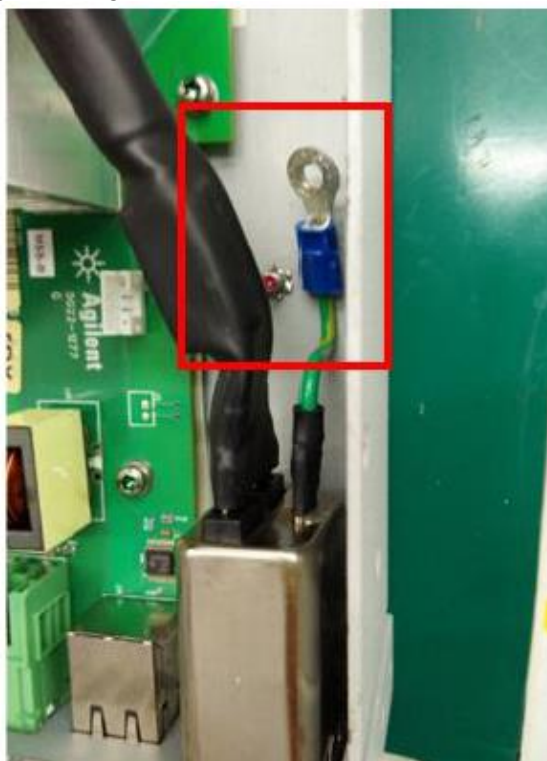
**Figure 10**

10. Remove nut to unsecure grounding cable AC line cable as shown in **Figure 10**.

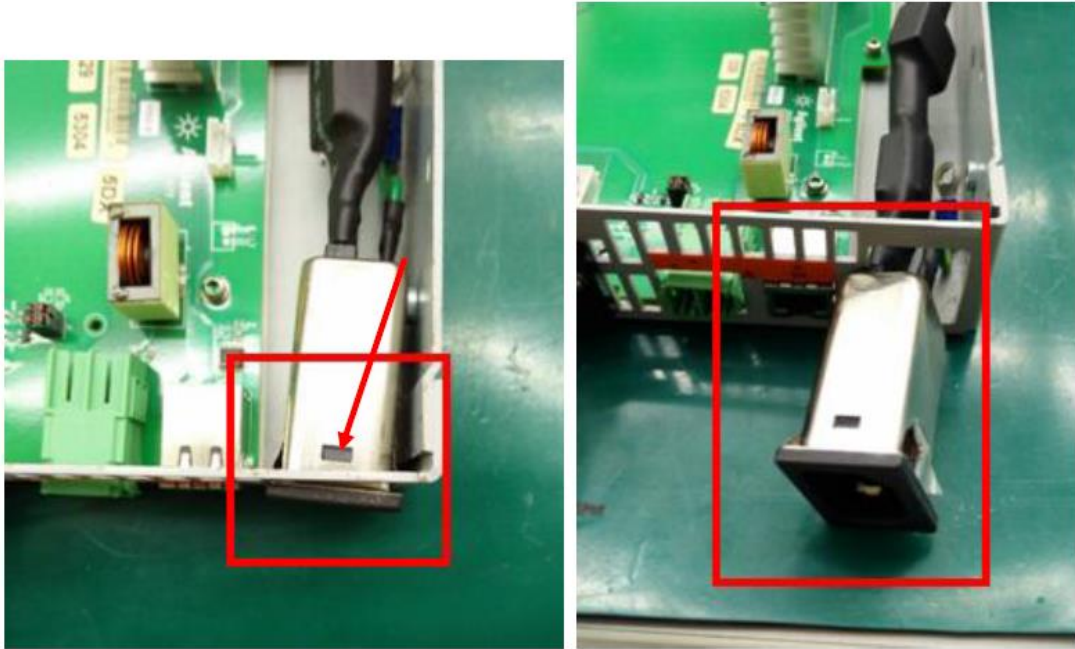
Figure 11

11. Remove AC line socket from chassis by pressing the lock chip as shown in **Figure 11**.

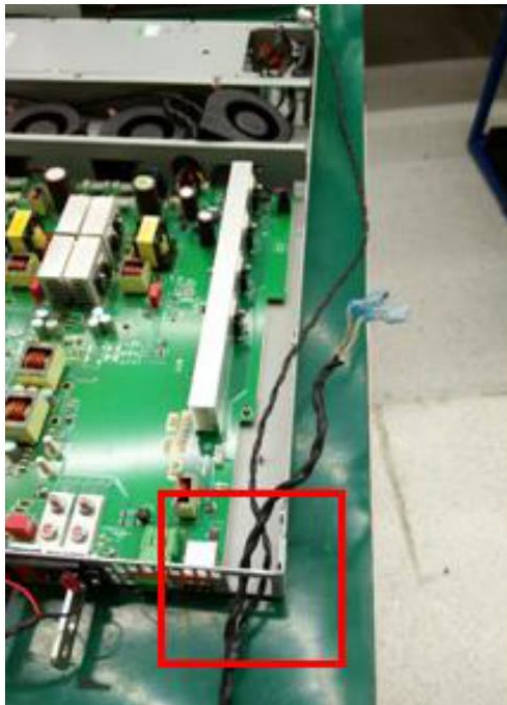
Figure 12

12. Insert the AC line cable (5190-4495) into chassis as shown in

13. Figure 12.

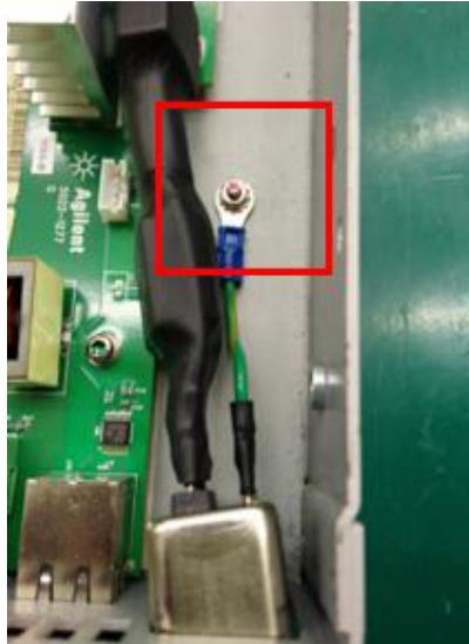
Figure 13

14. Secure grounding cable AC line cable with nut as shown in *Figure 13*.

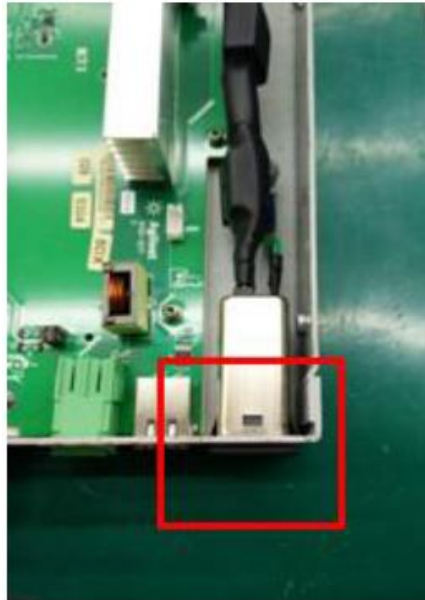
Figure 14

15. Press in AC line socket onto chassis as shown in Figure 14.

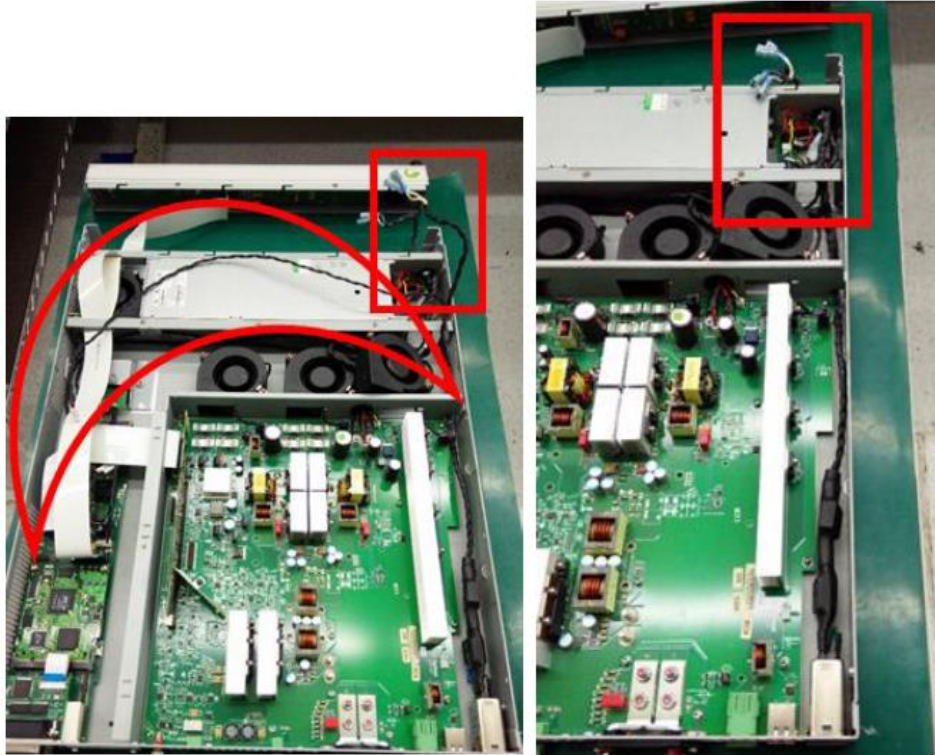
Figure 15

16. Route AC line through chassis hole until front panel. Another AC line cable will be insert into constellation PCA as shown Figure 15.

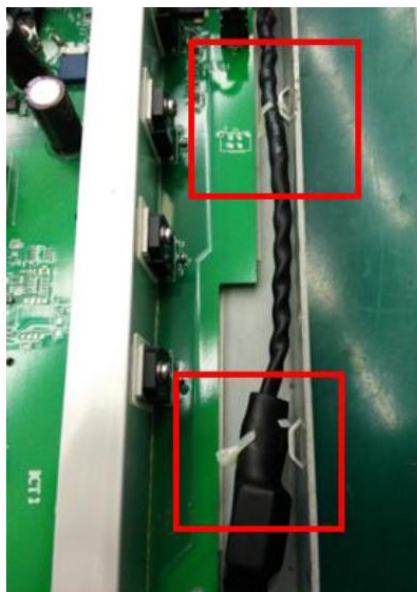
Figure 16

17. Insert 2 cable ties (1400-3204) to secure the AC line cable as shown in Figure 16.

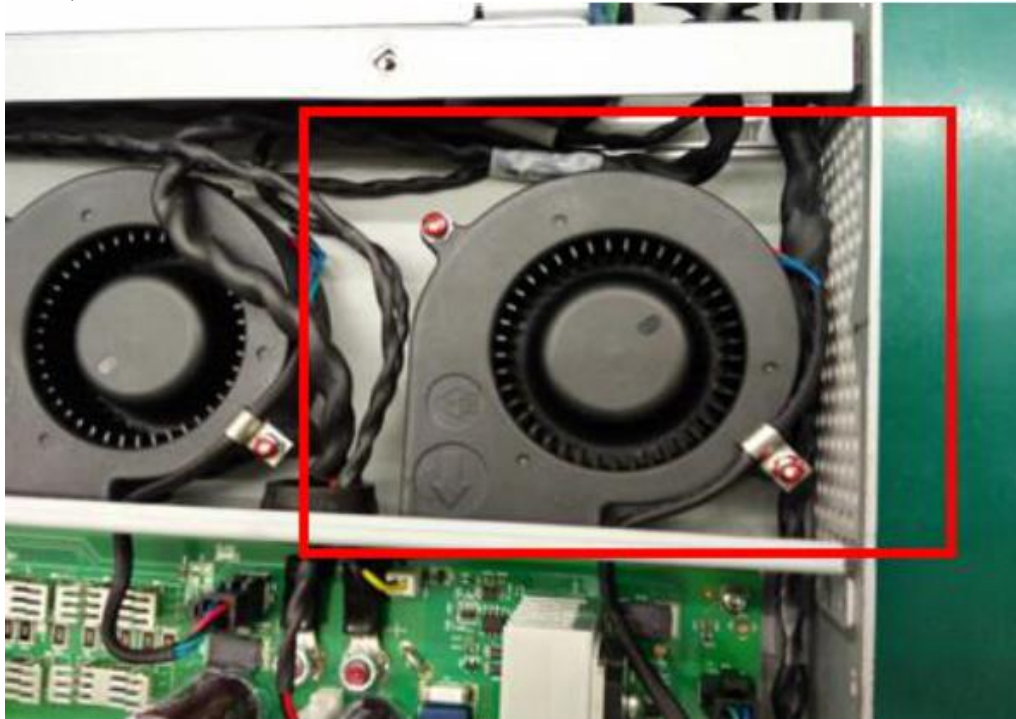
Figure 17

18. Screw the fan to the original position as shown in Figure 17.  
Note: Replace with new screws (0515-0667) if found loosen.

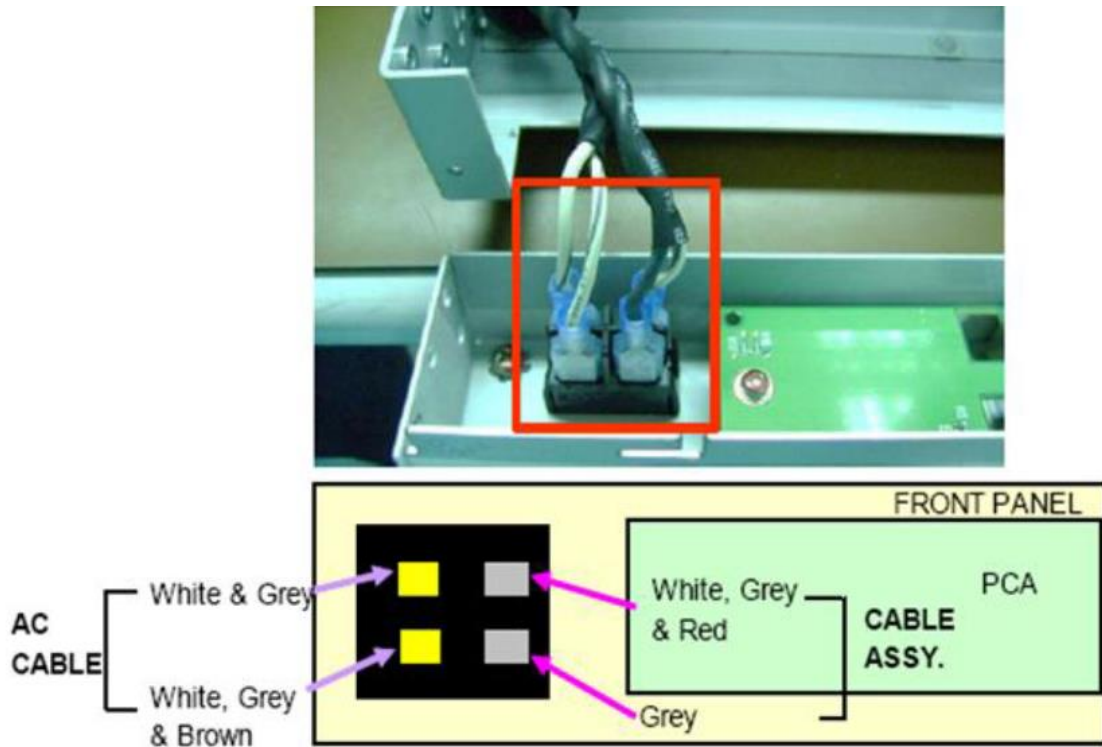
Figure 18

19. Insert the AC line cable and cable ASSY to the front panel as shown in Figure 18.

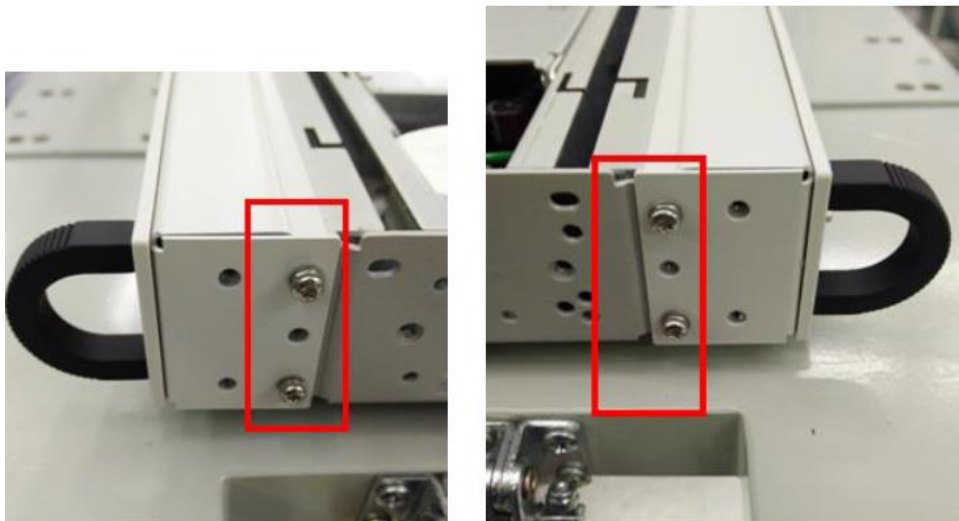
Figure 19

20. Screw 2 screws each side for both side of the front panel as shown in Figure 19.

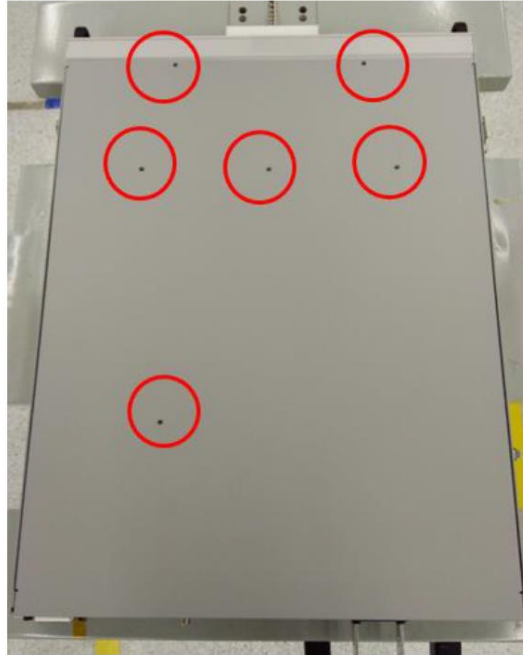
21. Screw 6 screws for the top cover as shown in Figure 20 .

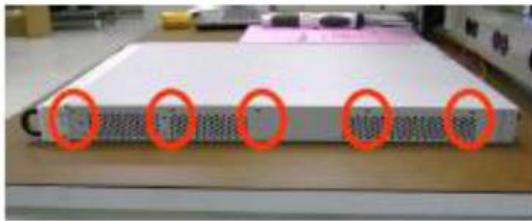
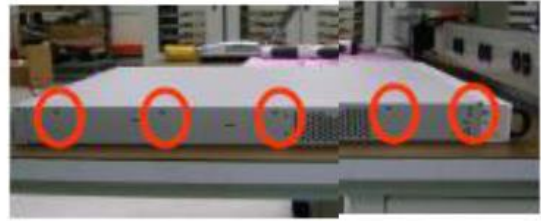
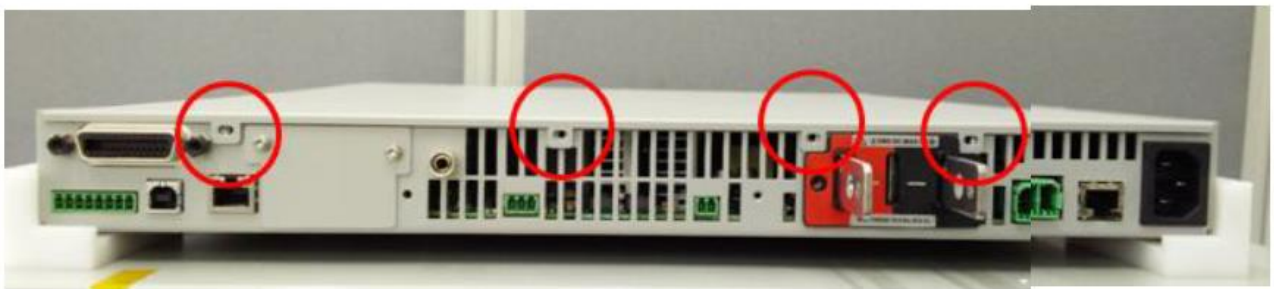
Figure 21

22. Screw total of 14 screws for both side and rear side as shown in Figure 21.
