N9010B-01A-S

Safety Service Note

N9010B EXA Signal Analyzer

POSSIBLE DROP HAZARD

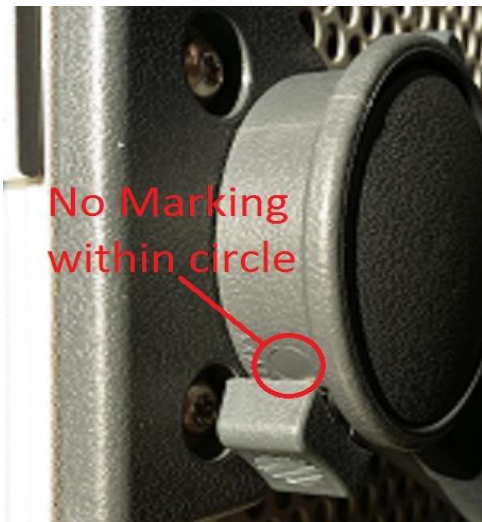
Replace the bail handle assembly with a known-good assembly. Figure 1 shows a close-up of the area around the hub of the bail handle assembly, near one of the buttons to rotate the handle. Look for the button that has “MADE IN USA” embossed near it. Note the circular feature in the bail handle. If there is no mark inside the circle, the bail handle assembly is an early production unit and must be replaced and destroyed to prevent it from being used again.

Figure 1. Circle with no markings. This handle should be replaced.

To replace the bail handle assembly, follow the instructions included in the Bail Handle Replacement Kit.

Any bail handle assembly replaced should be destroyed to prevent it from being used again. To destroy a handle, it is recommended that it be cut in half using a hacksaw, bandsaw, or similar tool.

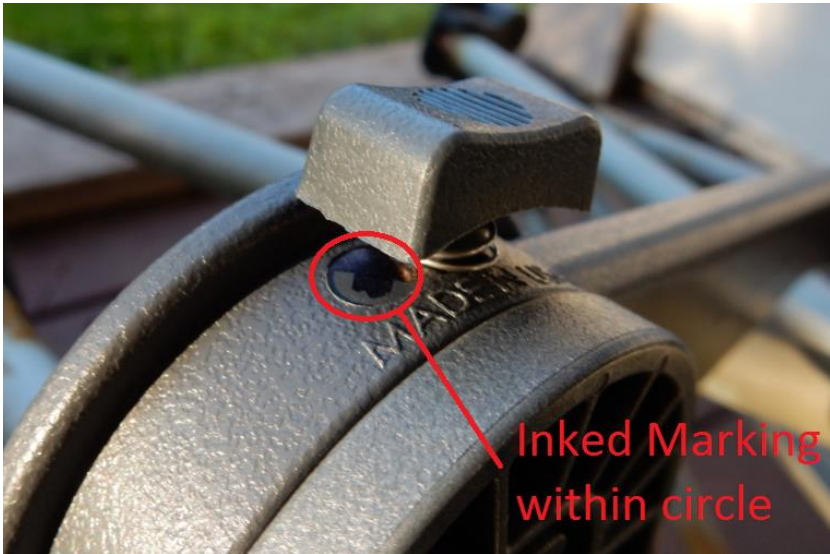
Figures 2 and 3 also show a close-up of the area around the hub of the bail handle assembly of later production units. Note the ink marking or an embossed ridge through the center of the circle.

Figure 2. Circle with inked marking. This handle is OK.

Check near the button that has “MADE IN USA” embossed near it for either an ink or embossed ridge mark. If you see one of these marks, the bail handle assembly is OK and does not need to be replaced.
