44470A-01A

S E R V I C E N O T E

44470A 10 channel multiplexer module for 3499A/B. Includes a screw terminal block

Defective connectors shipped with 44470A, 44471A, 44473A, 44474A

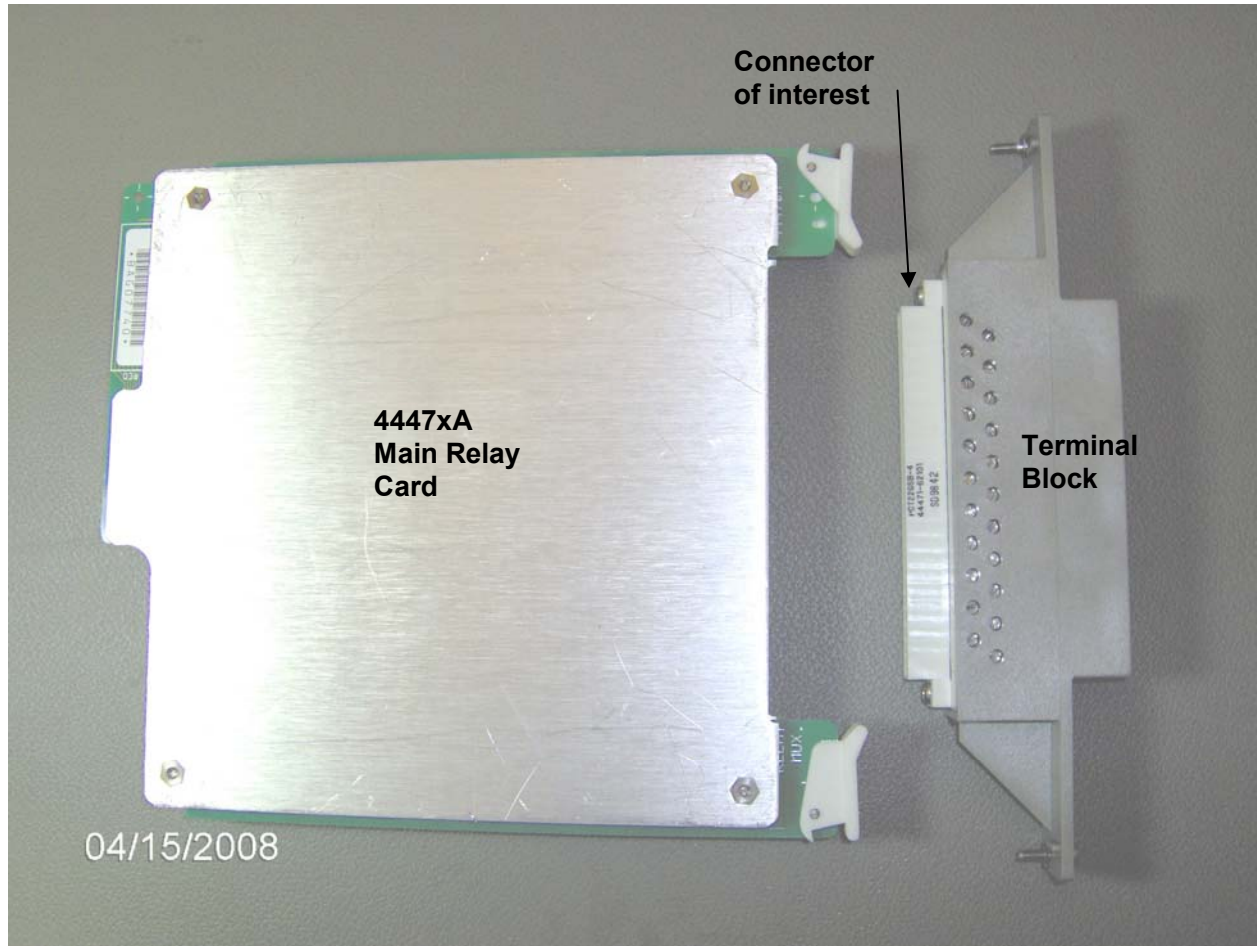
Figure 1: Main Relay Card and Terminal Block

The 44470A, 44471A, 44473A, and 44474A contain a main relay card and a removable screw terminal block (see Figure 1). Some of the removable terminal blocks that were shipped between 1-Jan-2008 and 08-April-2008 have a defective connector that results in half of the pins being unconnected.

The procedure to correct the defective connectors is very simple. One must replace the defective connector with a good connector (see connector part numbers list on page 2). The customer may perform this procedure or have an Agilent-qualified person perform this procedure.

Connector Replacement Procedure: After identifying a defective connector, the connector in the terminal block is repaired by removing the two screws that hold the connector to its case. Note the orientation of the connector. This will release the connector from the terminal block and then a good one can replace it. No soldering is necessary. See Figure 4.
