E5071C-13A

S E R V I C E N O T E

E5071C – ENA Series Network Analyzer, 9 kHz to 20 GHz

Step Attenuator Replacement Procedure

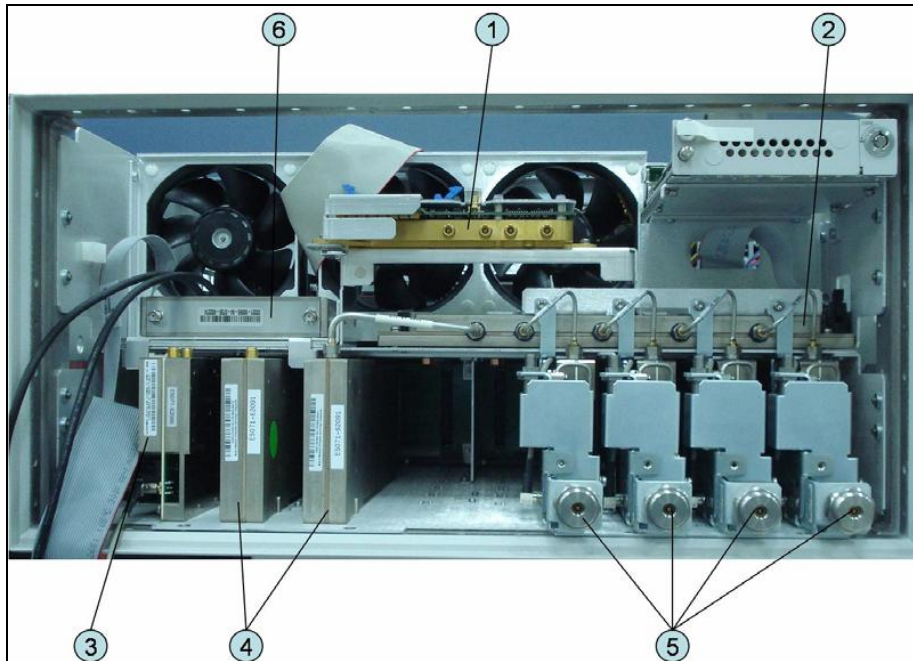
Table 5-9 Front View Over 8.5 GHz Options (Analog)

Shown is the front view of the unit.

1. Replace the Step attenuator module according to part replacement procedure shown on service guide for Over 8.5 GHz Option. Use **33321-60082** when **33321-60065** is broken.

3. Cable assembly **E5071-61665** is replaced by **E5071-61685** and **E5071-61686**. **E5071-61686** will be the newly added channel power supply to attenuator.
