N2830A-01

Modification Recommended Service Note

N2830A 4 GHz InfiniiMax III+ Series Probe Amplifier

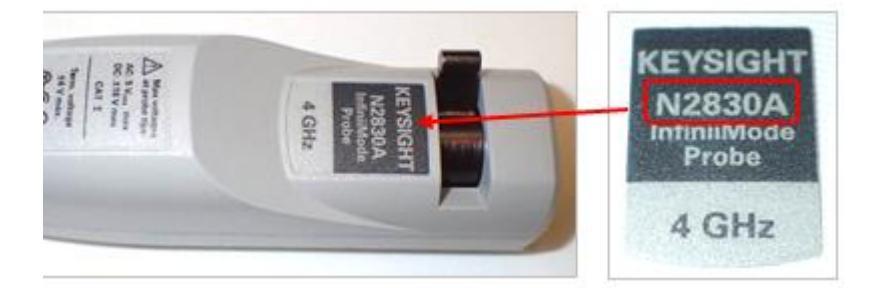
If the set screw is not stainless, it looks like the following after the sticker has been removed:

- a. If the screw is stainless, then remove adhesive and replace the label.
- b. No need to re-calibrate.
- c. If screw is black remove screw using T6 Torx.
