N4906B-01A-S

SERVICE NOTE

N4906B - Serial BERT

WARNING HAZARD CLASS 3

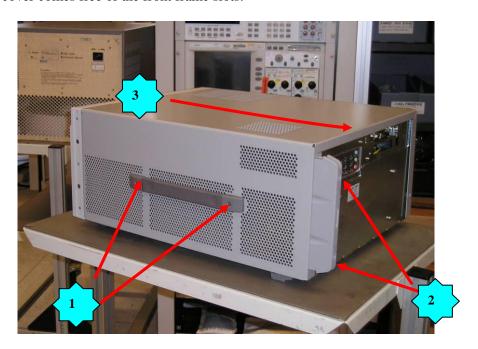
1. Open unit

- Remove the carrying handles from each side of the case by removing two screws (Torx 20) each.
- Remove the rear feet by removing two screws (Torx 15) each
- Remove the top cover by slightly lifting it up the back and then pulling it backwards until the cover comes free of the front frame slots.

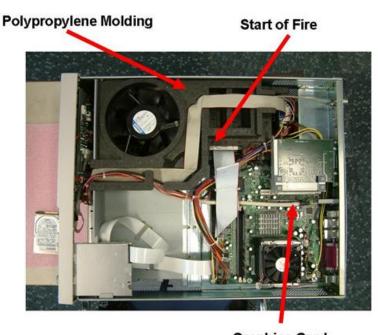
2. Inside View and Initial Inspection

Graphics Card
