MSOX3014A-03

S E R V I C E   N O T E

MSOX3014A – Oscilloscope, Mixed Signal, 4+8 Channel, 100MHz

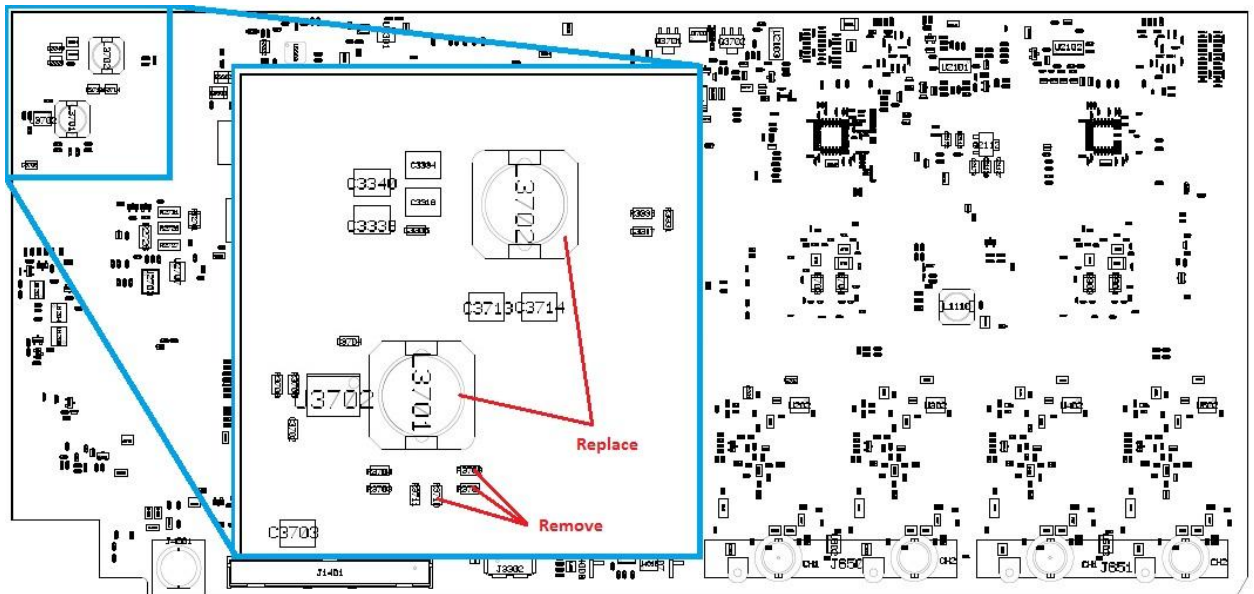
Situation:
With the oscilloscope power turned on and while under normal operation, the unit emits a hissing noise.

2. As the picture indicates, remove the three resistors (0699-7209, 1 Ohm) located at R3701, R3709, and R3710. They are not to be replaced.
3. Remove as well the two inductors (9140-6474, 100uH) located at L3701 and L3702 and replace them with inductors with part number 9140-6151 (68 uH).
4. Re-assemble to the point where the unit could be powered up to verify that the hissing is indeed gone. If the hissing is not gone, please, check modifications.
5. When the hissing is gone, put oscilloscope back together.
