**Title & Document Type:** 6942A Multiprogrammer Service Notes

**Manual Part Number:** 06942-90001

HP MODEL 6942A MULTIPROGRAMMER  
Serial Numbers 2039A - 1050 and below  
FRONT PANEL CHANGE

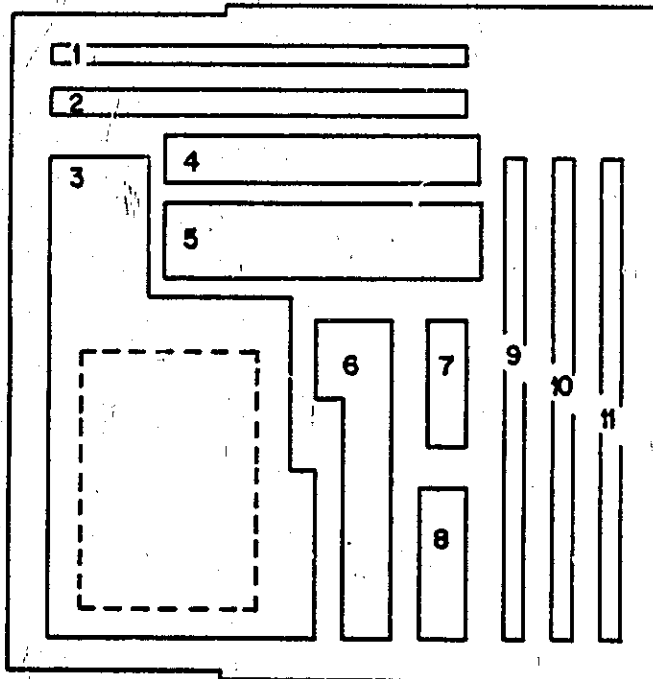
14711B KIT LAYOUT

<u>ITEM</u>	<u>NEW PART NO.</u>	<u>RESTORED PART NO.</u>	<u>DESCRIPTION &amp;</u>
1	06941-60020	-	DST JUMPER BD
2	06942-60024	06942-69024	HP-IB INTERFACE
3	-	-	This space is reserved for a top interconnect bd (06942-60001) which is not supplied with the 14711B.
4	5060-2768	06942-69003	BOTTOM POWER SUPPLY BD (A9)
5	5060-2767	06942-69002	TOP POWER SUPPLY BD (A7)
6	5060-2766	06942-69001	MIDDLE POWER SUPPLY BD (A8)
7	-	-	Space for data cartridges (verification programs).
8	-	-	This space reserved for a FAN, TUBEAXIAL, not supplied in the 14711B.
9	06942-60022	06942-69022	CPU BD (A1)
10	06942-60023	06942-69023	RAM BACKPL CONTROL BD (A2)
11	-	-	For discretionary use. 6943A backplane bd assy fits this slot.

NOTES: 1. A cutout under 3 may be removed to add storage space (a parts box, for example).

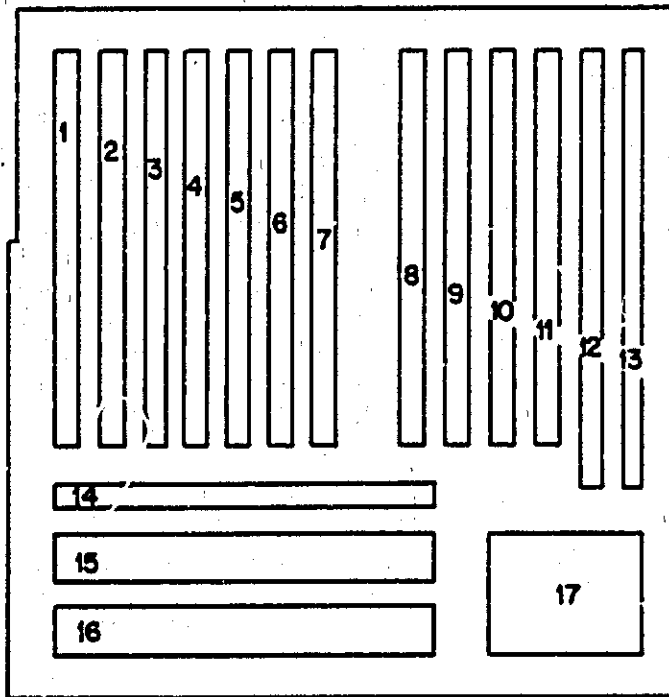
14711C KIT LAYOUT

<u>ITEM</u>	<u>PART NO.</u>	<u>DESCRIPTION &amp; NOTES</u>
1-11	-	Slots for standard I/O cards
12,13	-	Slots for scanner cards
14	-	Slot for standard I/O card
15,16	-	Slot for memory card pair
17	-	Cutout for small parts storage

NOTE: 1. There are no circuit assemblies in the 14711C. Refer to Table 5 for a list of I/O card models and part numbers of the restored equivalents. The initial stocking of a 14711C kit is made with new circuit assemblies appropriate for the system(s) being supported.

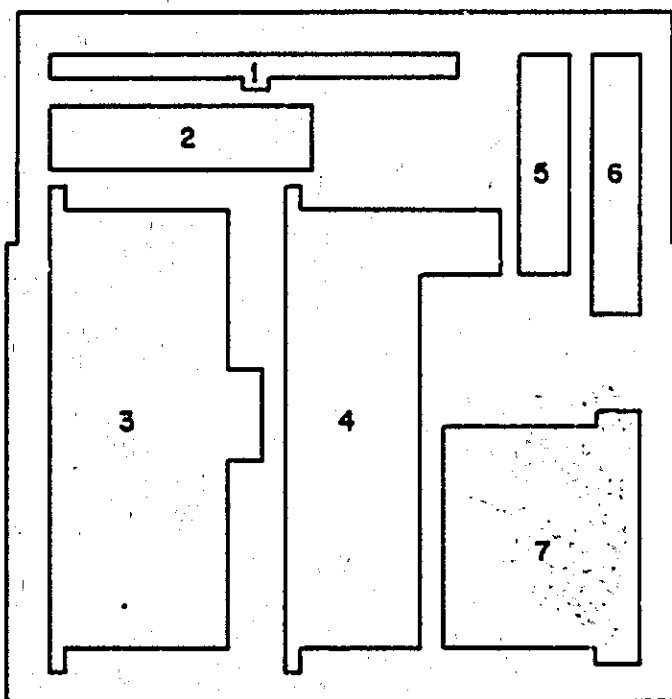
14711D KIT LAYOUT

<u>ITEM</u>	<u>PART NO.</u>	<u>RESTORED PART NO.</u>	<u>DESCRIPTION &amp; NOTES</u>
1	06944-60021	-	BT BOARD ASSY
2	-	-	Space for small parts box
3	06944-60024	06944-69024	MAIN PS ASSY
4	06944-60023	-	ISOL PS ASSY
5	-	-	Space for interface cable (up to 2 meters)
6	-	-	Space for box of program discs
7	98633-61001	-	INTEFACE BD ASSY

NOTE: 1. Areas under openings 3,4 and 7 have removable inserts that can be modified to add additional small parts storage.  
2. See table 4 for additional small parts that may be placed in the kit by the users.
