B2961A-02

Modification Recommended Service Note

B2961A 6.5 Digit Low Noise Power Source, 32W, 210V, 3A, 1ch

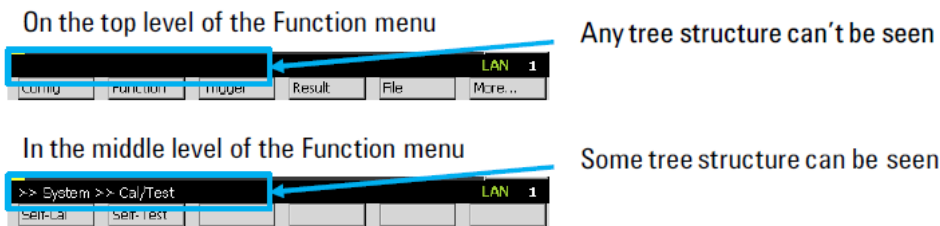
Step 1. If you aren't on the top level of the Function menu, press

repeatedly to return to the top level.

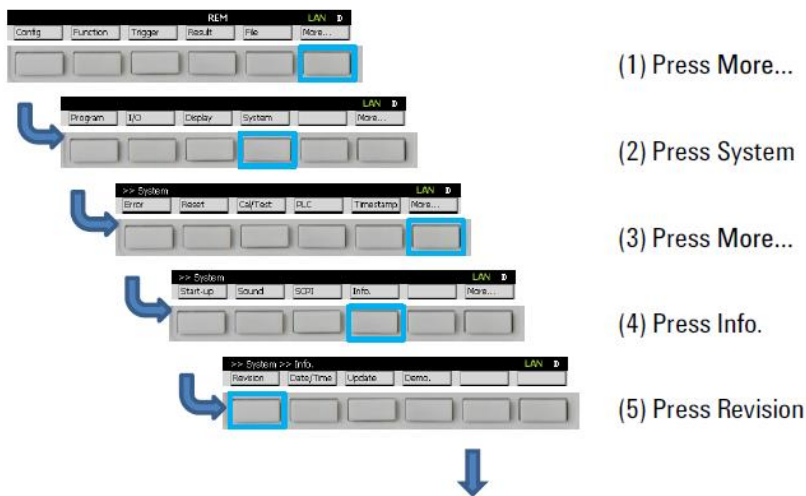
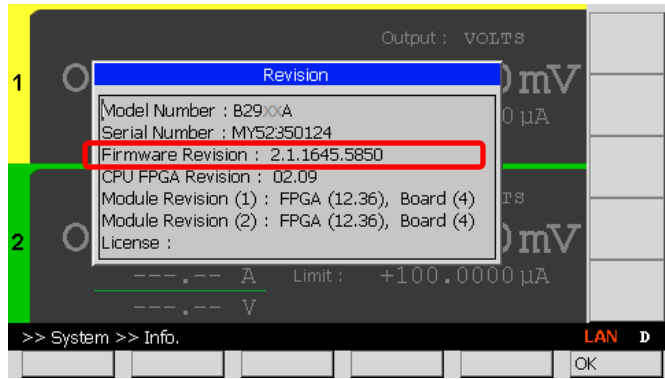
Step 2. Press

to open Revision dialogue.

Step 2: If the firmware revision displayed is 2.2.1744.8725 or earlier, install the firmware 2.2.1831.4380 or later, following the procedure below.
