Modification Recommended Service Note

E5055A SSA-X Signal Source Analyzer, 1 MHz to 8 GHz

DDS modification to improve performance

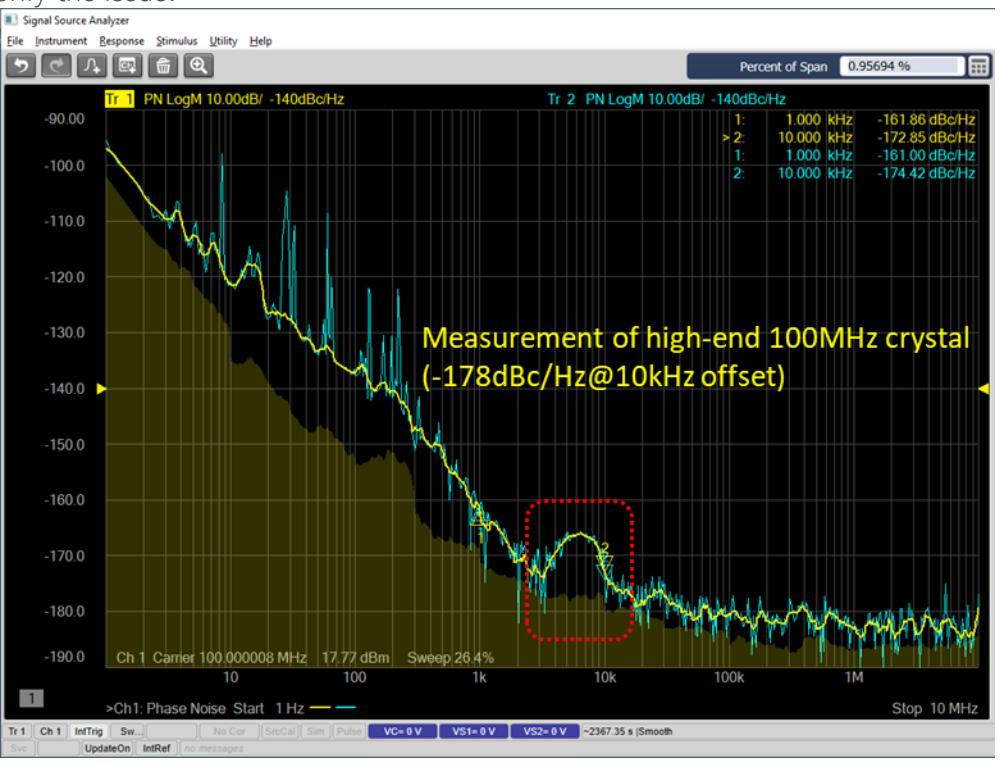
Customer may observe a bump of the measurement data at carrier frequency 100MHz with 10kHz offset although the performance is still within the product specifications. This bump can be observed when using a high-end 100MHz crystal as a DUT in the figure below. Keysight's standard test equipment at the service center such as a PSG will not be able to identify this issue. So, a screenshot is needed to verify the issue.

Fig 1. Measurement of DUT before replacing DDS modules

- 1) To verify the noise bump at around 10 dB/Hz, follow the steps below.
 - a. Connect DUT (high end 100MHz oscillator) to RF port.
 - b. Preset to measure phase noise. You can see carrier frequency as about 100MHz in the screen.
 - c. Set start offset to 1Hz.
 - d. Set correlation to 100 as the minimum. A user can't see this issue without correlation.
 - e. The user will see the bump at about 10kHz offset frequency.
- 2) If the noise bump is visible, send to the unit to the nearest service center (or factory) and Keysight will replace the DDS modules and do a re-calibration.
- 3) The modified modules should resolve the issue on any units. So, the verification of disappearing the bump is not needed. If the unit passes the standard Performance Verification test after the DDS modules are replaced, the unit can be returned to the customer.

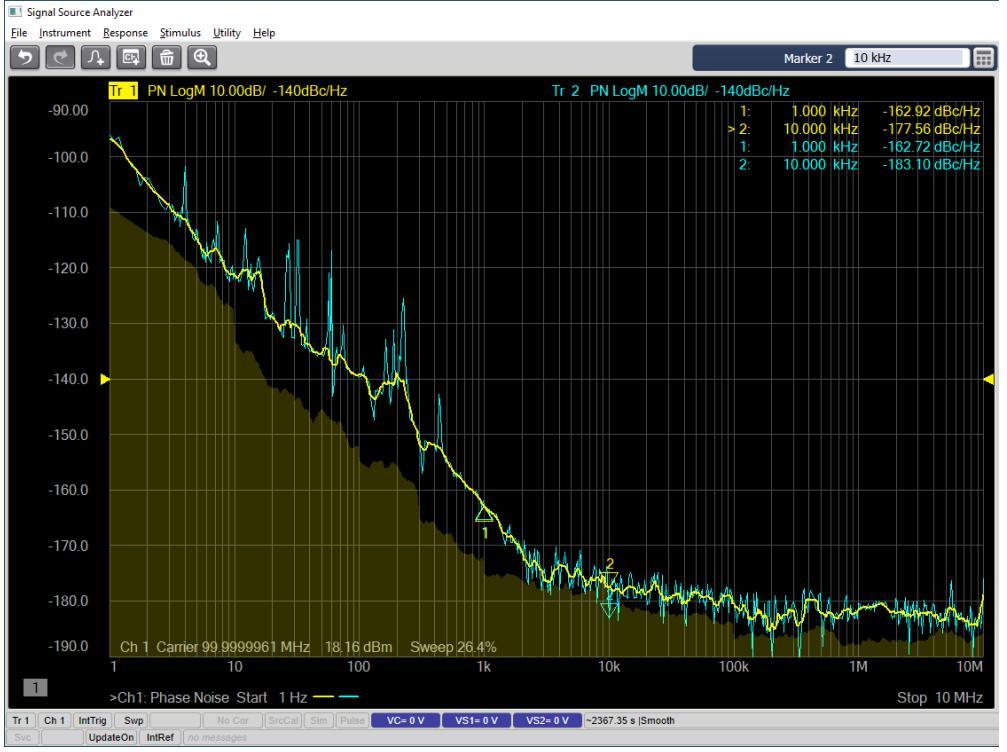
on the PCB changed. All inventoried modules have been reworked. After replacing the DDS modules, the measurement result would be as below.

Fig 2. Measurement of DUT after replacing DDS modules

Note: The DDS' part number is the same as the original part number because only the components
