# N5183A-01 <u>S E R V I C E N O T E</u>

## N5183A MXG Microwave Analog Signal Generator

"Batch related component issue may result in a non-functioning instrument."

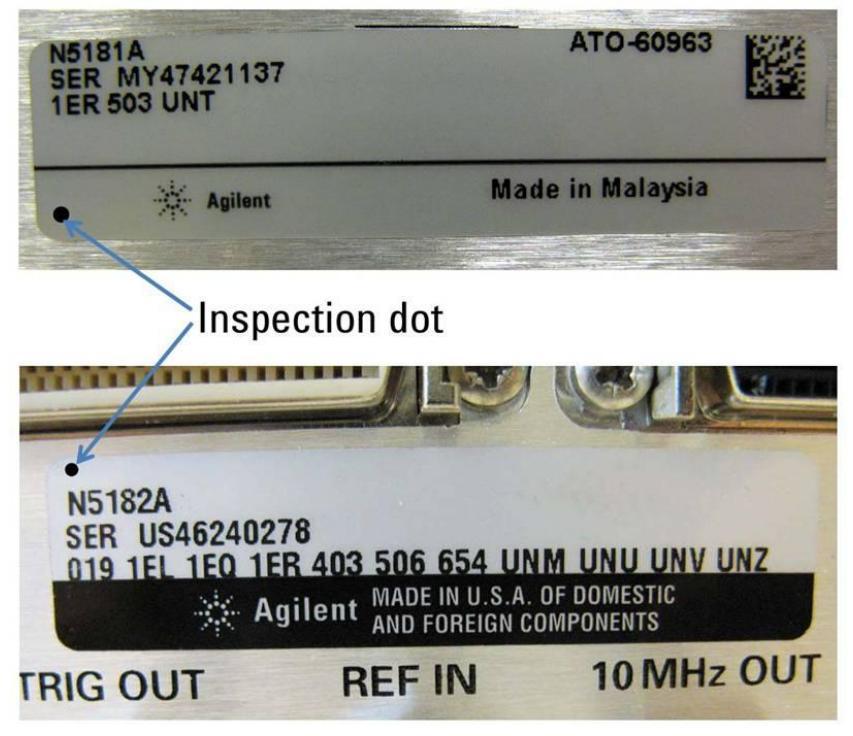
1. Check the rear panel serial tag for a small black dot (see picture). If a dot is present the instrument has already been checked and no further action required. If the dot is missing proceed to step 2.
