**16055A-01**

**S E R V I C E N O T E**

**16055A Test Fixture**

**Banana Plug (1251-8936) is Discontinued.**

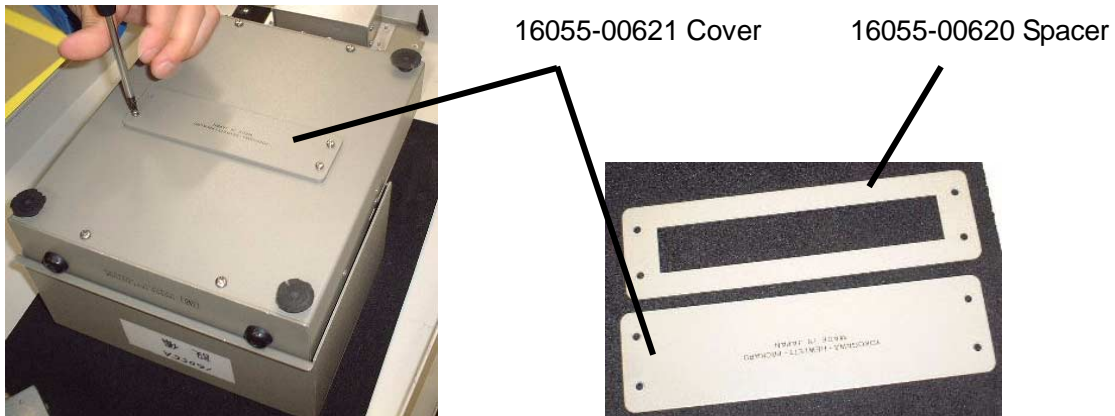
1. Check if the 16055A has the cover on the bottom as shown below.

2. If the cover is attached, replace banana plug only.
3. If the cover is NOT attached, order all banana plug, chassis, bottom cover, spacer, cover, and screw. And replace them as follows:
  - A) Remove the bottom cover.
  - B) Remove the chassis.
  - C) Remove all banana plug, insulator, and nuts.
  - D) Attach the banana plug to the chassis 16055-60102 as shown below.
  - E) Attach the chassis.
  - F) Attach the bottom cover 16055-60022.
  - G) Attach the spacer 16055-00620 and cover 16055-00621 to the bottom with four screws.
