33511B-02

Modification Recommended Service Note

33511B Function Generator

Serial Numbers: MY000000000 to MY57300600 and SG000000000 to SG57300600

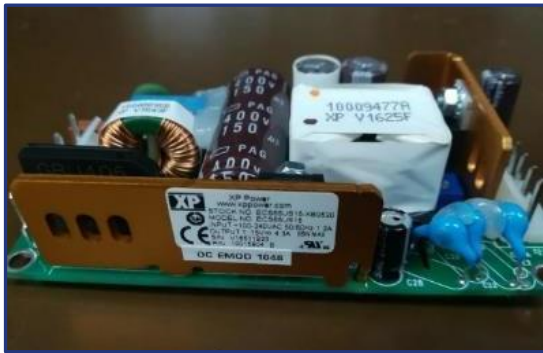
Old Noisy XP Power Supply (PN xxxx-xxxx)

The Problem – Some customers have reported that, when line power is applied to the instrument but the instrument is NOT turned on (“Standby Mode”), some instruments will emit an audible high-pitched whistle or whine. To fix this, the existing power supply must be replaced with a newly designed power supply, as detailed in the solution below.

The solution is to replace the old power supply with a new one. The old power supply was manufactured by XP Power. The new power supply is manufactured by MeanWell, and has Part Number 0950-6082.

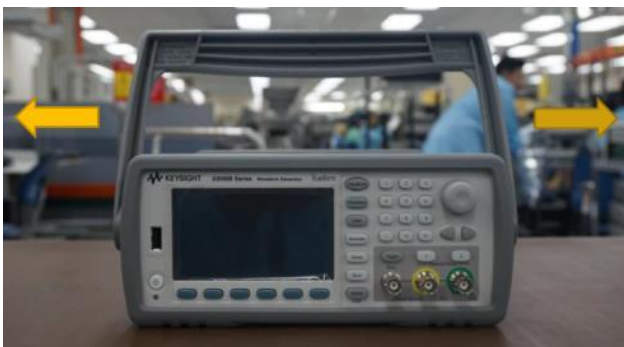
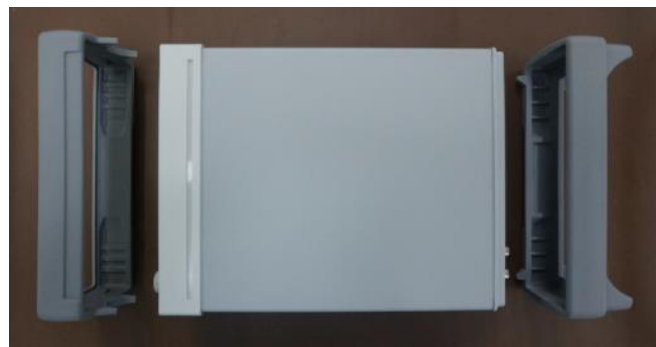
- 1) Rotate the handle upright and pull off the handle. Then pull off the instruments bumpers.

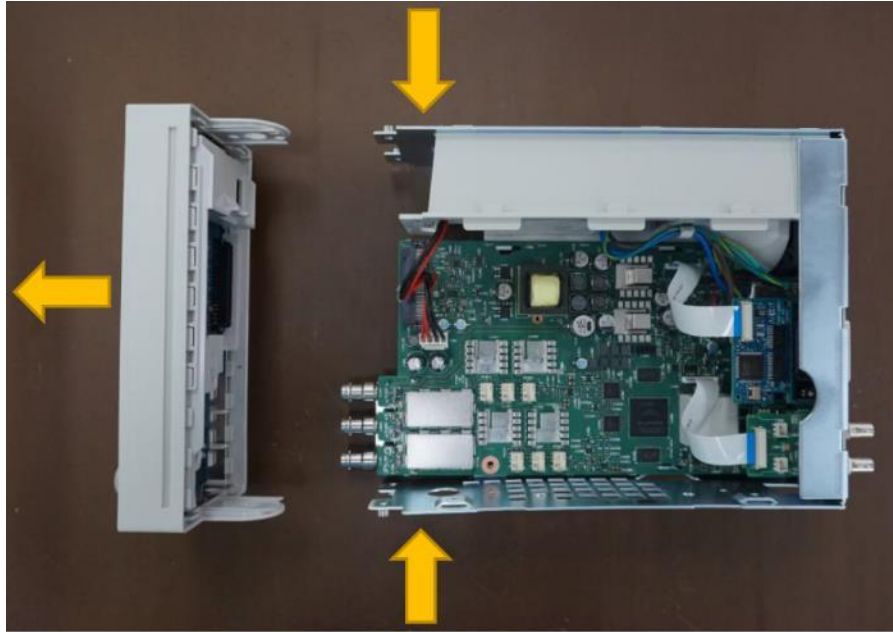
- 5) Push the sides of the metal chassis toward the center to disengage the studs on the sides of the front panel assembly. Then gently pull the front panel assembly straight back from the chassis. Note that the front panel assembly has an electrical connector to the main board. Be careful not to damage the connector.
