33519B-02

# Modification Recommended Service Note

## 33519B Function Generator

Serial Numbers: MY000000000 to MY57500600 and SG000000000 to SG57500600

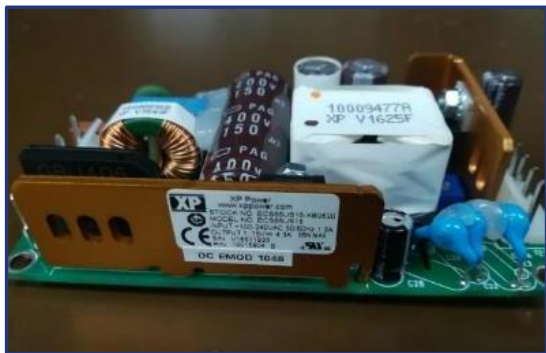
**Old Noisy XP Power Supply (PN xxxx-xxxx)**

The solution is to replace the old power supply with a new one. The old power supply was manufactured by XP Power. The new power supply is manufactured by MeanWell, and has Part Number 0950-6082.

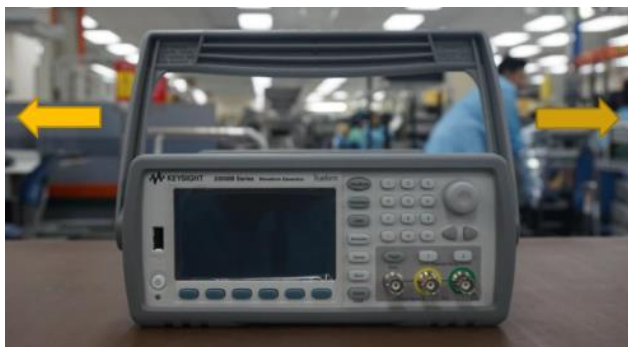
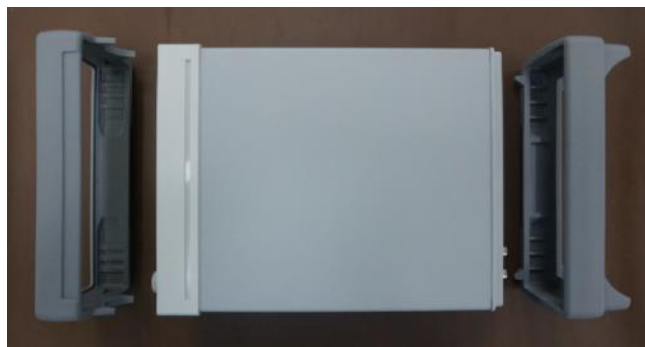
- 1) Rotate the handle upright and pull off the handle. Then pull off the instruments bumpers.

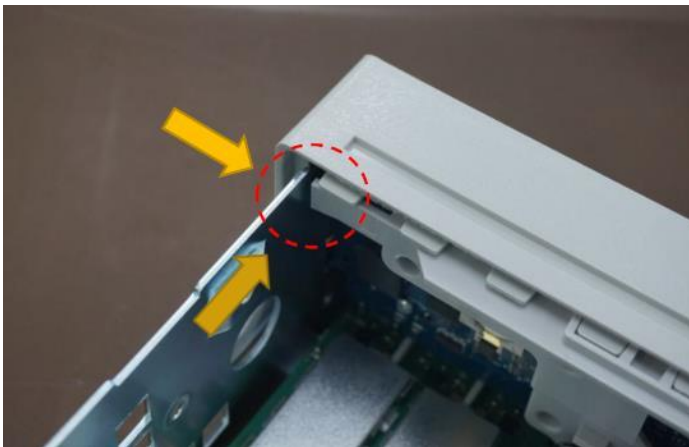
4) Press the latch on the left side of front panel, then press the latch on the right side of the front panel.

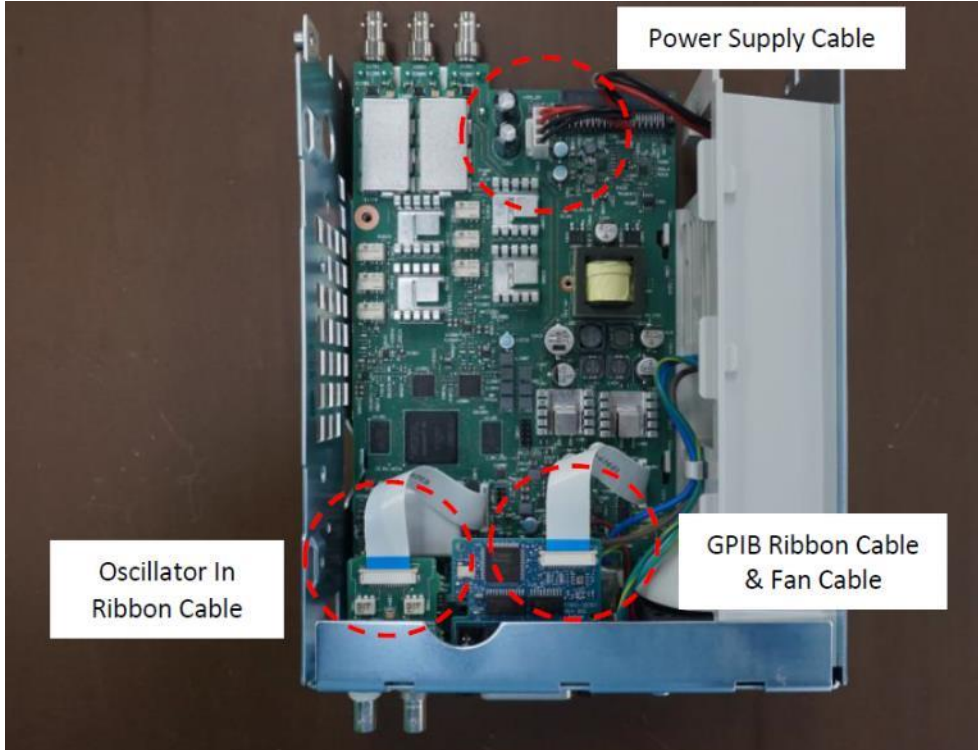
- 1) Disconnect the power supply connector from the main board. Disconnect the **GPIB** and **Oscillator In** ribbon cables. Disconnect the **Fan Power Cable** from the main board.

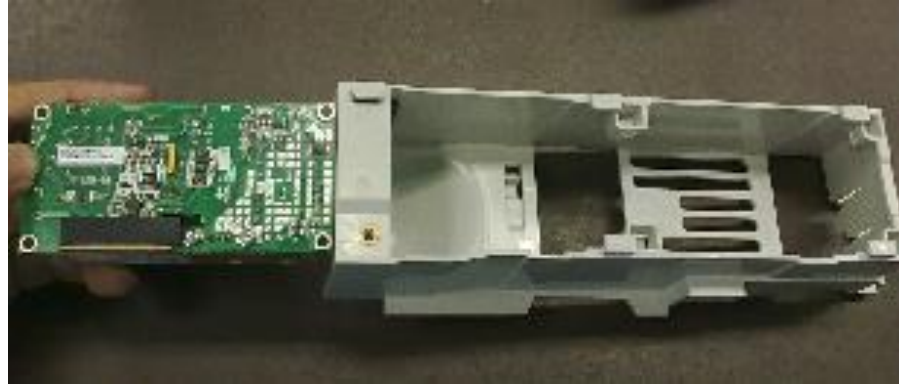
Figure 1

Take the New Power Supply (0950-6082) and slide it into the Power Supply Cover. Make sure the orientation of the power supply is correct as shown on Figure 1.

**NOTE: The illustrations below show the OLD XP power supply assembly. Be sure you are installing the NEW MeanWell power supply. Reference the photos at the beginning of this Service Note to be sure you have the correct supply.**

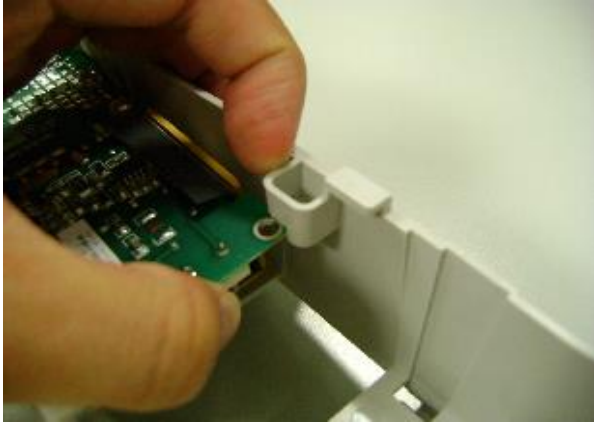
Figure 3a

Pull one side of the cover outward while pulling the Power Supply PCA upward, so that the power supply PCA slides into the slot on the Power supply cover as shown on Figure 3a. Do the same for the other edge of the power supply. The Power supply cover with the power supply properly installed is shown in Figure 3b.

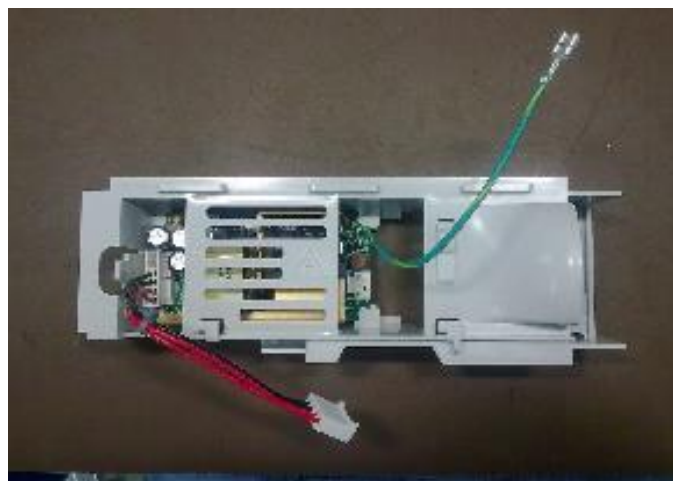
Figure 4

Install the Power Supply cable (53200-61619) and the Chassis Ground Cable (53200-61610) into the power supply connectors as shown in Figure 4.
