33520B-02

Modification Recommended Service Note

33520B Function Generator

Serial Numbers: MY000000000 to MY57600600 and SG000000000 to SG57600600

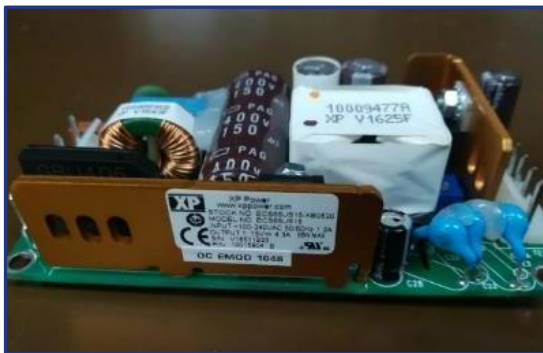
Old Noisy XP Power Supply (PN xxxx-xxxx)

The Problem – Some customers have reported that, when line power is applied to the instrument but the instrument is NOT turned on (“Standby Mode”), some instruments will emit an audible high-pitched whistle or whine. To fix this, the existing power supply must be replaced with a newly designed power supply, as detailed in the solution below.

The solution is to replace the old power supply with a new one. The old power supply was manufactured by XP Power. The new power supply is manufactured by MeanWell, and has Part Number 0950-6082.

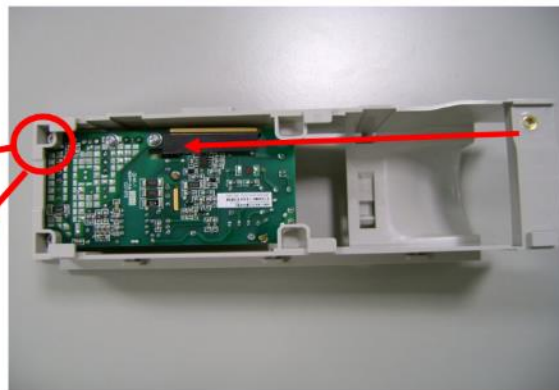
Push the power supply into the cover as indicated by the red arrow until it reaches the end of the power supply cover, as shown in Figure 2b. Make sure the two edges of the power supply PCA are completely inserted into the slots on the power supply cover as shown in Figure 2c. Figure 2a shows the Power supply PCA edge is not properly inserted in the slots on the power supply cover.
