33521B-02

# Modification Recommended Service Note

## 33521B Function Generator

Serial Numbers: MY000000000 to MY57700600 and SG000000000 to SG57700600

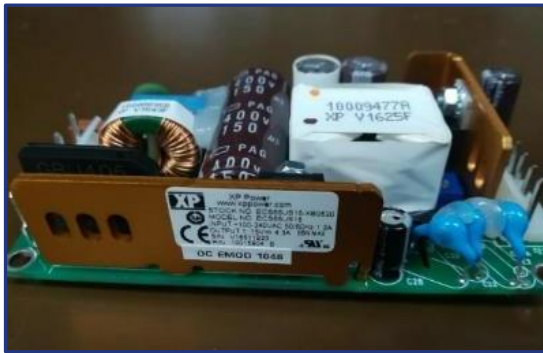
**Old Noisy XP Power Supply (PN xxxx-xxxx)**

**The Problem** – Some customers have reported that, when line power is applied to the instrument but the instrument is NOT turned on (“Standby Mode”), some instruments will emit an audible high-pitched whistle or whine. To fix this, the existing power supply must be replaced with a newly designed power supply, as detailed in the solution below.

The solution is to replace the old power supply with a new one. The old power supply was manufactured by XP Power. The new power supply is manufactured by MeanWell, and has Part Number 0950-6082.

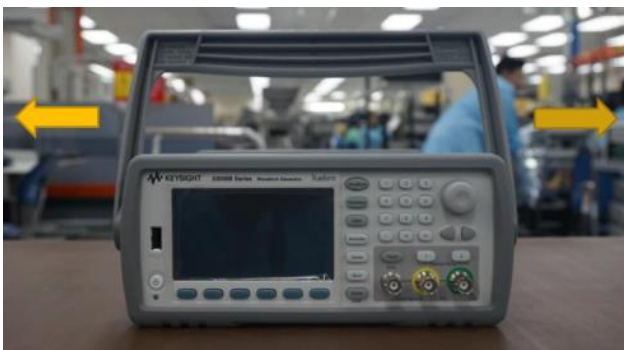
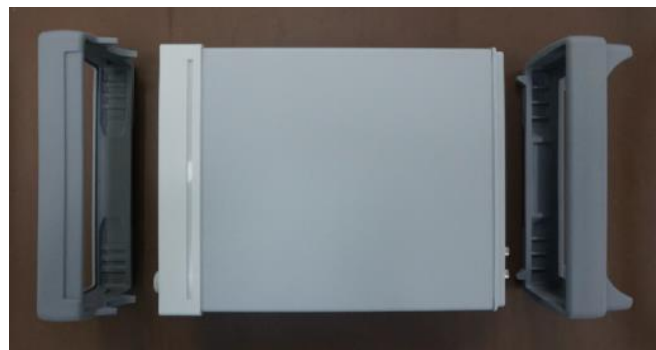
- 1) Rotate the handle upright and pull off the handle. Then pull off the instruments bumpers.

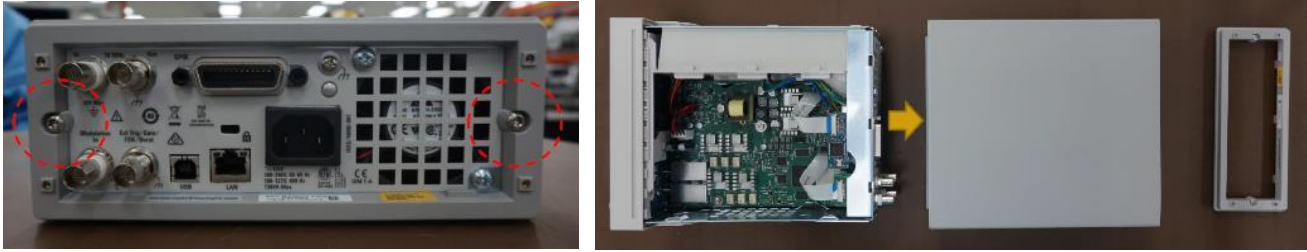
- 2) Loosen the two captive rear bezel screws, remove the bezel, and slide off the instrument cover.

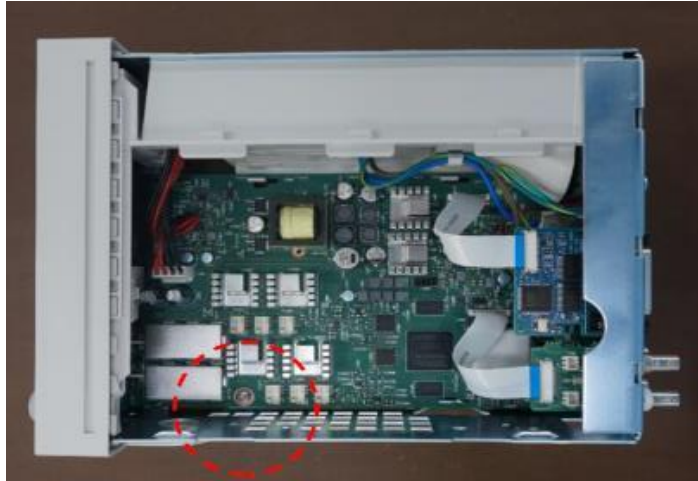
3) Remove the T15 screw holding the main board.

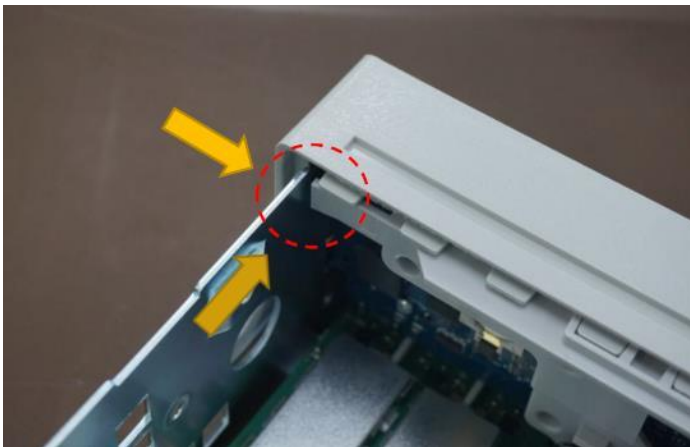
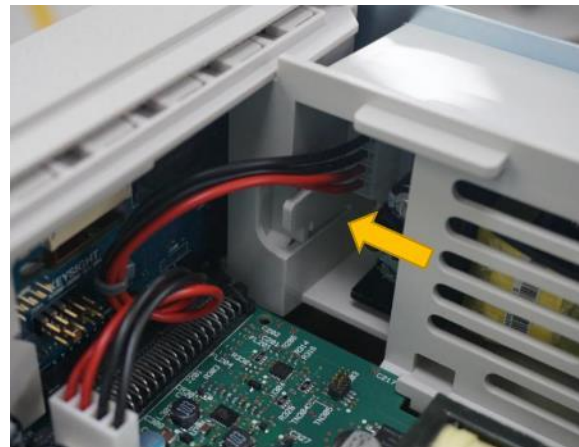
4) Press the latch on the left side of front panel, then press the latch on the right side of the front panel.

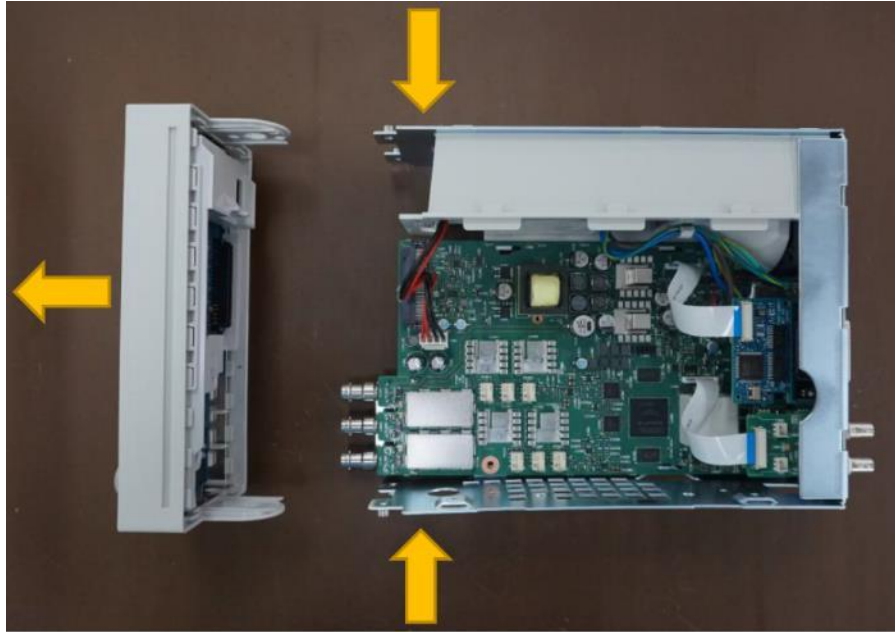
- 5) Push the sides of the metal chassis toward the center to disengage the studs on the sides of the front panel assembly. Then gently pull the front panel assembly straight back from the chassis. Note that the front panel assembly has an electrical connector to the main board. Be careful not to damage the connector.

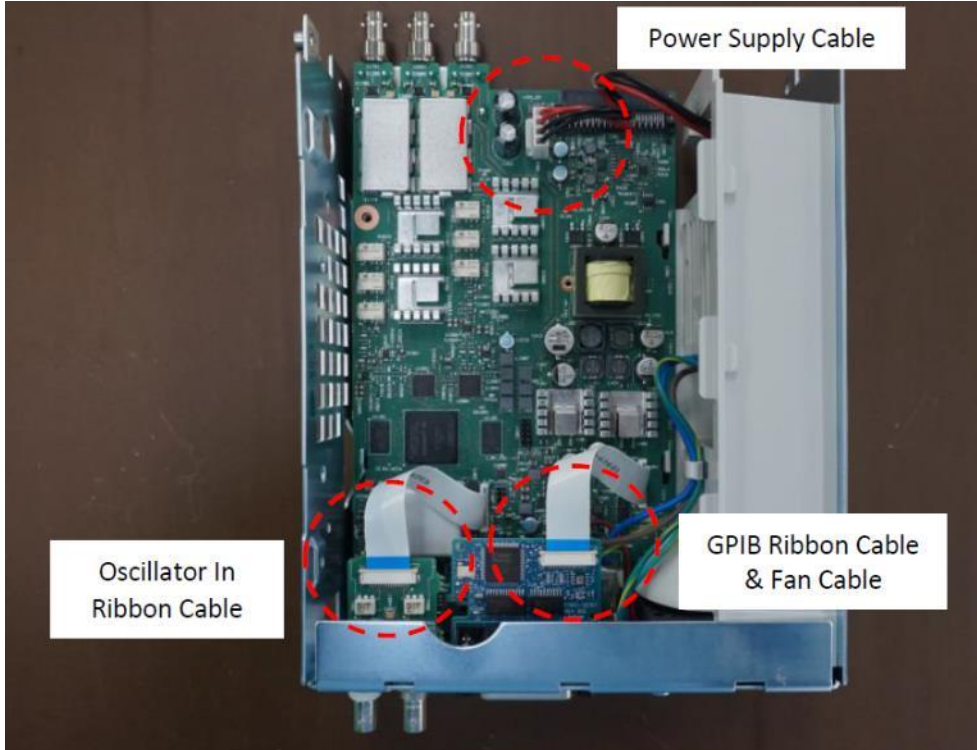
- 1) Disconnect the power supply connector from the main board. Disconnect the **GPIB** and **Oscillator In** ribbon cables. Disconnect the **Fan Power Cable** from the main board.

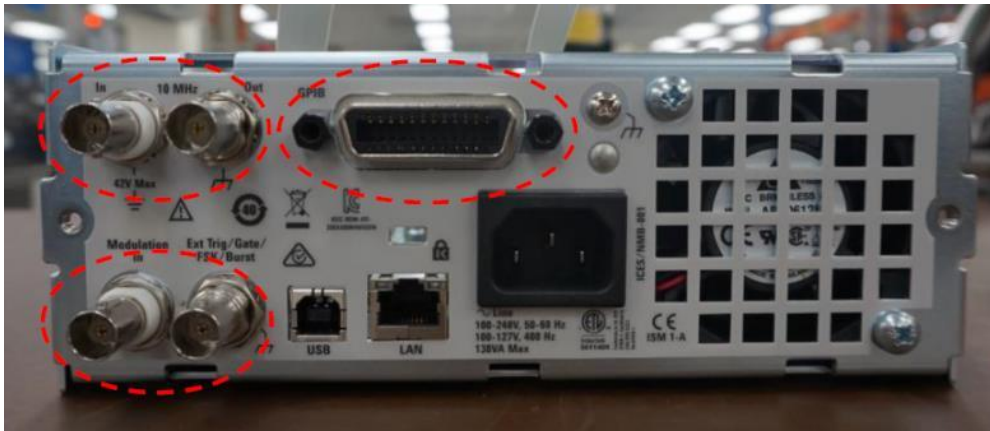
- 2) Loosen and remove the nuts securing the **10 MHz In**, **10 MHz Out**, **Modulation In** and **Ext Trig** BNC connectors to the rear panel. Remove the hex screws and washers securing the **GPIB PCA**.

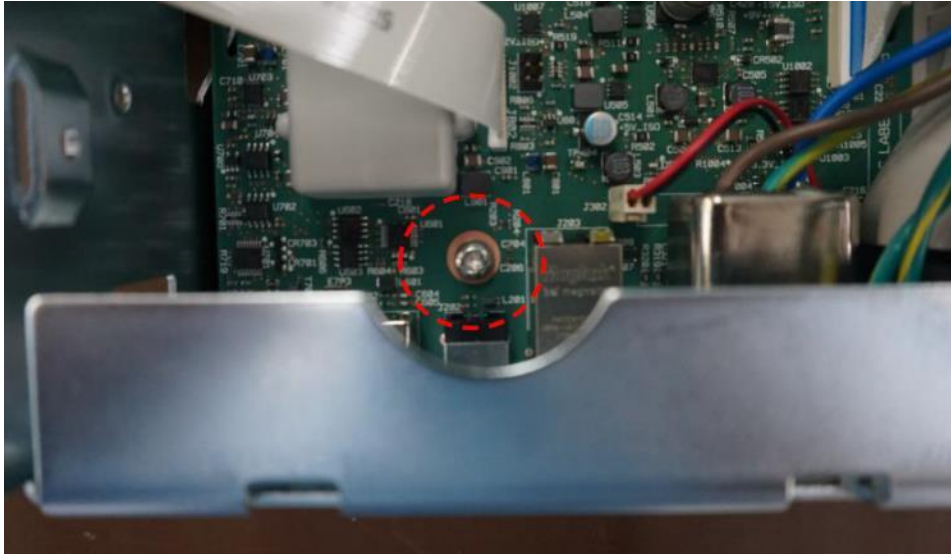
- 3) Remove the screw below the GPIB board which secures the main board to the chassis.

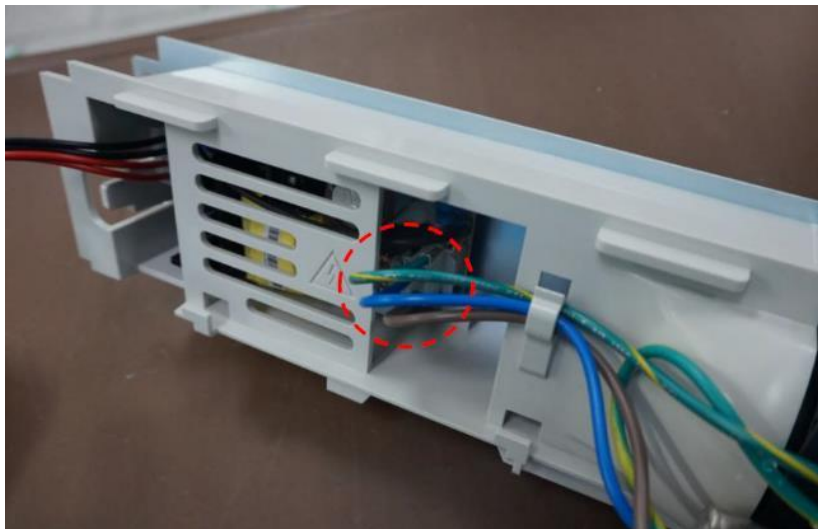
- 1) Disconnect the input power to the power supply board (blue and brown wires). Disconnect the green ground wire connector on the power supply board.

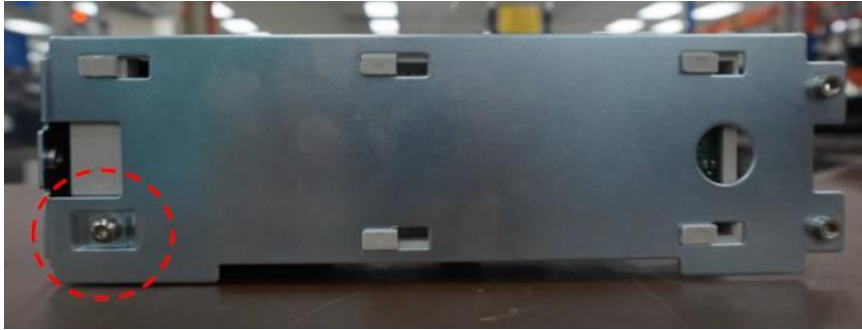
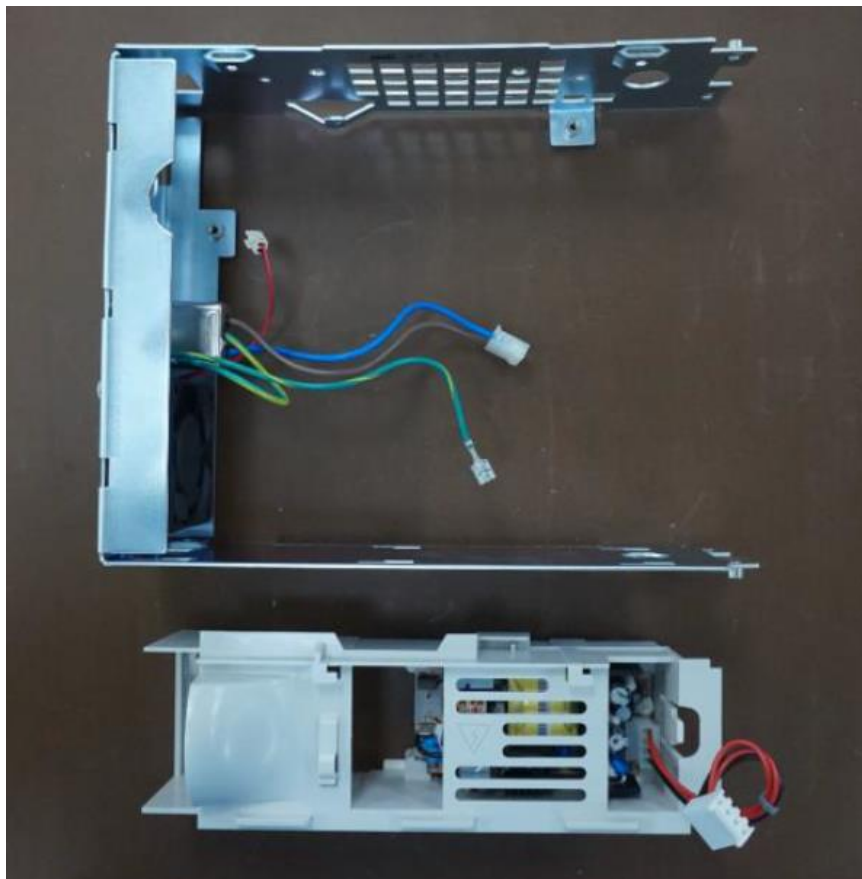
- 2) Remove the screw securing the power supply cover to the chassis. Then slide the power supply assembly toward the front of the instrument and remove it.

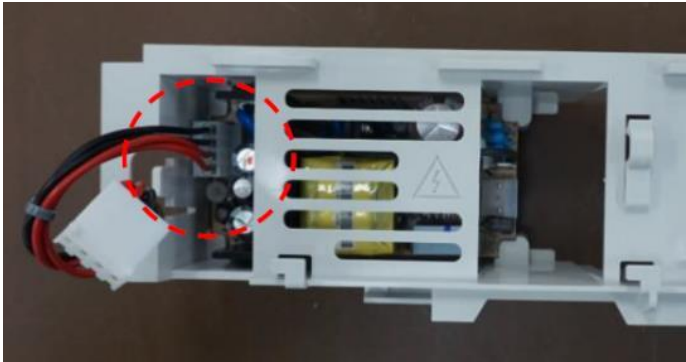
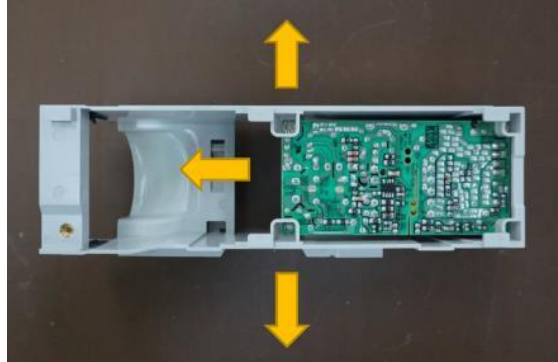
- 3) Remove the power supply cable from the power supply unit. Then pull the walls of the power supply cover to release the power supply.

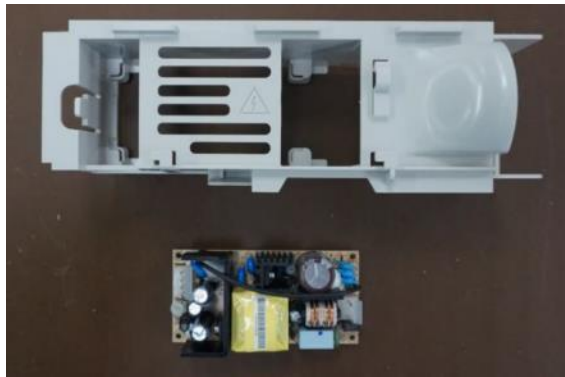
- 4) Remove the power supply from the power supply cover.

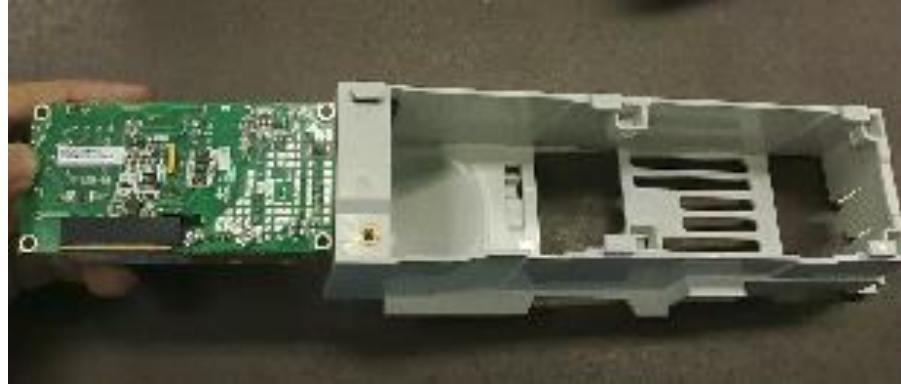
Figure 1

Take the New Power Supply (0950-6082) and slide it into the Power Supply Cover. Make sure the orientation of the power supply is correct as shown on Figure 1.

**NOTE: The illustrations below show the OLD XP power supply assembly. Be sure you are installing the NEW MeanWell power supply. Reference the photos at the beginning of this Service Note to be sure you have the correct supply.**

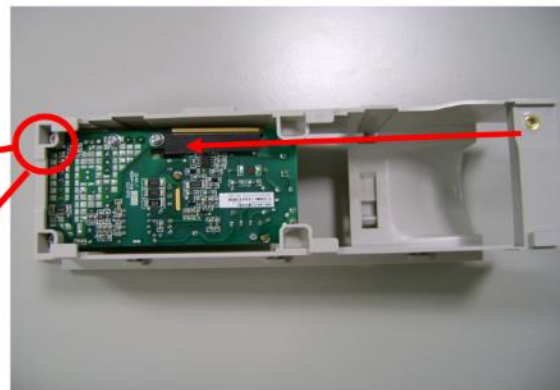
Figure 2b

Push the power supply into the cover as indicated by the red arrow until it reaches the end of the power supply cover, as shown in Figure 2b. Make sure the two edges of the power supply PCA are completely inserted into the slots on the power supply cover as shown in Figure 2c. Figure 2a shows the Power supply PCA edge is not properly inserted in the slots on the power supply cover.

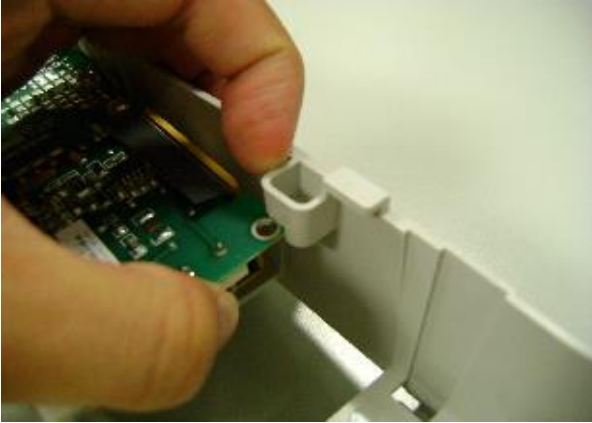
Figure 3a

Pull one side of the cover outward while pulling the Power Supply PCA upward, so that the power supply PCA slides into the slot on the Power supply cover as shown on Figure 3a. Do the same for the other edge of the power supply. The Power supply cover with the power supply properly installed is shown in Figure 3b.

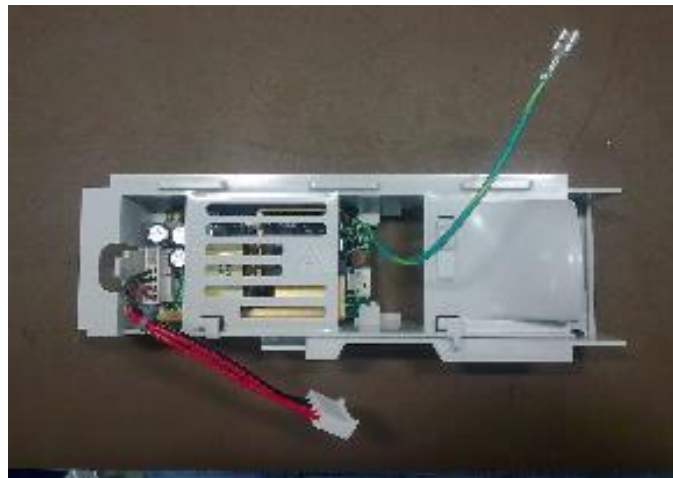
Figure 4

Install the Power Supply cable (53200-61619) and the Chassis Ground Cable (53200-61610) into the power supply connectors as shown in Figure 4.
