**4294A-05D**

# S E R V I C E N O T E

## Agilent 4294A Precision Impedance Analyzer

### Part Number Changes for LCD and LCD Assemblies with backlight lamp change recommendation

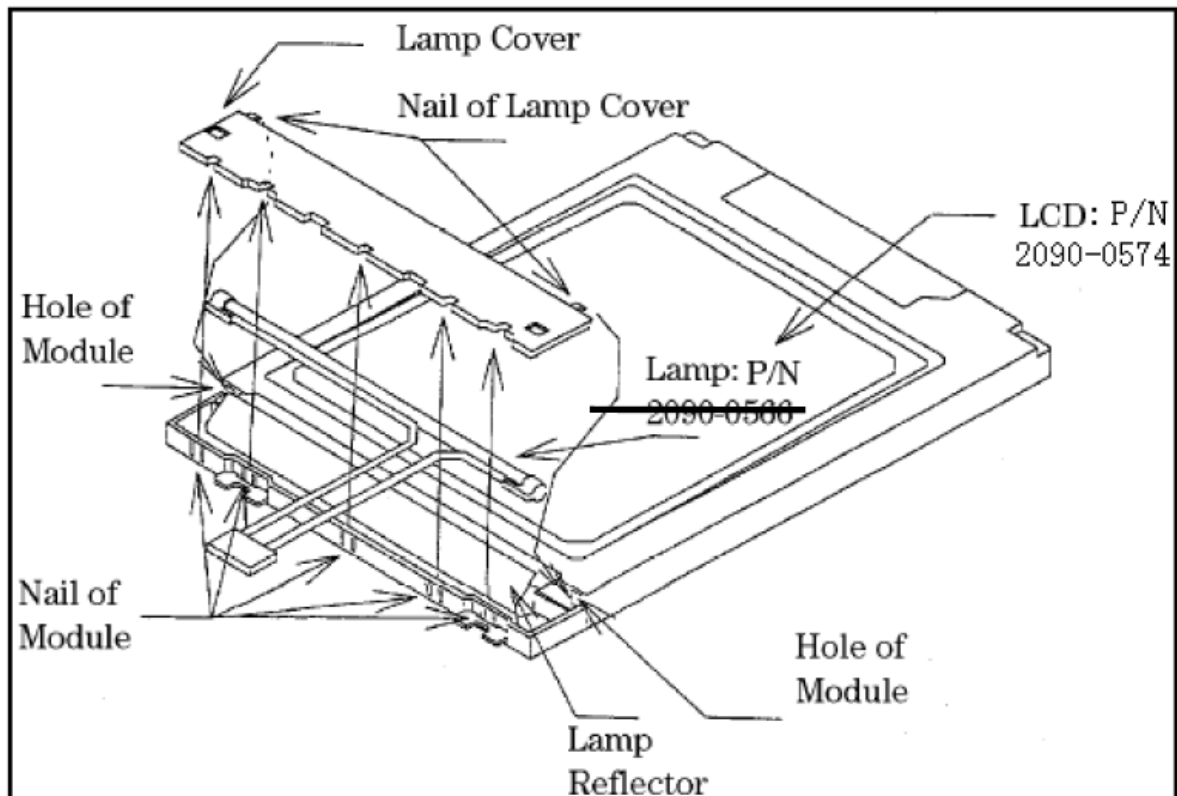
When replacing the backlight lamp in the old LCD, remove the lamp install new one as illustrated in the following figure.

2090-0556 was replaced by 5188-1640

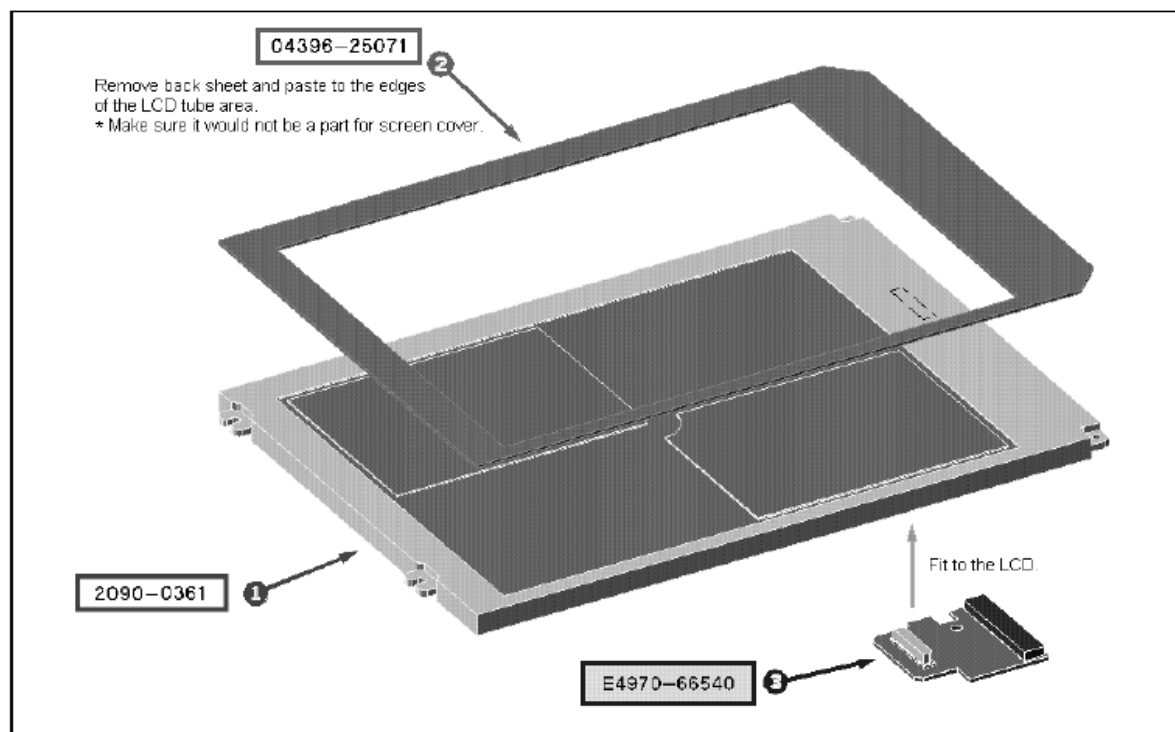
The procedure for the new LCD assemblies are as described below.
