5DX-89

S E R V I C E N O T E

5DX Series 5000 Systems

Defective Vac Ion Power Supply Failure Can Damage X-ray Tube

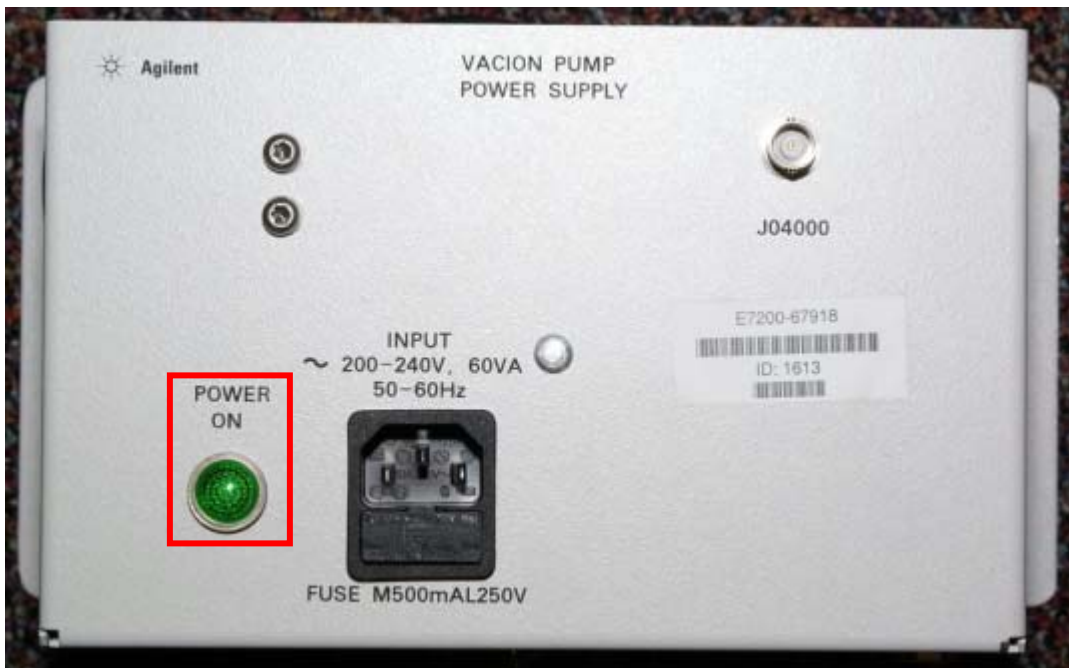
Figure 1: Green Lamp Indicator on Vac Ion Power Supply

1. During the weekly Preventive Maintenance of the system, verify that the green lamp indicator on the Vac Ion Power Supply is lit.

2. If the green lamp indicator is observed to be OFF, pull out the fuse compartment and verify if the active fuse is blown. Note that there is also a spare fuse
