6063B-04A-S

**6063B - DC ELECTRONIC LOAD SINGLE-INPUT
3-240 Volts. 0-10 A, 250 Watt**

POSSIBLE “SHOCK PINCH” HAZARD

Due to poor soldering, the instrument’s internal safety grounding may be faulty.

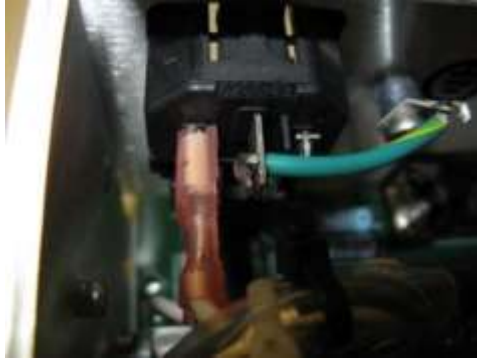
Figure A

Refer to Figures “A” & “B” below. These figures are representative of insufficient solder connections at the ground pin of the AC INPUT MODULE and the instrument chassis ground.

If the Safety ground wire connections shown in Figures “A” & “B” do not meet or exceed acceptable solder connections as shown in Figure “C”, then the Safety ground connections must be repaired. Any person doing the repair must have the required knowledge to identify defective solder joints. It is also a requirement that the person doing the repair has the required skills to use hand tools and a soldering iron.

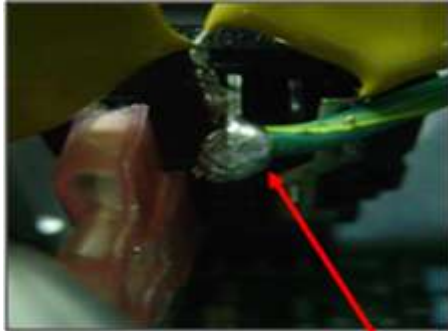
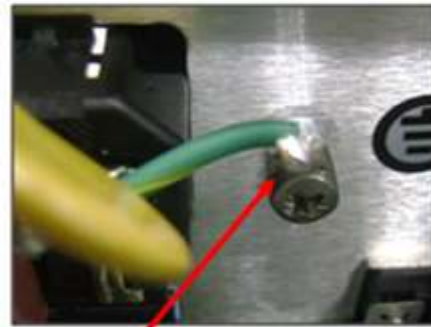
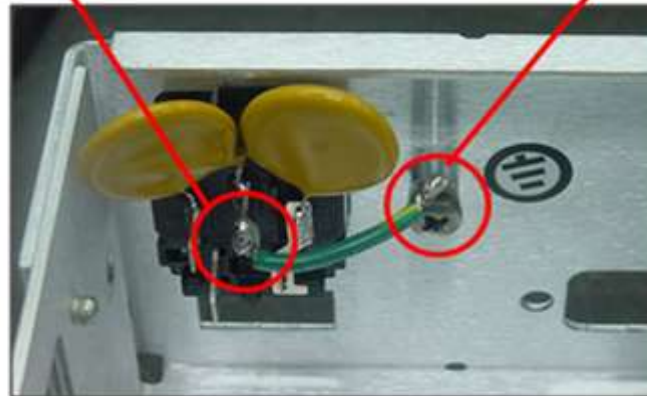
Figure “C”

“ACCEPTABLE GROUND CONNECTION”
