6621A-14

S E R V I C E N O T E

6621A DC Power Supply

Intermittent Power Transformer “Magma” Connections

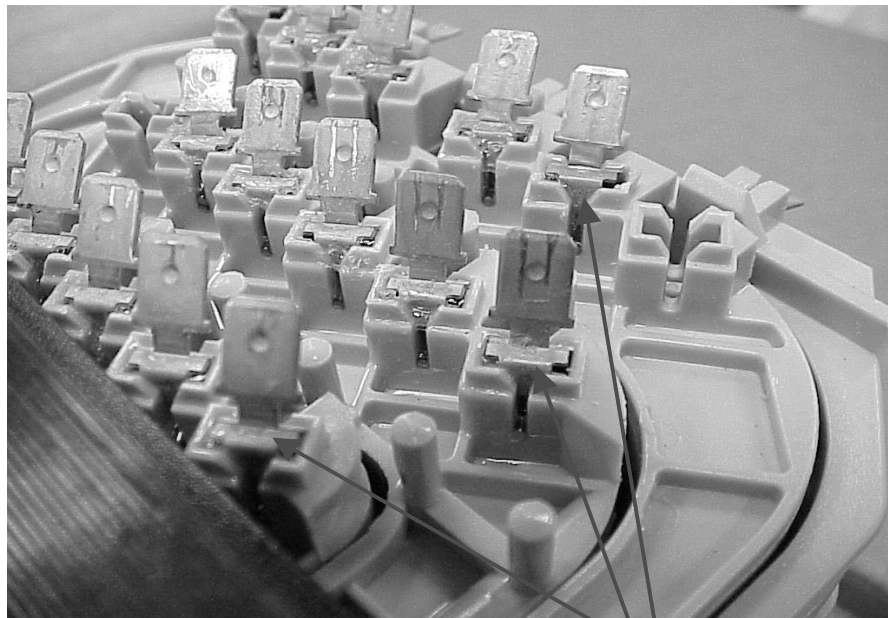
Top View of Power Transformer:

The power transformer vendor mistakenly installed the wrong “Magmates” in a run of power transformers. The incorrect “Magmates” have a # 43 stamped on them, which corresponds to a 15 gauge wire size. The correct size “Magma” should be # 24 designed for a 19 gauge wire size.

This could result in a variety of intermittent as well as steady hardware problems and errors. Examples: HDW ERR CH 1, Blank front panel display, not meeting specifications.

Replace the Power Transformer with a new replacement Transformer, see the table above for the correct power transformer part number.

NOTE: Please inspect the new transformer for the correct “Magma” number stamping.

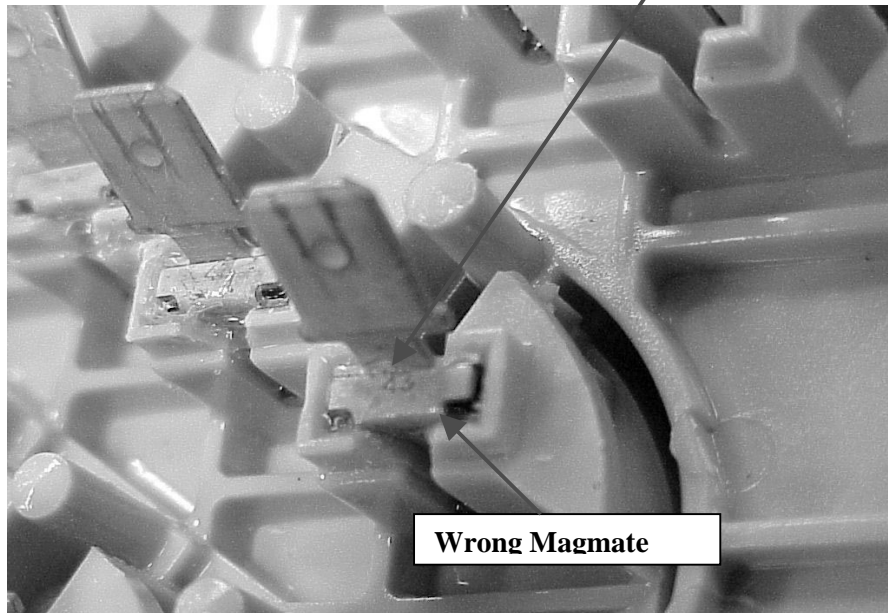
Incorrect “Magma” number 43 on the Surface, This should be number

Wrong Magma
