# 6633B-09 <u>S E R V I C E N O T E</u>

## Agilent 6633B DC Power Module

There is a possible glitch on the output due to an AC Line sag between 23 VAC to 27 VAC.

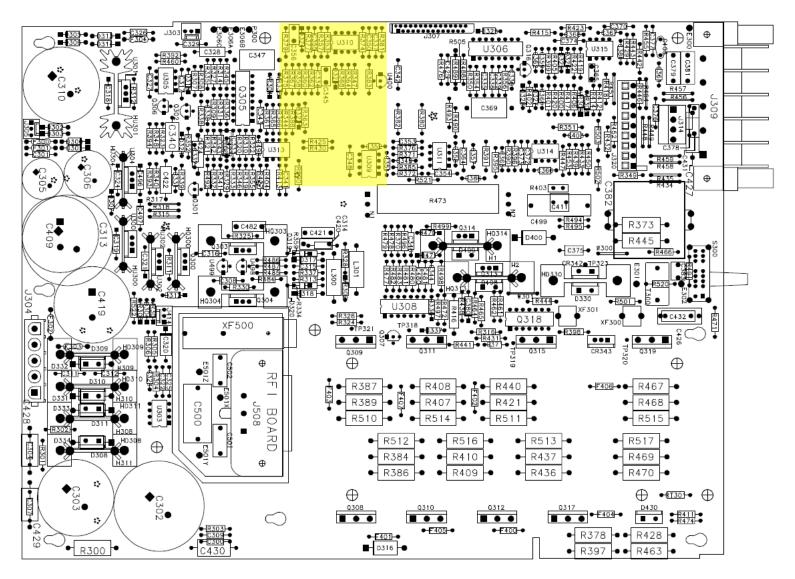
Figure 1. A1 Board Layout

The figures below show where to solder the diode (P/N 1901-1344) from R358 to C345 on the A1 main board.

The solution is to implement a diode (P/N 1901-1344) that clamps the op-amp to 0.7 V. This prevents the op-amp from driving the output on, and does not affect it due to a normal operation at -5V DC.
